Seri Nalla Fault Zone, Atal Tunnel, Rohtang- Overcoming the Challenges

Mridupam Pathak

PEMS Engineering Consultants Pvt. Ltd., D2-PEMS-ICT JV, Manali, India

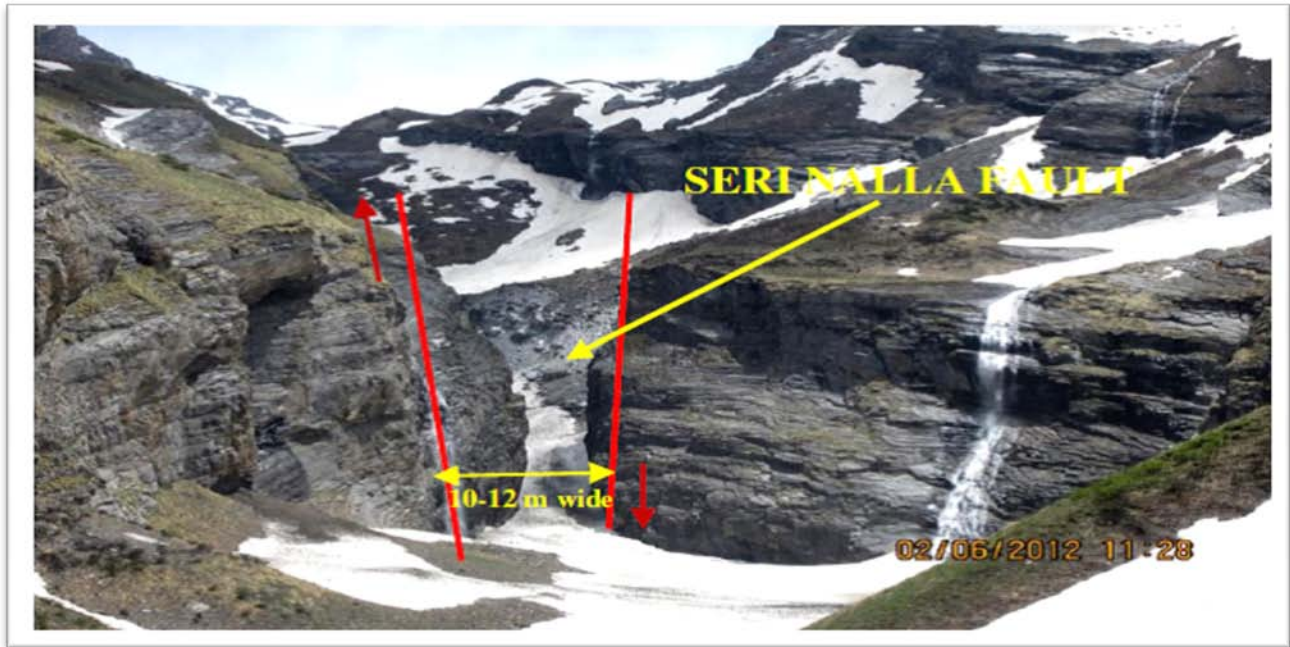
The Seri Nalla along the tunnel alignment at surface starts at Ch. 2+350m and ends at Ch. 2+523m. The most important lineament affecting the tunnel alignment is the Seri Nalla fault (Figs. 4, 5 & 6). This fault is trending N50°E-S50°W, with an almost vertical to sub-vertical dip. In addition to the Seri Nalla fault, there are a number of parallel or sub-parallel minor lineaments across the Seri Nalla that are also crossing the tunnel alignment. The width of fault zone at surface is around 173 meter and consists of sheared phyllite with clay gouge. Along the slopes of left bank (Western Bank) of Seri Nalla the rocks are highly jointed and fractured quartz phyllites. Along the slopes of the right bank (Eastern Bank) of Seri Nalla moderately jointed phyllites and quartz phyllites are observed.

Figure 4 - Seri Nalla fault at surface

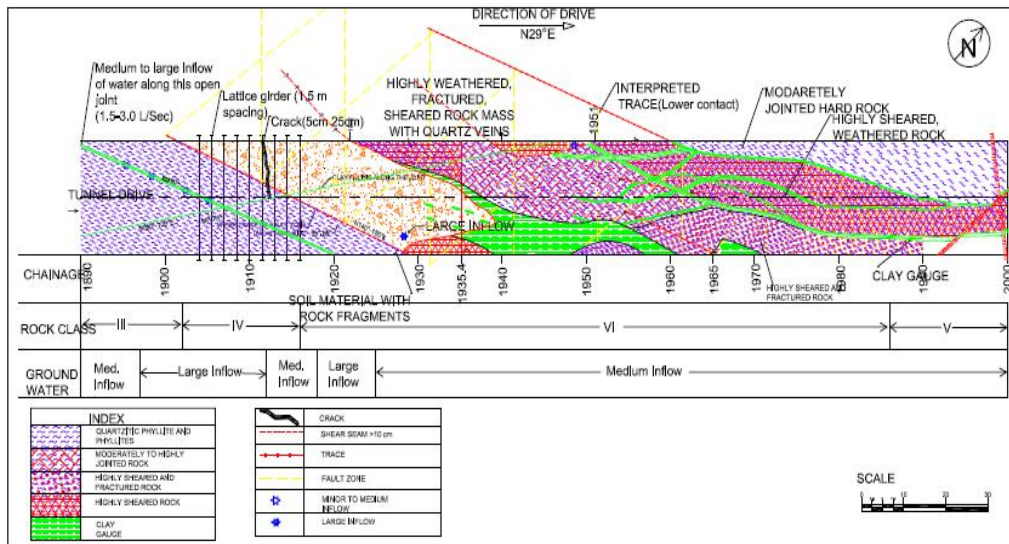
The rock type occurring in this zone was basically quartzitic schist, quartzitic phyllite and phyllite along with sheared and shattered rock mass and clay gauge. The presence of sheared rock mass and clay gauge materials indicates the presence of fault zone. The rocks were intersected by a number of shear seams and minor fault planes. The rock type was classified as rock class III at the start of this zone and gradually with the occurrence of continuous poorer strata; the rock type was gradually changed to Class IV, Class V and Class VI. “Q” value in this area ranged from 1.36 to 0.06 (Poor to Extremely Poor). Minor to medium inflow of water (1-3 l/sec) was seen in this zone (Fig.7).

Figure7- Geological plan at tunnel grade between Ch. 1+890m and Ch. 2+000m

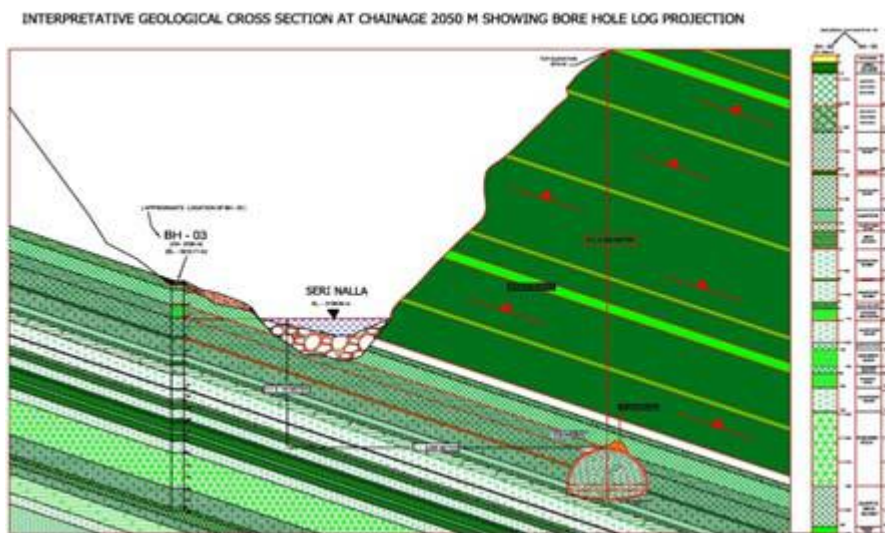
When the face reached Ch. 2+046 m, minor inflow of water was recorded from face along the foliation plane. The rate of seepage increased when face reached Ch. 2+049 m; initial rate of inflow of water at face was around 5 l/s and then increased upto 30 l/s. Ch 2+049 to 2+050 m, the first cavity was formed with about 400 m³ of muck flowing out. Figure 8 shows the geological cross section.

Another cavity much larger than the previous one was formed at Ch. 2+077 m where about 1000 m³ muck flowed out. One more cavity was formed at Ch 2+158 to 2+159 m where 20-25 m³ muck came out.

Figure 8 - Geological cross section of Seri Nalla at Ch. 2+050m (Pathak et al., 2020)

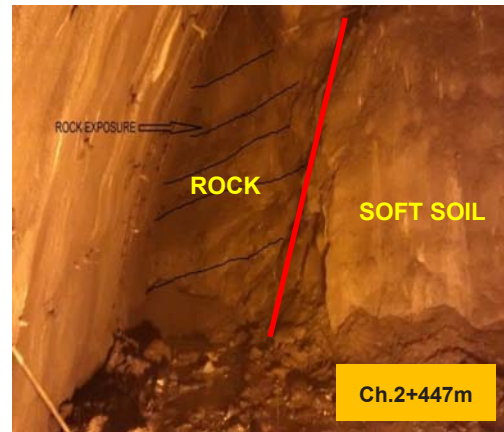
With the increase in rock exposure in the face, “Q” value increased to 0.73 to 0.95 at Ch 2+459 and 2+460 m (Figs. 9 & 10).

Figure 10 - End of Seri Nalla fault zone

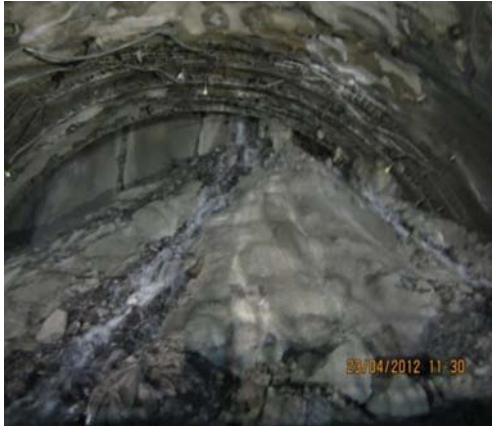
When the excavation face reached Ch. 2+046 m, minor inflow of water was recorded from face along the foliation plane (Fig. 11). The rate of seepage increased when the face reached Ch. 2+049 m; initial rate of inflow of water at face was around 5 l/sec and then increased up to 30 l/sec. At Ch 2+049 m to 2+050 m, the first cavity was formed with about 400 m³ of muck flowing out. Effort was made to control and divert the water from the face by using PU grout and also by stabilizing the face with shotcrete and additional rock bolts. The second cavity, much larger than the previous one was formed at Ch. 2+077 m where about 1000 m³ muck flowed out (Fig. 12). The third major cavity was formed at Ch. 2+390 m where 100 to 150 m³ muck flowed out. Table I shows the muck flow in the Seri Nalla zone.

Figure 11 - Cavity at Ch. 2+045m

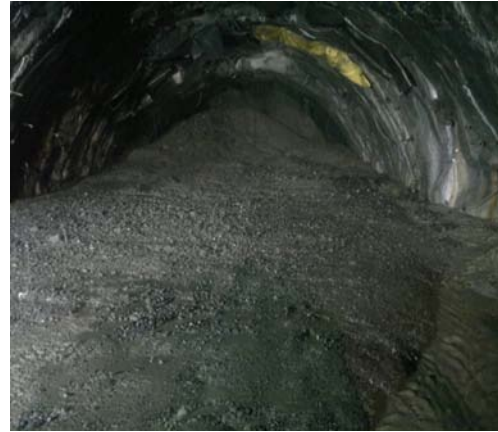
Figure 12 - Cavity at Ch. 2+077m

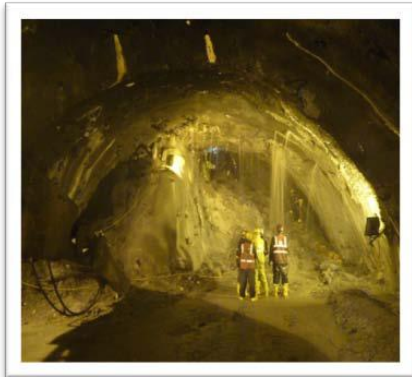
High ingress of water was first encountered at Ch. 2+045m where the flow on the first day was 5l/sec which after 2-3 days increased to 30 l/sec. The maximum ingress of water was encountered between Ch. 2+390m to Ch. 2+410m where the inflow of water was 100-110 l/sec.

Figure 13- Heavy ingress of water

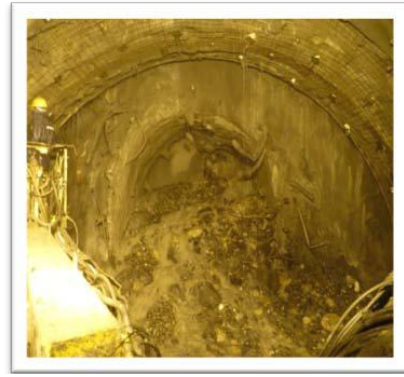
River borne materials (RBM) was encountered from Ch. 2+370m till Ch. 2+460m from the south portal side. The RBM material comprised of rounded to sub-rounded boulders, cobbles, pebbles, gravels in clayey, silty, sandy matrix along with sand pockets and clay bands.

Figure 14 - Flow of river borne material

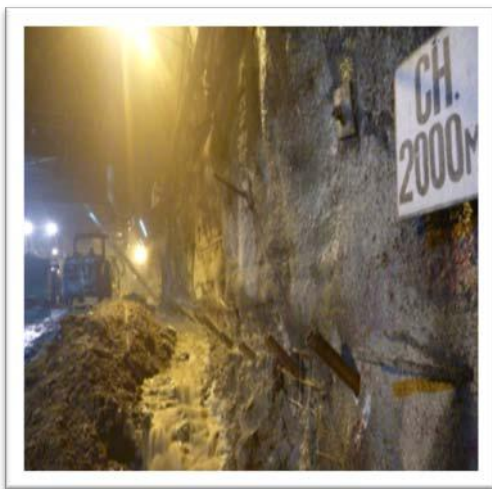
Figure 18 - Piling

Piling was carried out to provide additional support to the tunnel walls before benching. Pilling was carried out from Ch.2+000 to 2+080m using MS pipes of 76 mm diameter, 6 m in length and inserted at a spacing of 1 m on both sides at an angle of about 45° in downward inclined direction (Fig. 18).

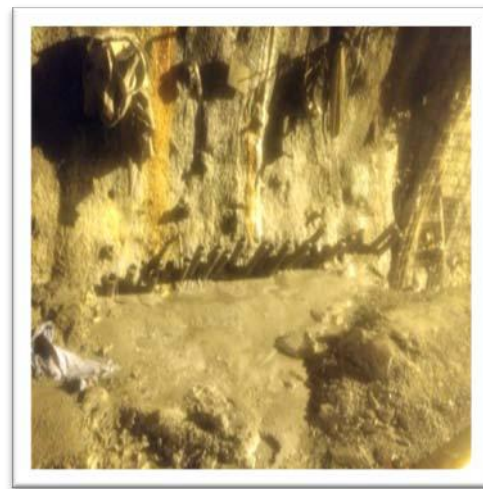
Figure- 19 Micro piling at LG base

These were same as soil dowels. These were reinforcing hollow bars and were grouted. Micro piling was carried out between Ch. 2+345 to 2+370m to counter the high vertical deformations. These micro piles were 114 mm in diameter and 6 m in length, fully reinforced. These micro piles were inserted near the base plate of Lattice Girders in vertical direction downwards. Eleven numbers of micro piles were again inserted between Ch. 2+403.50 and 2+407.50m. These were inserted 50° downwards near the base plate of lattice girders and reinforced with 20 mm steel bars. These micro piles were 76 mm in diameter and were of 6 m length with 3 m length being perforated (Fig. 19).

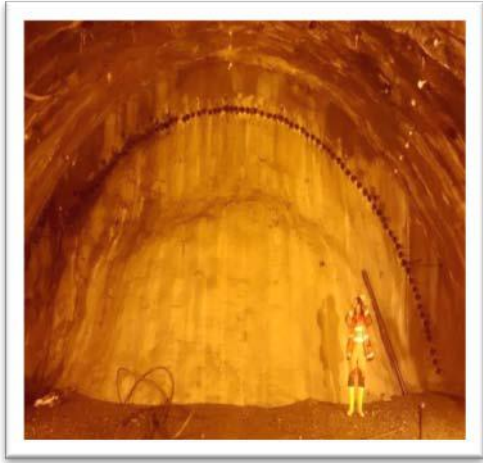
Figure 20 - Single row pipe roof

Forty rounds of pipe-roofing were installed in the Seri Nalla zone with different length and diameter between Ch. 2+045 and 2+458m (Figs. 21 & 21) with following specifications:

- Single & double layer pipe roof,
- Pipe roofing using dia 76.0, 88.9, 114.3 mm,
- Length of pipe-roof used 9, 12 & 15m,
- 40mm rod inserted within 114 mm pipe-roof to act as additional reinforcement,
- Fore-piling also done with SDR in between pipe roofs, and

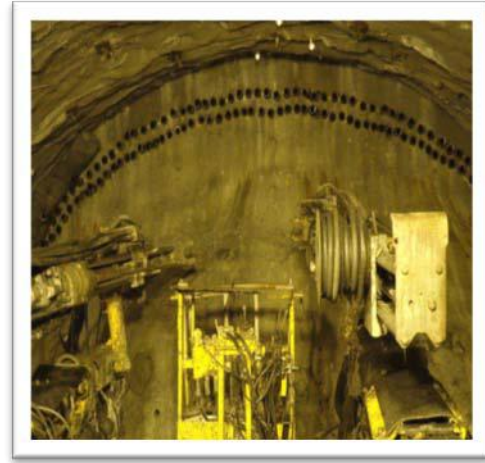
Figure 21 -Double row pipe roof

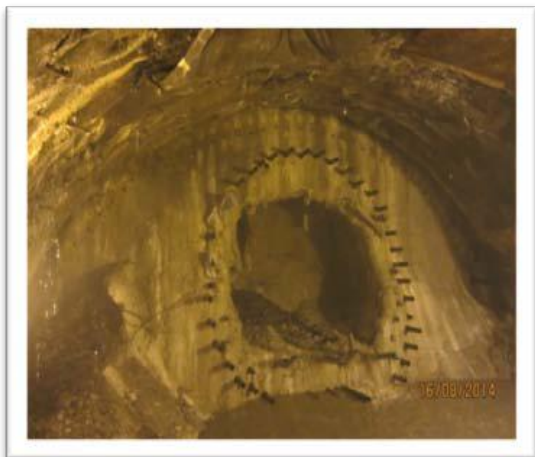
Figure 22 - Pilot tunnel

This method was applied in a small stretch from Ch. 2+385.45m to Ch. 2+394.50m where a secondary tunnel smaller in diameter (4 m) to the main tunnel was first excavated through the weak strata (Fig. 22).

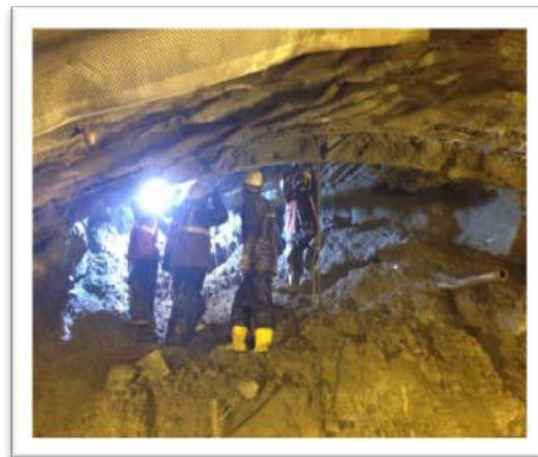
Figure 23 -Multiple drift excavation

Multiple drifting with panel excavation was done in the RBM (river borne material) encountered area where the heading was divided into small panels and excavated accordingly (Fig. 23). A continuous shell was created by excavating sections in panels. Each panel was individually supported with wiremesh and shotcrete. Once peripheral arch was completed, the lattice girder was erected. This also ensures that the deformation of the rock mass/tunneling media is kept to a minimum. A face stabilization core was left at the centre of the face to act as additional support against the flowing ground condition, which had been previously supported with wire mesh, shotcrete and rock bolts.

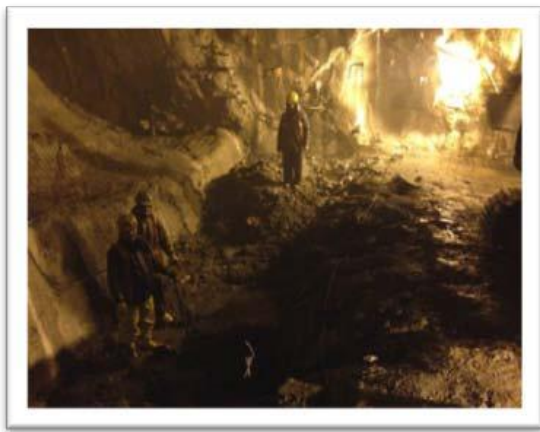
Figure 24 - Excavation for temporary invert

Temporary invert was excavated in very poor to extremely poor ground conditions (Excavation Class 6 &7) to act as a counter measure against upheaving of soft ground (Fig. 24).

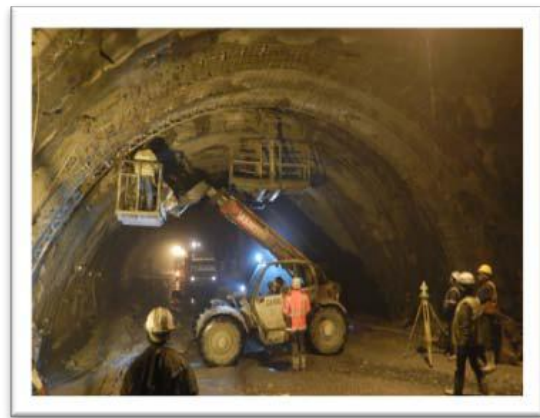
Figure 25 - Saw tooth filling

As the pipes used in pipe roofing cannot be inserted horizontally along the tunnel, so they had to be drilled at an inclination of about 8° to 10° from horizontal. Due to the inclination, it created gap between excavation and actual required level, so to fill this gap saw tooth filling was used. Saw tooth filling was carried out between Ch. 2072.00 to 2462.00 m. The Saw tooth was filled with shotcrete from one pipe roof round to another (Fig. 25).

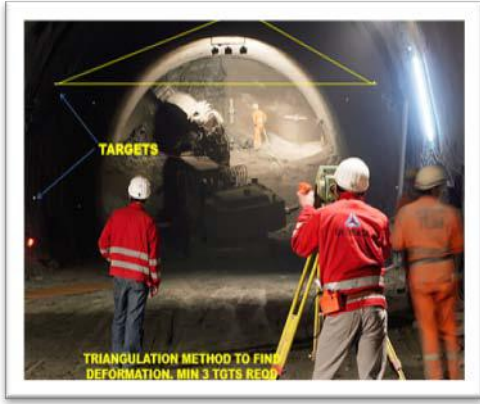
The maximum vertical deformation recorded was 861.0 mm at Ch. 2+403m between 11'O clock and 12' O clock position after excavation. The maximum horizontal deformation recorded was 275.0 mm at Ch. 2+030m between 9 and 10'O clock position. The rate of movement was very high in this zone.

The larger and continuing long-term deformation normally occurs in rock of low strength. The entire reach of Seri Nalla were in sheared, shattered rock mass and river borne material (RBM) with medium to high inflow of water, which has low strength as indicated by its character(Fig. 26).

Figure 26 - 3D deformation monitoring

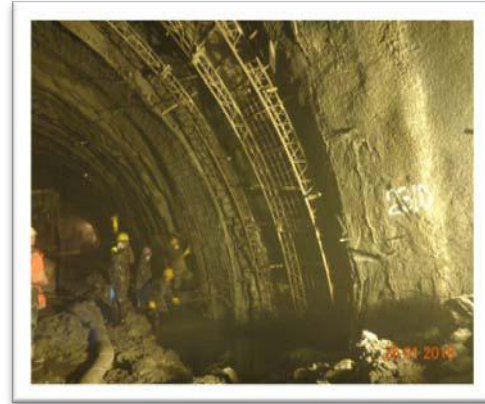
As seen from the 3D monitoring results, the deformation in the Seri Nalla heading had deformations up to 891mm. Re-profiling had to be carried out at several places due to undercuts in those sections. These undercuts were due to the higher deformations in those areas. Scaling of these areas had to be carried out together with cutting of the previously installed pipe roofs, lattice girder, rock bolts and new lattice girders had to be installed followed by wire mesh and shotcrete (Fig. 27).

Figure 27 - Re-profiling and lattice girder support
