## *Failure Mechanism of a Large Wedge in Open Cast Mine Composed of a Granite Porphyry Rock Mass of Aravali Region - A Case Study*

*Manish Kr. Meena\*, Ashok Kr Singh, R. D. Dwivedi, J. K. Mohnot*

*CSIR-Central Institute of Mining & Fuel Research Centre, Roorkee, India*

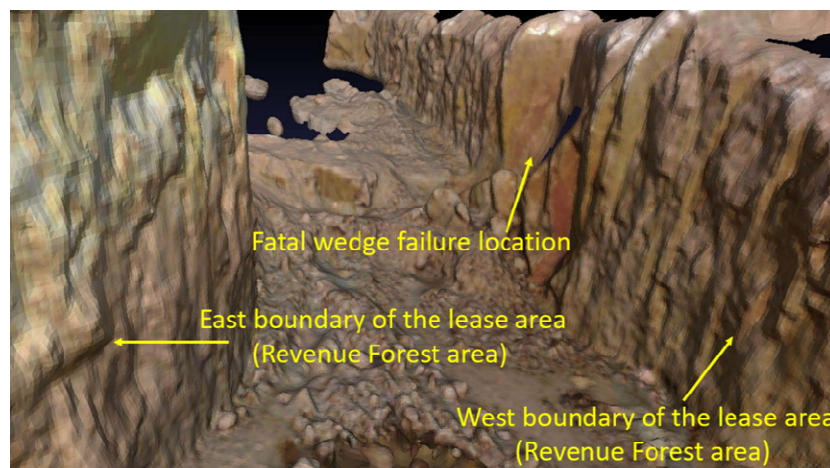
The slope failure accident occurred in the slope section of Pit No. 37 & 38 adjacent to the revenue forest area in the eastern and western margin of the pit (Fig. 1). As the failure occurred at the boundary of Pit No 37 and 38, both the Pits are shown in Figure 1. The height of the slope is about 40 m with an almost vertical slope inclination towards  $90^{\circ}/120^{\circ}\pm 5^{\circ}$  (slope face direction). The rock mass of the failed slope appears very blocky and competent. The flow imprints of infilled joint materials (clay and silts) were quite visible on the remnant vertical and day-lighted oblique joint walls (Fig. 2a). This signifies the water inflow within the open joints that washed out the soft infilling materials and might create slip surfaces along the oblique joint resulting in massive wedge failure probably due to a sudden decrease in shear strength along the basal joint plane. The surface joint (J1) acted as a release plane for such a huge size (28 m × 12 m × 8 m) wedge failure (Figs. 2a & 2b).

Figure 1 - 3D view of Pit No. 37 & 38 with location of fatal wedge failure derived from LiDAR survey

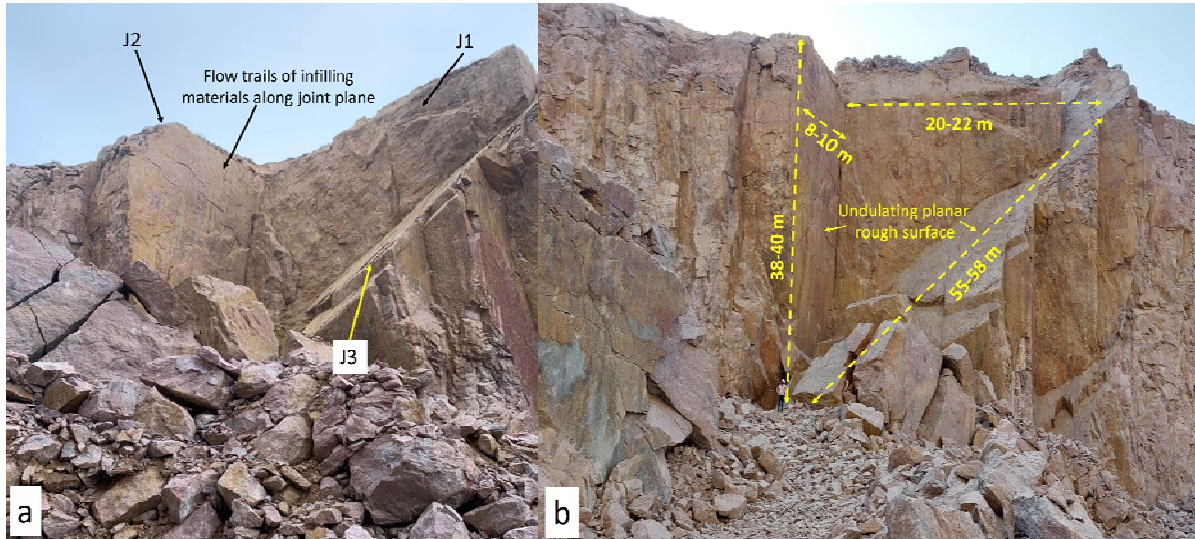
Figure 2 - (a) Failed wedge with relic flow trails of infillings along the major joints (b) Dimension of failed wedge

The exiting slope section consists of three sets of major joints ( $J_1$ ,  $J_2$  and  $J_3$ ) with random ones (Fig. 2a & c). The major joints ( $J_1$ ,  $J_2$ ,  $J_3$ ) are quite persistent (varying from 22-55 m) with wide to very wide spacing (8-10 m) that instigates the occurrence of very large to extremely large in-situ blocks to failure. The major joints,  $J_1$ ,  $J_2$ ,  $J_3$  are mutually orientated unfavourably leading to the formation of various unstable blocks that cause rock failure mainly wedges and toppling types (Fig. 2c). Joint  $J_3$  acted as plane along the slid wedge (Fig. 2a). The stability condition degrades drastically as joints dilate due to progressive weathering (Fig. 2d) as suggested by Goel & Mitra (2021) due to geo-environmental agents such as water, temperature variations along with the distressing of rock mass because of excavation. The visual inspection suggests that pit slopes have the potential for joint-controlled block failures due to overhanging blocks.

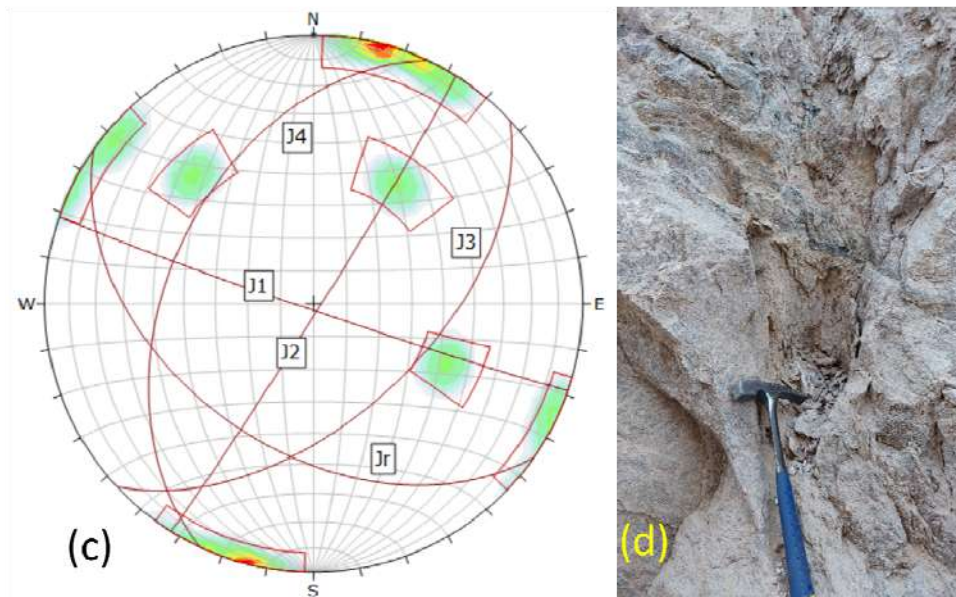
Figure 2 – (c) Stereographic projection of collected joints (d) highly weathered granite rock mass

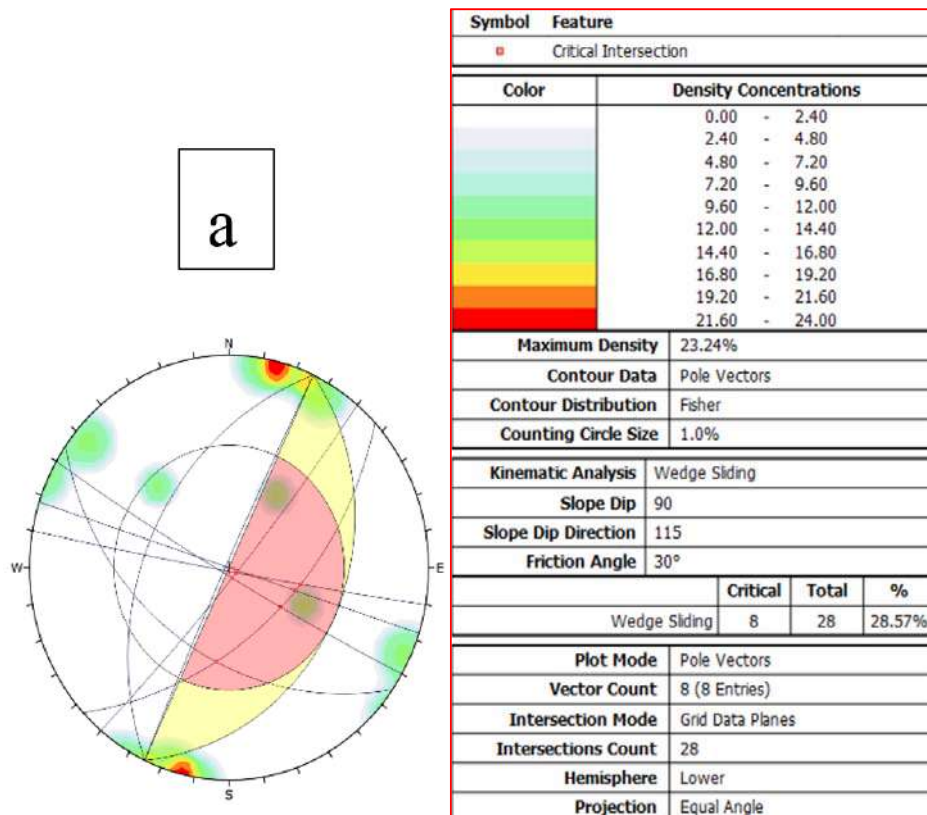
Kinematic analysis of the pit section suggests a high potential for large wedge-type failure released from the  $J_1$  &  $J_2$  having mean orientations of  $88^\circ/199^\circ$  &  $88^\circ/122^\circ$  respectively and gravitational sliding along the day-lighted joint,  $J_3$  with the mean orientation of  $55^\circ/137^\circ$  (Figs. 4a-d).

Figure 4 (a) - Potential wedges from all joint data

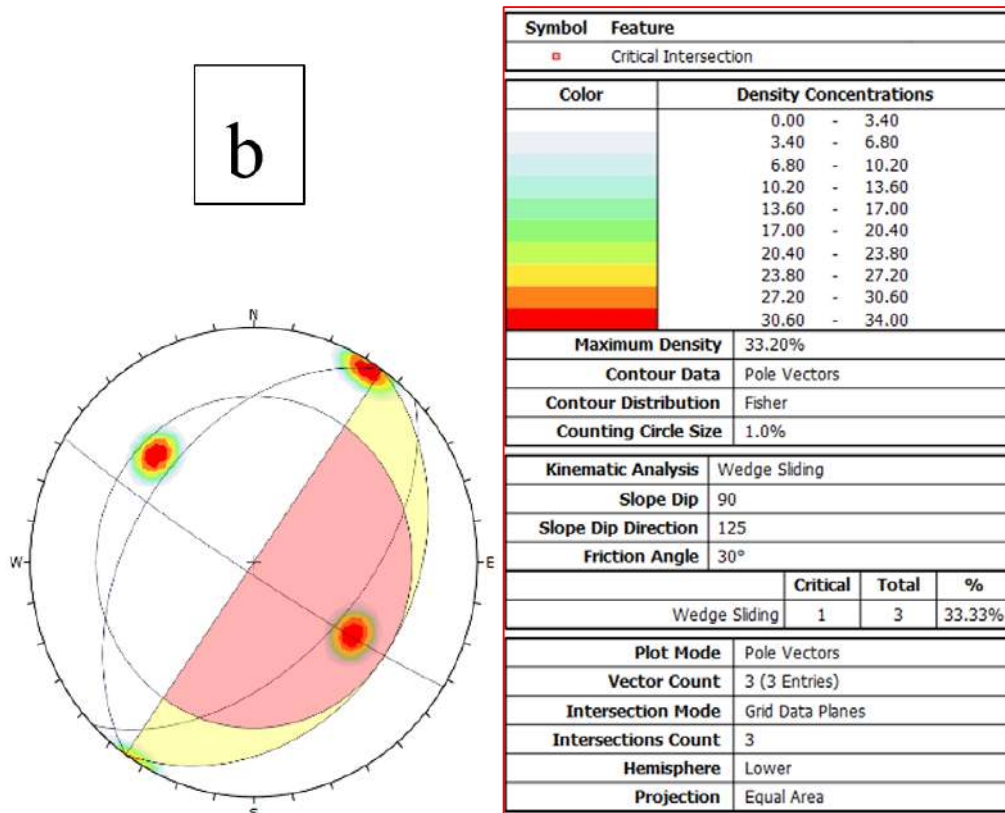
Figure 4 (b) - Potential wedges from mean joint

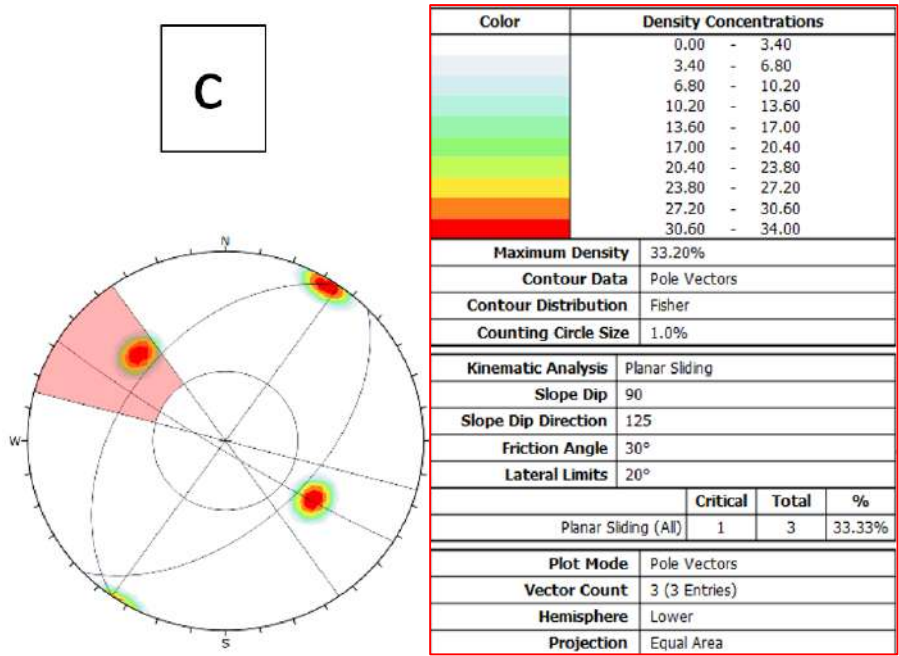
The kinematic analysis also suggests susceptibility for planar and direct toppling types of failure. The planar failure is prone along the inclined joint, J<sub>3</sub> towards vertical excavation (120°±5°). The calculated SMR using the continuous function is from 16 to 27 referring to class IV & V (Romana, 1985). Class IV refers to planar or big wedge failure, whereas class V refers to big planar or soil-like or circular failure. Exactly the same has happened at the site. The kinematic analysis predicts 8 critical wedge failures out of 28 from all the joint data (Fig. 4a). Based on the collected joint data and field evidence, the wedges formed by joints, J<sub>1</sub>, J<sub>2</sub> & J<sub>3</sub> are most susceptible to failure as depicted by the kinematic analysis (Fig. 4a) which were involved in the failure. However, the individual criticality of each wedge has not been determined in this work.

Figure 4 (c) - Potential planar failure from mean joint

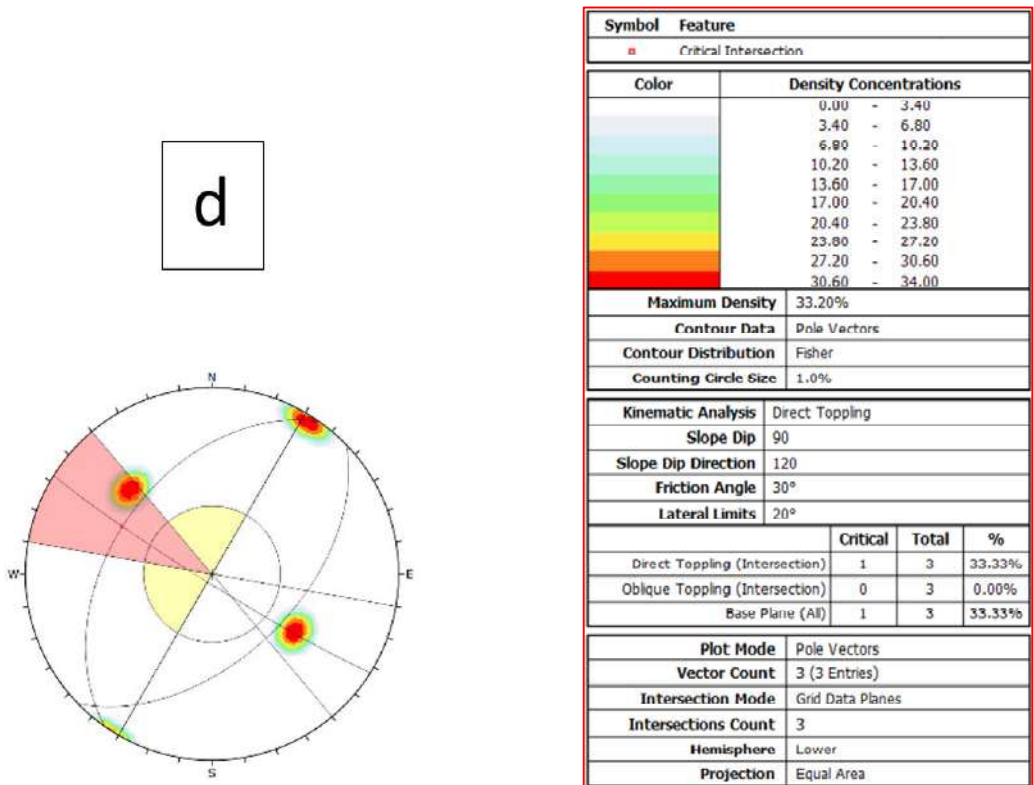
Figure 4 (d) - Potential toppling from mean joint

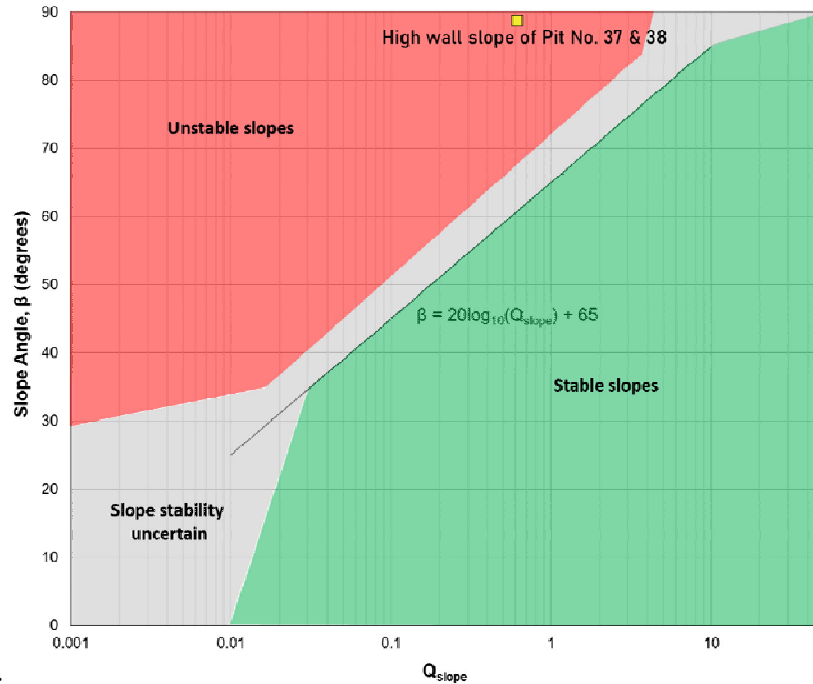
Parameters RQD,  $J_n$ ,  $J_r$ ,  $J_a$ , and  $J_w$  were evaluated for Q-slope considering the potential wedge failure with values of 74.5, 12, 3, 3, and 0.8 respectively with O-factor of 0.75 (Set A) and 0.8 (Set B). The SRF is taken as 5 based on the prevailing slope mass conditions. The Q-slope is found to be 0.59, which suggests the maximum safe slope angle for the studied pit is around 60° (Fig. 5).

The natural slope height on the western side of Pit No. 37 & 38, ranging from 38 m to 40 m, indicates that the Q-slope system's empirical ratings suggest an inherently unfavourable stability condition due to steep slope angles coupled with kinematically vulnerable slope mass (Fig. 5). The natural slope activity is also on the higher side due to the presence of an inherently high degree of jointing, the existence of over-hanged blocks, and open joints filled with soft materials (clay silt/sand). The weathering condition in the upper part of the slope and clay and silt coating in the open joints allowed the gravitational movement of an inverted loose wedge upon saturation conditions due to water. The shear strength along the rock joints decreases after the soft clay comes in contact with the water. Along with this, as mentioned earlier, several other geological and geotechnical aspects contributed to the movement of such substantial wedge failures.

Figure 5 – High wall slope of Pit No. 37 & 38 plotted in Q-slope stability chart

Considering the prevailing field constrained due to the adjacent forest area at Pit No. 37 & 38, the benching would not be feasible. However, based on the preliminary conventional stability analyses, the drapery/rock netting along with systematic bolting on a kinematically vulnerable zone can improve pit safety in the long run.
