# ***A Geotechnical Approach to Assess Roof Rock Instability In Underground Coal Mine***

***D.N.Sharma***

*The Singareni Collieries Co Ltd,  
Kothagudem-507101, A.P., India  
Email: drdn\_sharma@yahoo.co.in*

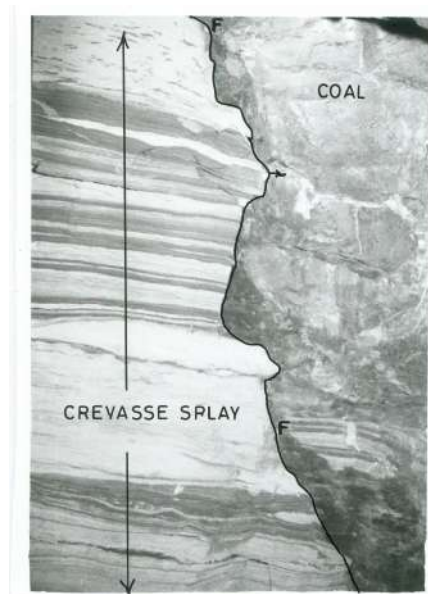
Usually, roof of working section is fine grained to medium grained sandstone with carbonaceous laminae and intercalated with shale bands very often. Some beds are poorly cemented, friable and disintegrated into loose sand, while other beds separate readily along mica rich bedding planes into flaky slabs. In some places micaceous laminae permit the roof to separate in layers and to break in large slabs. The shale is susceptible to moisture slaking and over long periods of time large falls develop. The planar-bedded siltstone is marked by closely spaced regular partings of carbonaceous matter with in bedding planes. The rock easily splits and separates along these partings, and spectacular roof falls are common (Fig. 2).

Fig. 2 – Example of crevasse splay type deposit in mine roof. A high angle fault is also seen

splay sequences generally occur when a separation along a bedding plane occurs and at or above the horizon of the roof bolts anchors, and the bolts are unable to maintain the integrity of the rock spanning the immediate roof. In the SE part of the block, it is observed that thickness of the Ross seam has increased to a maximum of 6.50 m, where mostly shale forms the roof of working section, leading to unstable conditions.

In the MVK-5 incline block, majority of the area is covered by Madaram ridge and its affect on roof instability is clearly reflected in the form of roof falls (Fig. 2). In the

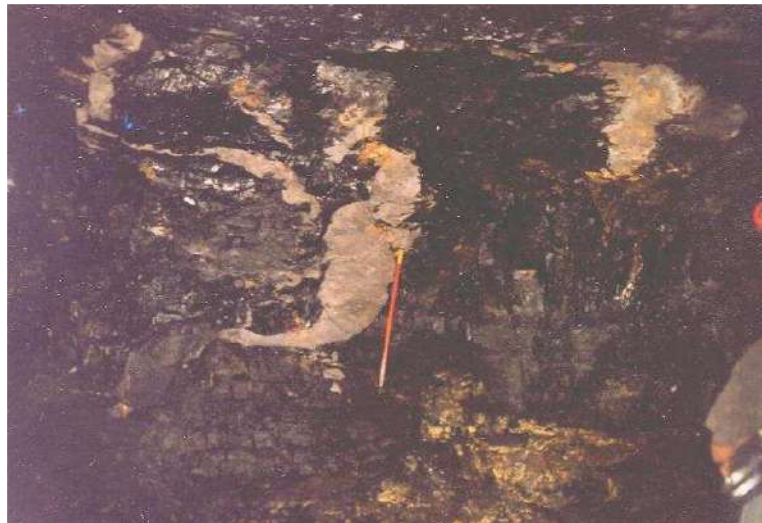
Clay veins, clay stone dykes or sandstone fillings are wedge – shaped masses that occur in crevice of a coal bed. These generally range up to 1 m. in width at the top of the coal seam. The pattern and character of these structures suggest that they formed as tension fissures in coal which later filled with clayey / sandy material and then were compacted after burial. Such sandstone dykes are observed in the Ross seam workings of the study area (Fig.3). Moebs and Ellen Berger (1982) opined that these structures occur chiefly in areas that were slightly above the level of the surrounding swamp, such as a peat island, and were therefore more subject to desiccation and fissuring. In addition to forming a discontinuity in the coal bed and immediate roof is likely to break away from the top as supporting coal bed mined.

Fig. 3 – Sandstone dyke in the coal seam and roof of working section

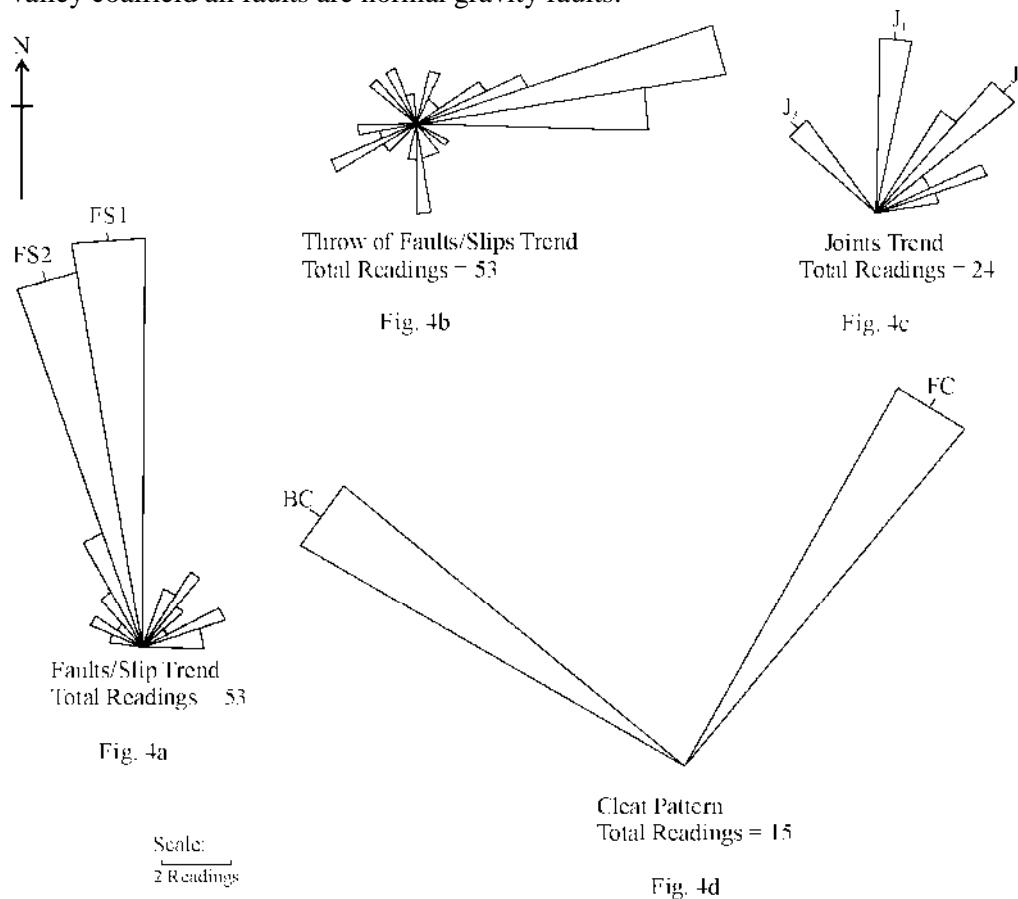
Fig. 4 – Rose diagram of Ross seam, MVK5 incline

A distinct cleat pattern is developed in the coal bands of Ross seam. The trend of cleat pattern in the study area is mapped and depicted in Rose diagram (Fig. 4d). Face cleat trends in N 35<sup>0</sup> E and butt cleat trends in N 55<sup>0</sup> W. The interesting observation as shown in Fig.6 is that both face and butt cleats are parallel to dip gallery and level gallery respectively. However, it is observed in the underground workings that cleat pattern is not significantly having any bearing on unstable roof conditions.

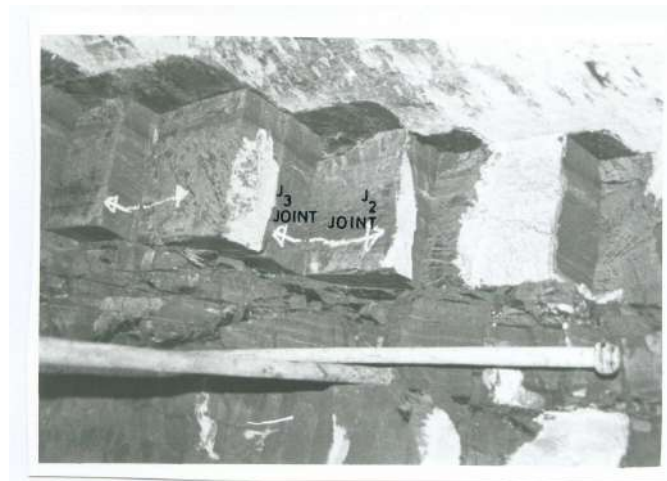
Not all joints will affect roof stability. Closely spaced joints commonly contribute to bad roof. Sharma and Chandra (1988) found that the roof falls in the Queen Seam of VK-7 Incline are due to the most prominent tensional joints J<sub>1</sub> aligned to the greatest principal stress direction ( $\sigma_1$ ). The Rose diagram drawn for joints mapped in the study area reveal that most prominent joint J<sub>1</sub> is in the direction of N4<sup>0</sup>E (Fig. 4c). Next prominent set J<sub>2</sub> falls in the direction of N 45<sup>0</sup> E and the least prominent set J<sub>3</sub> is in the direction of N 45<sup>0</sup> W (Fig. 4c). Joint spacing varies from 0.05 m to 1.00 m Apertures in the joints are present which varies from 3 mm to 20 mm. The intersection of J<sub>2</sub> joints with J<sub>3</sub> joints is at right angles as observed in the mine (Fig. 5). In few cases along the joints, apertures were filled with calcite. It is noticed that nature of joint surface varies between planar to undulating rough surface. It is evident from the above observations that joints also contributed for the unstable roof conditions in the study area.

Fig. 5 – Intersection of J<sub>2</sub> and J<sub>3</sub> joints at right angle

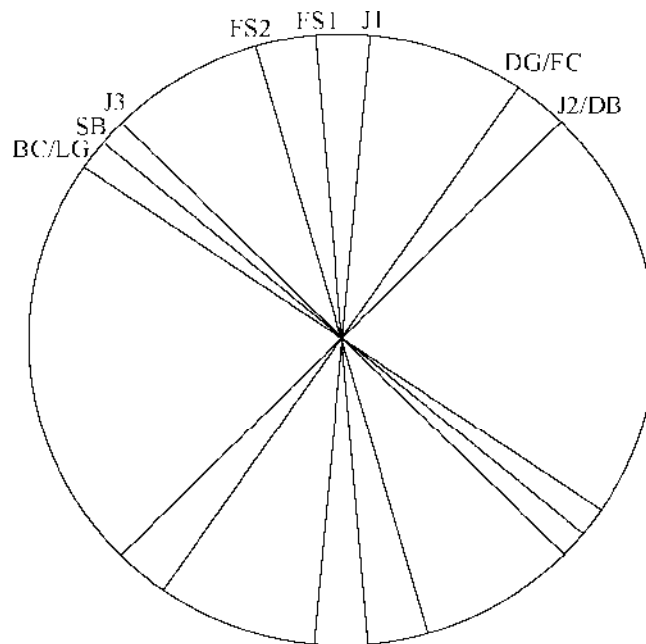
Fig. 6 – Trends of discontinuities
