Case History of Head Race Tunnel of Dulhasti Hydroelectric Project

D. G. Kadkade

Jaiprakash Associates Ltd.

ABSTRACT

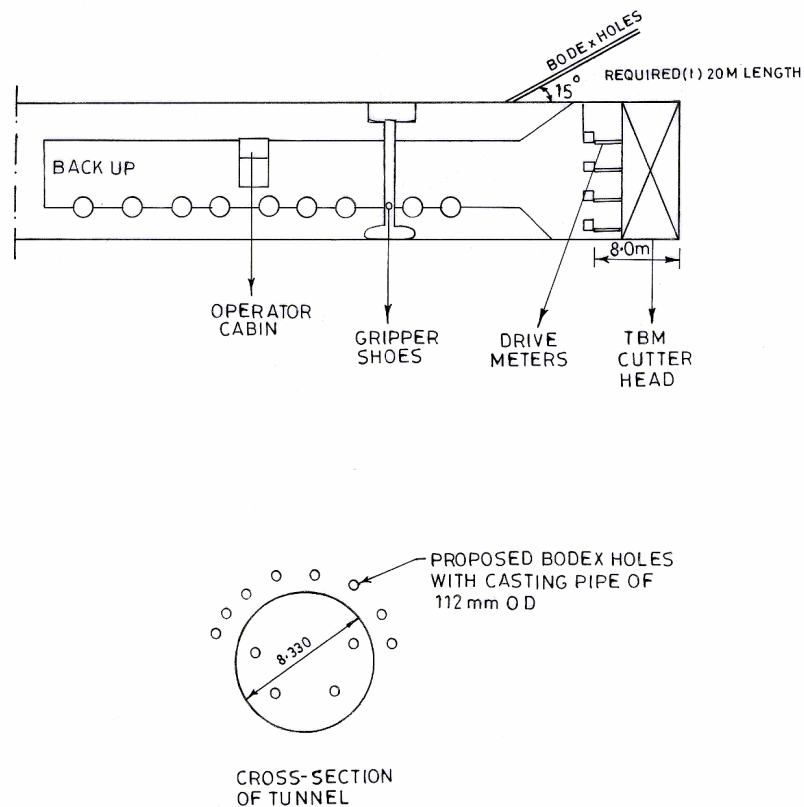
On 26th of June 1999, the TBM went out of action due to a massive shear zone. The first attempt was tried to see whether engineers could get over the shear zone by use of umbrella arch method. In order to do this, Odex equipment was imported from Atlas Copco, Sweden. During the use of this equipment, the shoe bit was crushed due to highly abrasive rock in a drilling length of less than 5.0 metre and thereby the casing pipes were cracked and jammed. Drilling had to be started from behind the TBM whose length itself was about 8.00 metre and for effective drilling engineers had to drill at least 20 metre as shown in Fig. 1.

Fig. 1 – TBM at Dulhasti head race tunnel and drainage holes

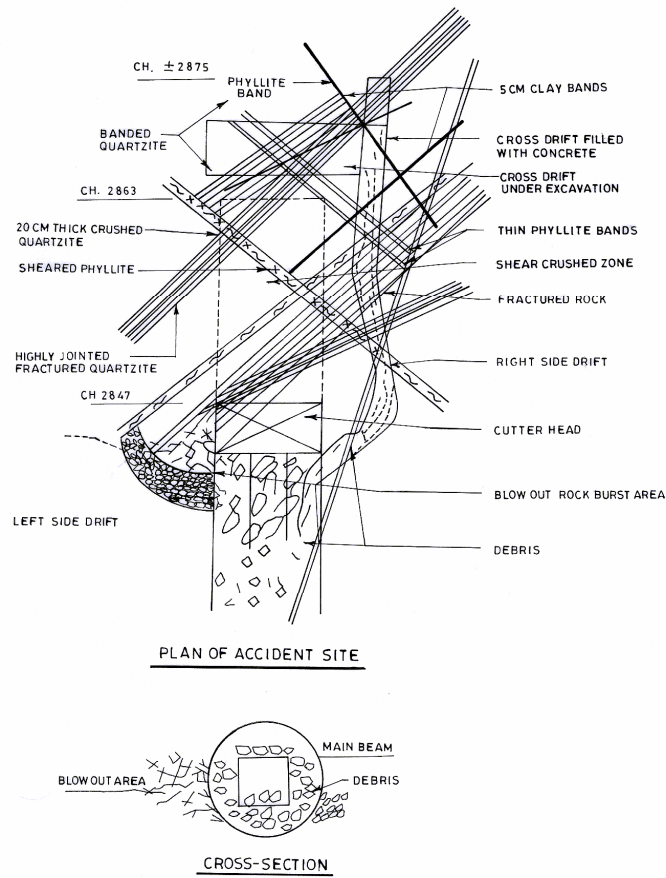
Fig. 2 – Side drifts to tackle face collapsed problems in TBM driven section

After discussions with the client, it was decided that the method to be adopted in the circumstances would be to make 2mx2m drifts on either side of the tunnel allowing the water to drain and consolidate the debris in front of the TBM by further use of chemicals and cement as shown in Fig. 2. Details of the drifts excavated and creation of an umbrella on them is given in Fig. 3.

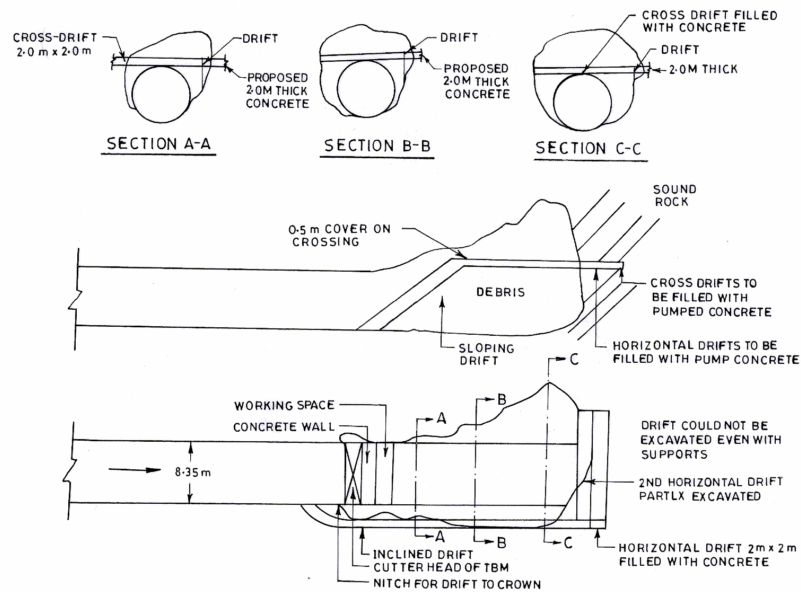
Fig. 3 – Proposed method for crossing shear zone, Ch. 2846 to 2865m in HRT

- a) Construction of two drift on each side of the tunnel alignment as described above.
- b) Construction of 2m x 2m cross drift between the above drifts spanning the tunnel. These cross drifts were to be excavated in the rock just above the proposed profile of tunnel, it was supposed to be sloping right and left side having highest point at the centre line of HRT. This cross drift was to be filled with concrete and next cross-drift was to be made adjoining the previous one.
- c) By making a number of cross-drifts and filling them with concrete, a canopy of concrete was to be created in advance above the projected crown of HRT to be excavated by TBM subsequently.

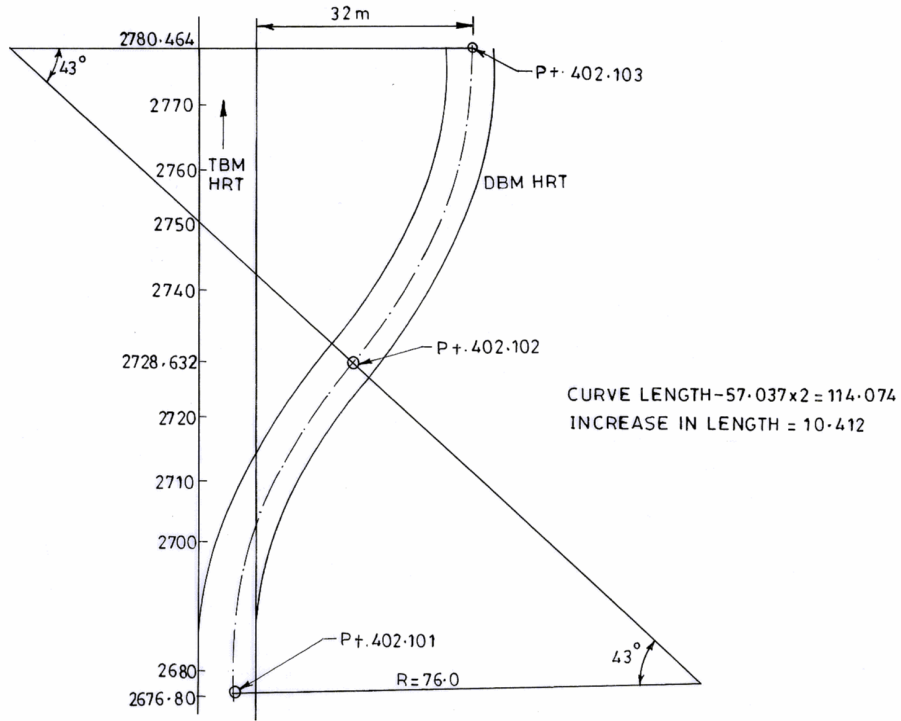
Fig. 4 – Plan of proposed HRT - 402

Since the TBM got buried, it was decided to divert the tunnel from Ch. 2676m as given in Figs. 4, 5 & 6 and excavate it by drill and blast method. The rock mass quality of this area was grey quartzites with thin phyllite bands (2-5mm) alongwith foliation. The rock quality in terms of Q ranges from 2.6-6. The rock support system (from Ch. 2702 to 2895m) was by full length adhesive anchors of 5.0 and 6.0 m length alternate at 1.0 m centre to centre staggered with wire-mesh. The thickness of the shotcrete was 10 cm. From Ch. 2895 to 2928m, ribs spaced at 1.0 m centre to centre with legging and blocking concrete was executed. From Ch. 2928m onwards, since the quality of rock improved, the system of support was again full length adhesive anchors 5.0 to 6.0 m length at 1.0 m centre to centre staggered with wire-mesh and 10 cm thick shotcrete. The method followed for crossing the shear zone in the diverted area was by drilling forepoles and providing drainage holes as shown in Fig. 7 and Table 3.

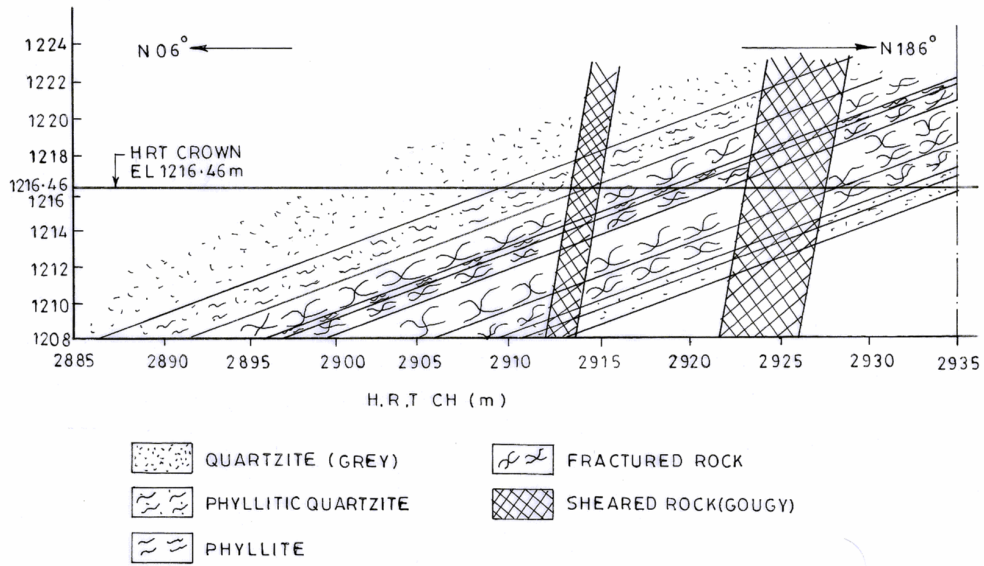
Fig. 5 – Geological section along C.L. of HRT 402

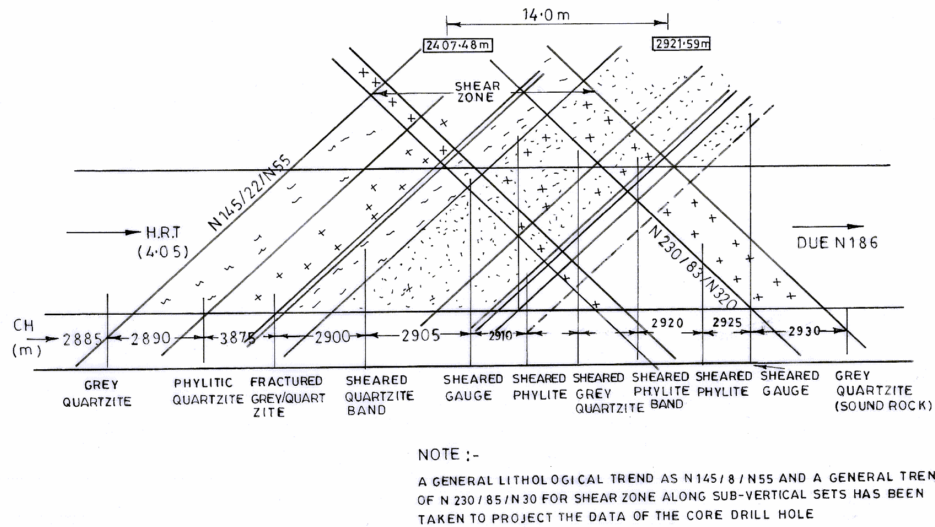
Fig. 6 – Geological plan at EL 1210.9m along core drill hole showing location of shear zone

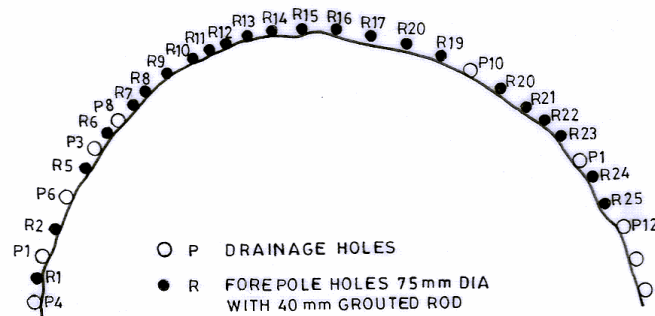
Fig. 7 – Details of pre-treatment carried out in HRT 402 at Ch. 2913m
