Study of Rockfall at Amritanjan Bridge Site on Mumbai – Pune Expressway – A Case Study

***Kishor Kumar
P. S. Prasad
Nitesh K. Goyal
&
Sudhir Mathur***

*Geotechnical Engineering Division
Central Road Research Institute
Mathura Road, New Delhi- 110 020, India
Ph: 91-011-26842612 Fax: 91-011-26845943
Email: kishornhrm@gmail.com*

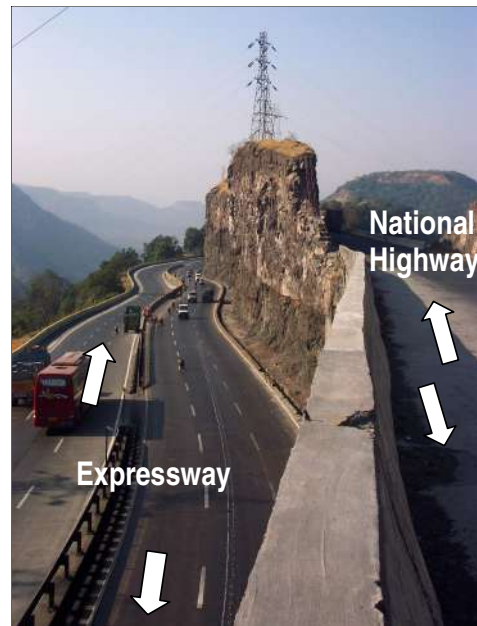
Fig. 2 – A view of Amritanjan bridge rockfall site

At this location, the major problem identified is of frequent fall of rock blocks from the vertical cut slope. The frequency of the rockfall increases during rainy season. The size of the blocks ranges from a few cm to 1.5 or 2.0m size. The impact of the falling rock as noticed is very high. There are instances of falling boulders damaging the side drains and the expressway. The slope is vertical and there is no object on which the detached rocks could hit so as to reduce their momentum before actually hitting the expressway. This direct fall of rock on expressway makes the impact more dangerous and could be some times fatal when they might hit a running vehicle.

In view of the above, two alternative methods were suggested. Under the first alternative, the entire vertical face of the sledge was recommended to be stabilized with steel fiber reinforcement shotcrete (SFRS) of 70mm thickness and wrap-up the whole sledge from the top to bottom on both sides (Expressway and National Highway – 4) with steel rope net of aperture size 300mm X 600mm. The SFRS provides measures to prevent the rock blocks moving from the slope and also prevent the weathering of the rock slope.

The steel rope net of aperture size 300mm X 600mm should be anchored at the top. For installing the steel rope net on the slope it is required to dig a trench of 30cmx50cm at a distance of 1.5m from top of the cliff. In the trench, iron rods of 0.5m are inserted from the bed of the trench. After inserting the rods the holes are grouted with cement concrete. Subsequently, the steel rope net of desired length is laid and the trench is filled with cement concrete for anchorage. The steel rope net is spread on to the vertical face of the slope up to the toe on both sides of the sledge. Fixing the steel rope net to the slope surface either by means of expansion bolts or grouted bolts at 3m intervals is to be done. The length of the bolt should not be less than 0.5m. This kind of stabilization solution will control rock block directly falling on to the expressway.

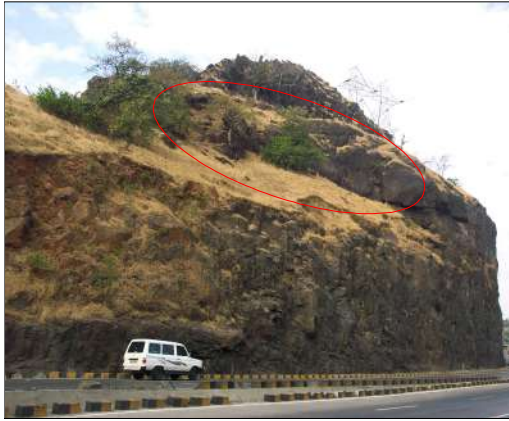
The field investigations were focused on obtaining information about the condition of rock/soil, causes and mechanism of their failures etc. The rocks at this point, as in most of other areas, are in general two types of basalts, amygdaloidal and compact basalt. The compact basalt is fine grained and less weathered, but contrary to the amygdaloidal type it is more fractured. The fractures are more prominent at the intersection of the vertical discontinuities with the horizontal (base). At the top of the hill towards Mumbai (Fig. 3), the hillock has columnar joints at close spacing. The joints are open and provide easy access for entrance of huge quantity of water. These joints are presently in loose state (Fig. 4) and may experience toppling failure in the coming monsoon months

Fig. 3 – Columnar joints at top of the sledge

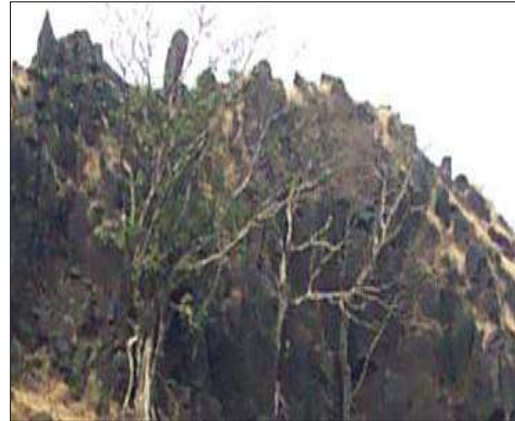
due to ingress of water. The vesicular variety of basalt is more prone to weathering compared to the other variety; however, it is less jointed. The surficial weathering on the face of vesicular variety is more. There are predominantly three sets of joints i.e. the vertical, horizontal and oblique joints.

Fig. 4 – Close view of separated columnar joints

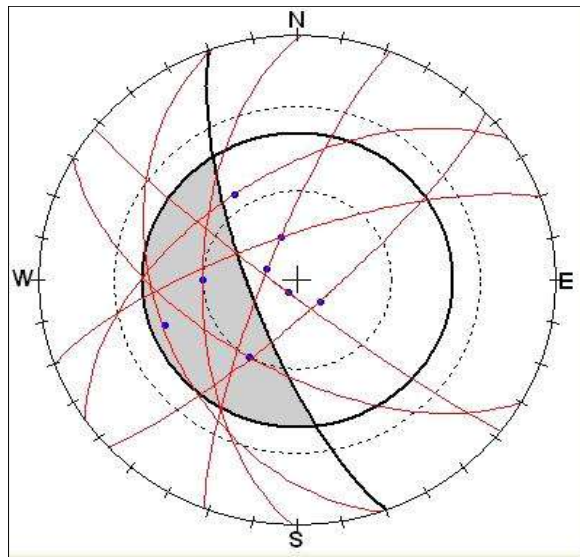
On the other hand, there are many other fractures, which are some time confused with the joints. The vertical joint sets daylight on the slope is part of the columnar joints assembly and most dominant joints with regular spacing. A few of the representative joints sets are plotted in a stereographic projection (Fig. 5). It is indicated from the stereographic projection of a few joints that there is a distinct interaction of joints forming wedges on the face of the slope towards both NW and also SW directions.

Fig. 5 – Stereographic projection indicating the wedges day lighting on the face of slope

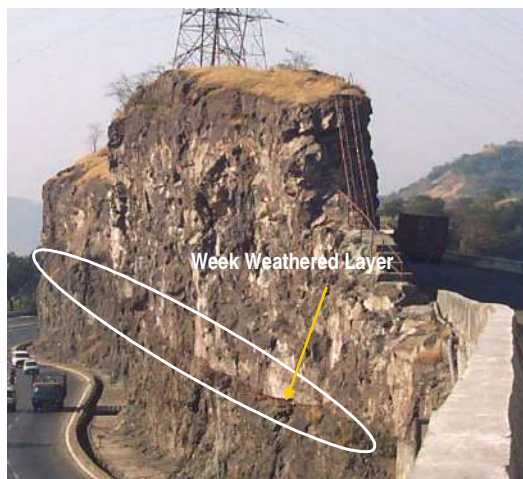
There are some horizontal layers of weak material, mainly, brownish in color, interbedded between the two basaltic layers. The weak layer is also a product of the basaltic layer on which it rests. This layer has altered in the present form as a result of weathering (Fig. 6). This layer, being weathered and altered is extremely dangerous, if exposed because of its access to water. This layer can accelerate weathering and can facilitate further division between two basaltic layers, which finally can fail along its joints. The situation had already been daylighted on the face of the slope (Fig.7). After the construction of the highway there are few locations where the rock blocks are left in loose conditions. A few rock blocks seem to be tightly hanged, however, in due course of time due to water and gravity these blocks are expected to get loosened and fail in the form of rockfall.

Fig. 6 – Weak pelagic clays and chert layer between the two successive flows

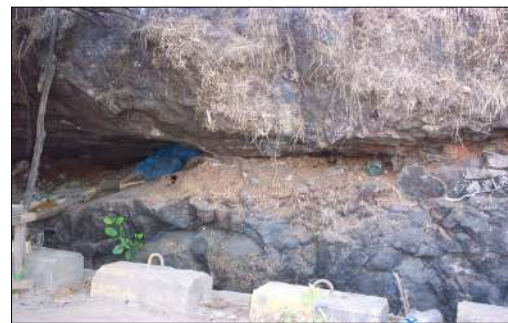
Fig. 7 – Weak layer sandwiched between two basaltic layers
