Stress Mapping for Preferred Orientation of Galleries in Underground Coal Mines

*Dr.D.N.Sharma
U.Shivnarayana
Pankaj Kulshrestha*

*The Singareni Collieries Co. Ltd,
Kothagudem-507101, A.P., India
Ph.: 08744 242418
Fax: 08744 245968
E mail: drdn_sharma@yahoo.co.in*

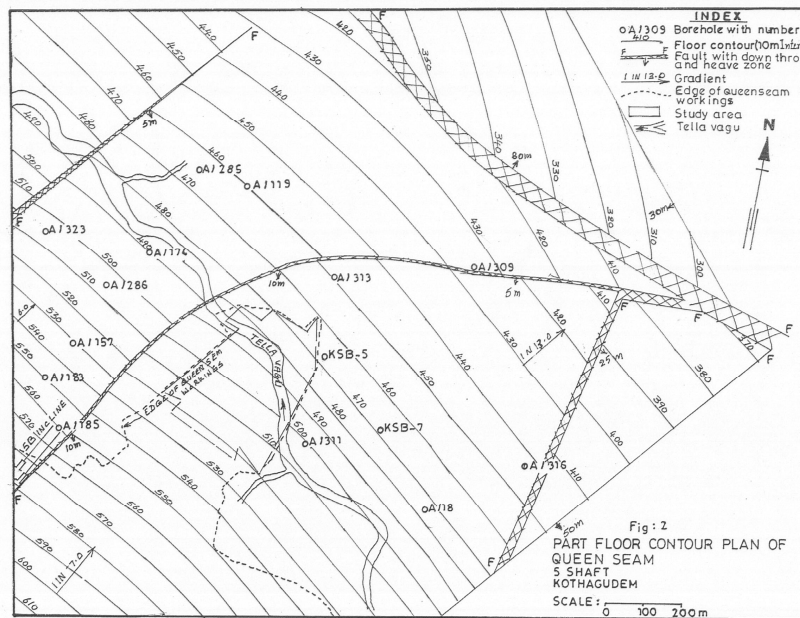
- (i) The workings have crossed 340 m depth line and approaching the fault in the dip side of the block. From the perusal of floor contour plan, the seam gradient varies from 1 in 6 to 1 in 13. Because of the fault also, roof conditions have deteriorated (Fig. 2).
- (ii) Among the most troublesome obstacles found within a coal mine are those partial or complete removals of a seam known as ‘washouts’, which is the result of erosion at some period during or soon after the formation of the seam or seams. In its simplest form and on the smallest scale, a washout may be defined as a channel cut into or through a coal seam and filled generally with sandstone. The common feature is that of the ‘stone intrusions’ or ‘stone eye’ (irregular masses of sandstone) that occur within the seam or penetrating into the seam from top or bottom (Raistrick and Marshall, 1939).

A stream / channel is generally created by surface run off water that cuts through a weak rock zone or an area of high fracture density. Streams tend to follow surface fractures. It is generally known that in the coal mines area, the roof rocks immediately under and adjacent to a stream are almost always less stable and much liable to fall once the area is under active mining. Over the study area, Tella Vagu is passing through the block and contributing for the unstable roof conditions (Fig. 2).

- (iii) The workings have crossed 340 m depth and approaching the fault in the dip side of the block. It is believed that because of this fault also the roof conditions have deteriorated. Other wise, roof is stable in the rise side of the study area.

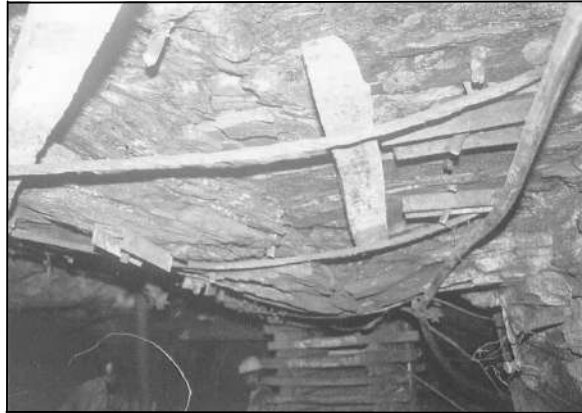
Fig. 3 – Location 116 LS-2D: Sagging and compressional crack developed in the roof strata resulted into ‘Gutter Roof’ in 116 level

These kink zones / gutter roof in study area has been mapped and plotted in the underground working plan. From the exposed section of roof strata of workings in the study area, it is noticed that the strata is thinly layered and failure of the roof is observed in the centre of level galleries (Fig. 3) and some times they develop preferentially on one side of the gallery.

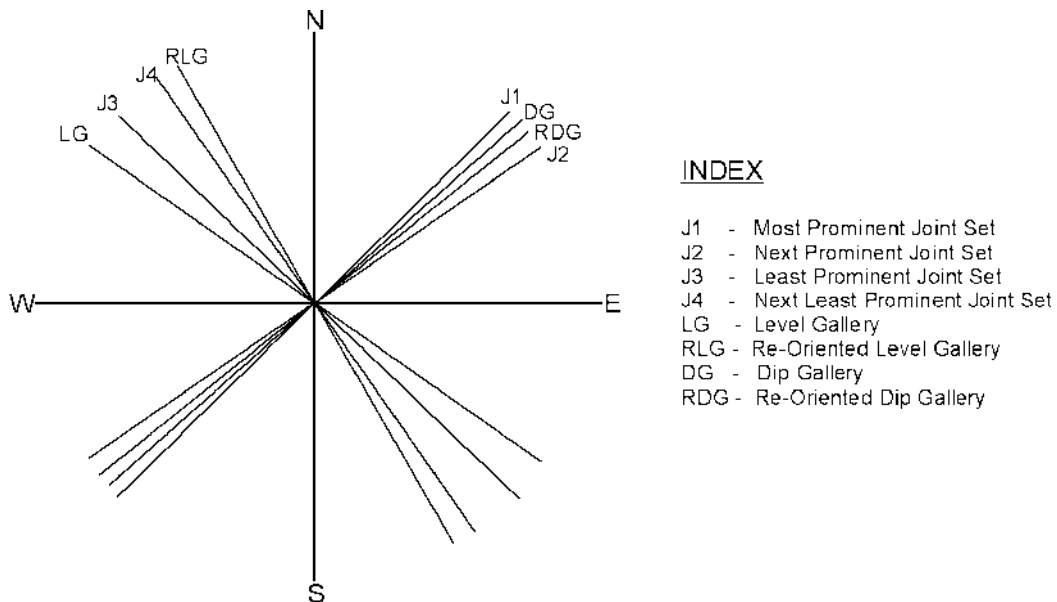
Fig. 4 – Trend of joints and galleries

Similar stress conditions of VK-7 are observed in the area under reference that is 5 shaft, being northern continuity. The rose diagram drawn for 100 readings of joint orientation reveals two distinct directions of joints viz. J_1 and J_2 (Fig. 4). The most prominent joint set J_1 is in the direction of $N45^\circ E$ which is almost perpendicular to level galleries and next prominent joints J_2 trends in $N 55^\circ E$. The least prominent sets J_3 and J_4 fall in the directions $N 45^\circ W$ and $N 35^\circ W$ respectively. The identification of total number of joints sets and their dips and dip direction is very important in the analysis of stability of underground openings. As such, true dip and dip directions of a large number of joints are measured in the study area. Zhang and Tong (1988) developed a computer program, STEREO, for automatic plotting of pole concentration. Using the software of Singh and Goel (2002), the poles of the joints are plotted on the stereonet and are contoured at 5% interval to infer the major principal stress direction (σ_1) indirectly, as there are no major or minor folds in the study area to derive the σ_1 from the orientation of fold axis (Fig. 5).

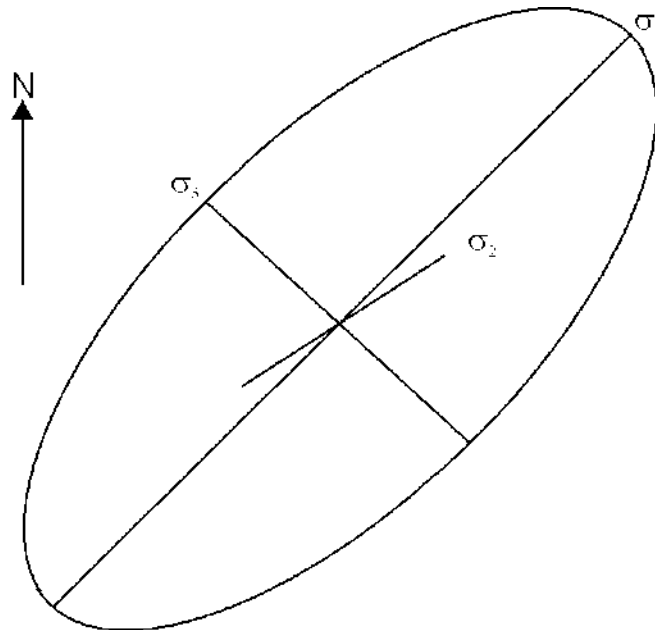
Fig. 6 – Direction of strain ellipsoid developed in the queen seam workings

Using these studies (as it was already established in VK-7 shaft), the most prominent Joint J_1 ($N 55^{\circ} E$) is inferred to be the tensional joint and develop perpendicular to the minor stress axis (σ_3). In the study area, the major stress axis (σ_1) is parallel to J_1 and accordingly the strain ellipsoid is developed which is depicted in Fig. 6. Further J_1 dips at steeper angles, hence the major principal stress direction σ_1 is oriented parallel to the most prominent joint set J_1 , direction of minor principal stress axis σ_3 which develop under compressive stress and contributing the stable roof conditions in dip rise galleries (Fig. 7). It is inferred that the most prominent tensional joints J_1 aligned to the major stress direction are normal to the level galleries, which contribute towards unstable roof conditions resulting into ‘gutter roof’ (Fig. 8).

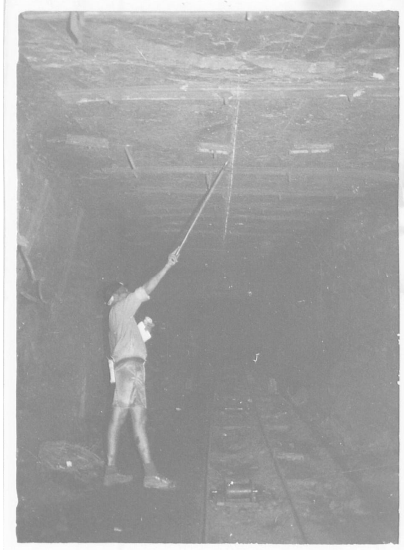
Fig. 7 – A Typical stable roof condition in dip-rise gallery

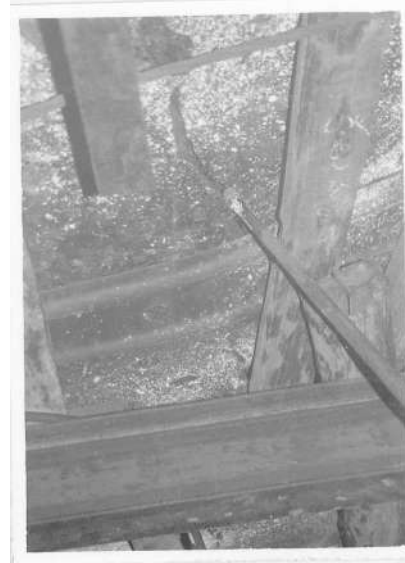
Fig. 8 – Failure of roof associated with cleats and bend in the W-strap support
