# ***Response and Earthquake Induced Damage of Underground Structures in Rock Mass***

***Ömer Aydan\****

***Keywords:*** Underground opening; Earthquake damage; Fault; Shaking; Concrete lining

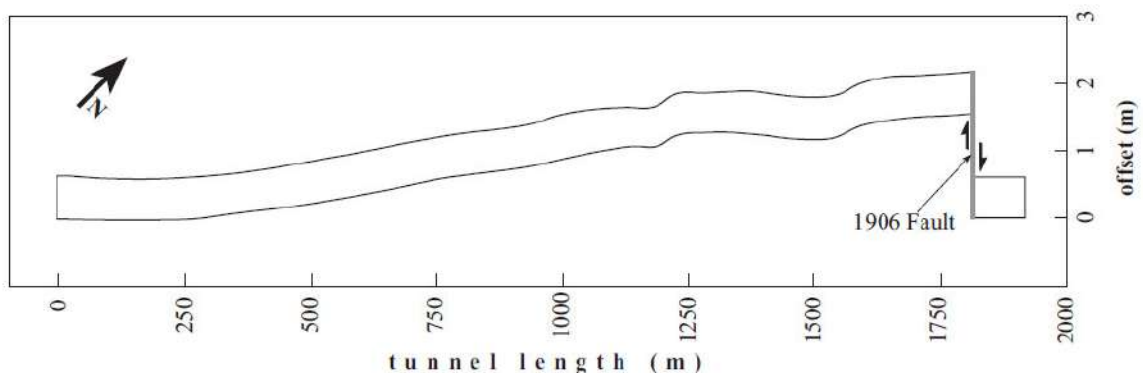
Wrights tunnel is the first example of damage to tunnels by the earthquakes and it is associated with the 1906 San Francisco earthquake (Mw 7.9, where Mw is moment magnitude). A right-lateral displacement of 1.7-1.8 m occurred along the San Andreas shear zone intersecting the Wrights tunnel about 120 m from the northeast portal (Fig. 12). Damage in the vicinity of the maximum offset included crushing of timber supports, heaving of rails, and rock fall. Some railroad ties were broken (Prentice and Ponti (1997)).

Fig. 12 - Deformation of Wrights tunnel during the 1906 San Francisco earthquake

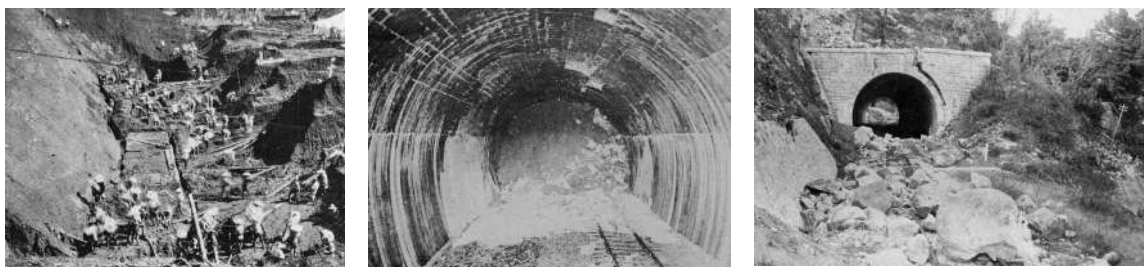
The Great Kanto earthquake with a moment magnitude of 7.9 occurred on September 1, 1923. This earthquake was the most disastrous earthquake in the seismic history of Japan. Although the epicenter of the earthquake was in Sagami Bay, Tokyo, Yokohama and prefectures of Kanagawa, Shizuoka and Chiba were greatly affected by the earthquake. 93 tunnels were affected and 25 of them received various levels of repairs (Okamoto, 1973; Yashiro et al., 2007). The tunnels were either single or double track tunnels and most of them were lined using brick liners and they were all situated on the hanging wall of the earthquake fault, which dip into NE with an inclination of about  $30^\circ$ . The damage to tunnels and their portals occurred mainly by the intense ground shaking and the degree of the damage was very high in the vicinity of epicentral area (Fig. 13). The complete collapse of the tunnels were observed when the ground conditions were relatively poor.

Fig. 13 - Examples of damaged tunnels by the 1923 Kanto earthquake (JSCE Archive)

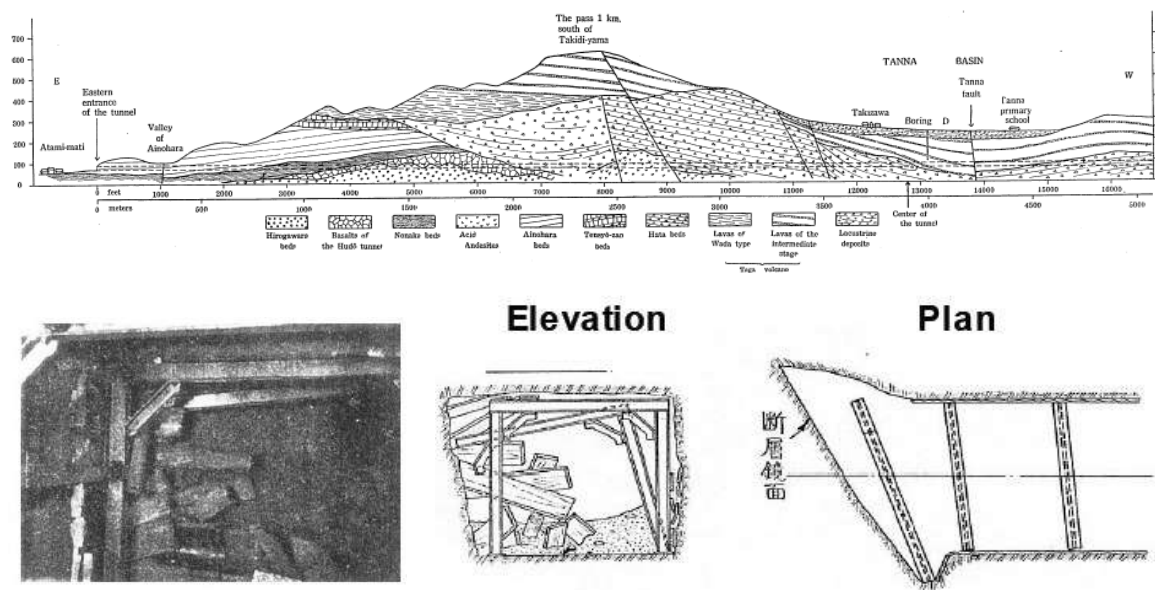
of water inflow through fault zone and many drainage drifts were bored. The epicentral distance of the tunnel was 15 km while the distance to the causative fault was 0 km. The overburden of the tunnel at fault crossing was 160m and the width of fracture zone was about 45m consisting of sandy clay lake deposits overlying lower Pleistocene tuff, agglomerate and lava flows (Kuno, 1935). Near the heading of one of the drainage tunnels, an existing shear zone displaced by the earthquake and the drainage drift was completely closed (Figure 14). However, only a few cracks appeared in the main tunnel walls, in spite of the fact that the main tunnel heading was only 0.5 m east of the active shear zone (Sakurai, 1999).

Fig. 14 - Geology of Tanna tunnel and damage at tunnel heading by the earthquake (arranged from Kuno (1935) and Sakurai (1999))

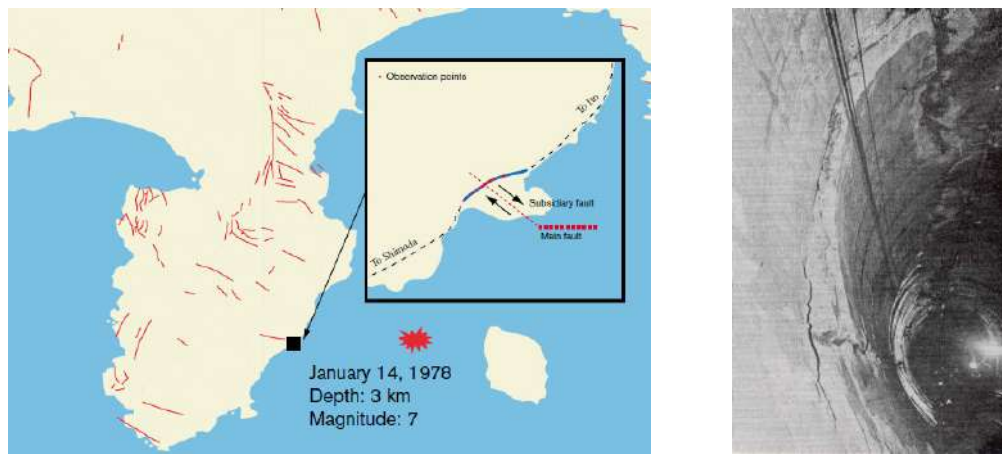
The 1970 Izu-Oshima earthquake ( $M=7.0$ ) damaged the Inatori tunnel, which is a 6 m diameter 906 m long single-track railway tunnel. Overburden is about 100 m at the most. The tunnel was excavated through a deposit of volcanic mudflow deposits that have been hydrothermally altered to clay. The tunnel was supported with 0.7 m thick concrete lining. The centre line of the tunnel was displaced by 50-70 cm within a zone of 20 m at 440 m from the tunnel portal of the Ito-side where a fault segment crossed the tunnel (Fig. 15). Cracking and deformation occurred in a zone up to 300-400 m from the main fault rupture (Tsuneishi et al. 1978; Kawakami, 1984). The northeastern half of the tunnel was displaced about 0.85 m seaside (east); while its western part was displaced about 0.2 m towards mountain side (west). The tunnel was seriously damaged at location where the tunnel was cut by the fault.

Fig. 15 - Damage to Inatori tunnel by 1970 Izu-Oshima earthquake

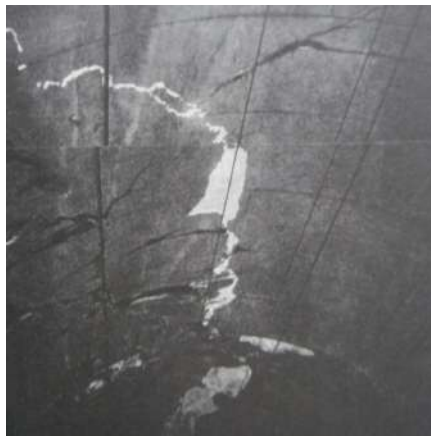
(a) Cracking in the roof

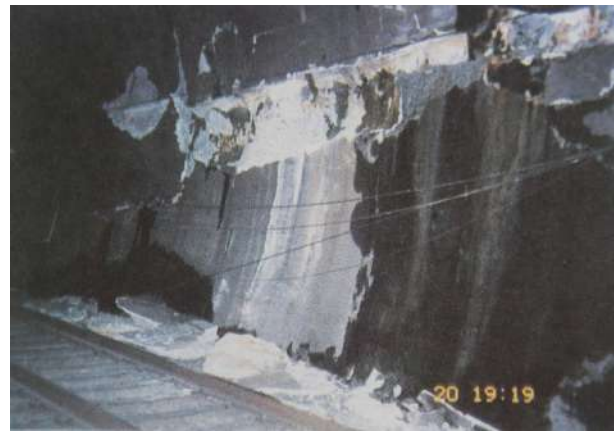
(b) Side wall spalling

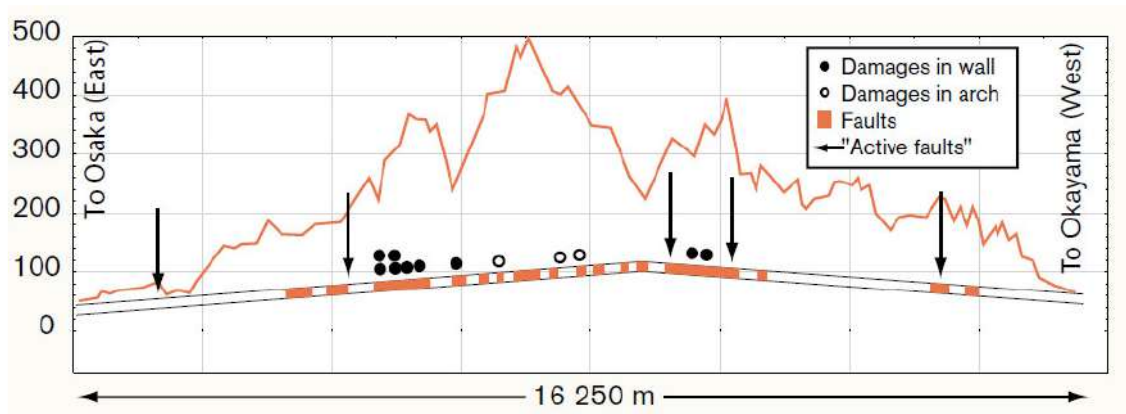
al., 1996; Asakura and Sato, 1998). Typical damage patterns were cracking in the lining, spalling of concrete in the arch and the sidewalls, expansion of existing cracks, heave and cracking of the invert, settlement of the arch crown, pounding of construction joints, collapse of portals. The closest tunnel, the Maiko tunnel under construction, with an epicentral distance of 4 km received only slight damage while a four-story building on the surface on top of the tunnel was completely destroyed. The 16km Rokko tunnel excavated in granitic rock was severely damaged by the earthquake. Damage was mostly observed at the location of faults with poor rock conditions and small overburden. This tunnel is crossed by five major fault of the dextral Rokko fault zone. The inferred relative movements are expected to range between 10-30cm while the maximum relative dextral motion along Nojima segment was more than 180cm. Huge chunks of concrete lining were fallen over the rails (Fig. 16). As the earthquake occurred before the start of shinkansen trains (running), no major secondary disasters was caused.

Fig.16 - Damage at the Rokko tunnel by the 1995 Kobe earthquake (Asakura and Sato, 1998)

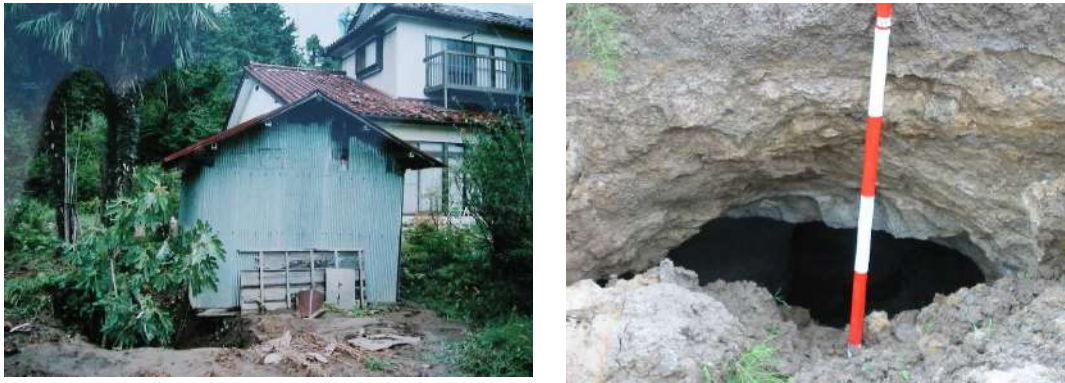
The 2003 Miyagi-Hokubu earthquake caused damage of abandoned mines in the vicinity of Yamato town although the magnitude of the earthquake was 6.2. The damage surveys on abandoned lignite surface are restricted to surface damage. Although there is no doubt that some damage in the form of roof collapse and pillar failure may take place, it is very difficult to observe those damage due to the limitation of access to old workings. The local authorities (Yamato town) identified 28 locations where the surface damage was observed (Aydan and Kawamoto, 2004). The damages were in the form of caving (sink-hole) and water discharge. Figure 17 shows some examples of damage observed. Some sandy material was ejected due to the sloshing of the ground water in the abandoned-lignite mines as a result of ground shaking caused by the earthquake.

The local people showed that some wells adjacent to damaged locations had very high water level, implying that the abandoned-mine workings were fully submerged with ground water. Further, it is reported that the water discharge from caving locations

Fig.17- Caving and sand-boiling.(Aydan and Kawamoto, 2004)

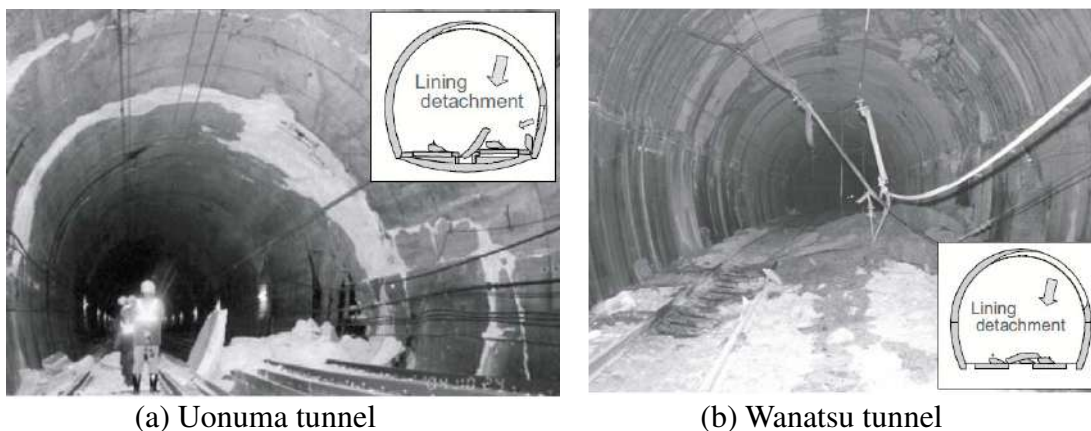
Fig.18 - Damage to some of tunnels by the 2004 Chuetsu earthquake (Yashiro et al. 2007)

The 10 roadway tunnels were damaged by the 2004 Chuetsu earthquake (TEC-JSCE, 2005). Wanatsu tunnel is a double-lane 300m long tunnel excavated in silty sandstone. About 100m away from Nagaoka side portal the concrete lining had fallen in a length of 20m. The tunnel axis is parallel to the strike of the earthquake fault and there is contraction at the bottom of the tunnel.

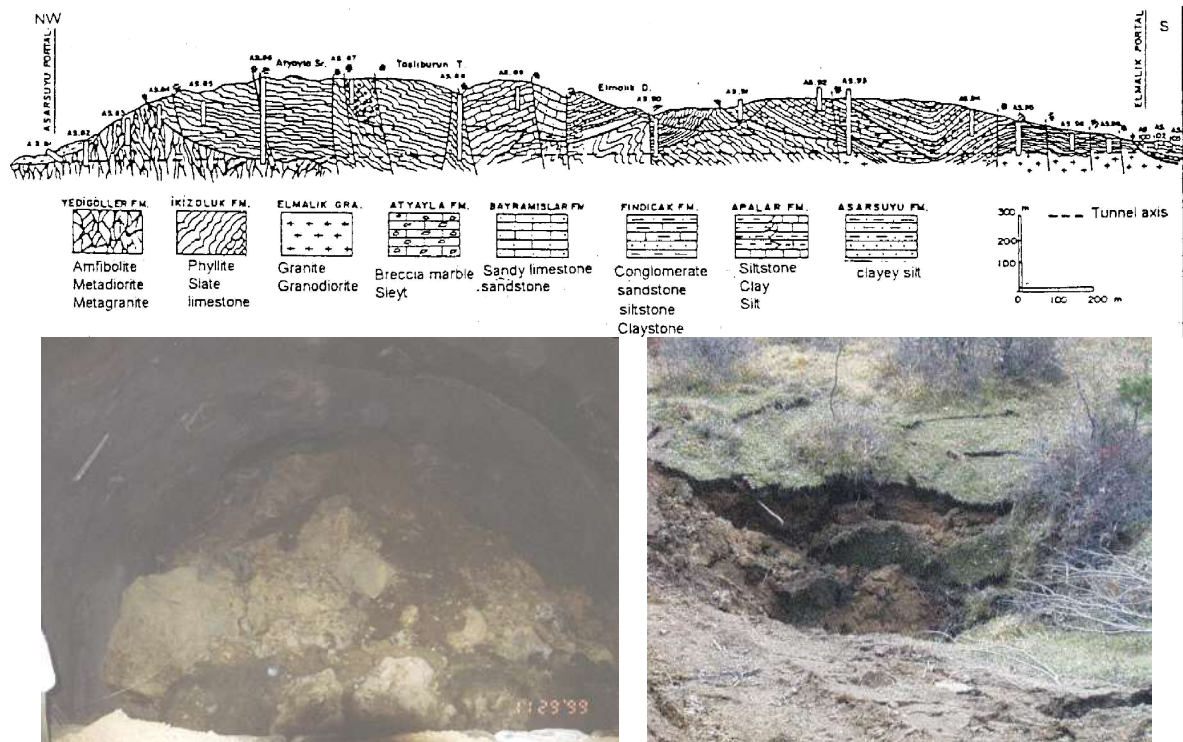
The epicentre of the 1999 Düzce earthquake ( $M_w = 7.2$ ) earthquake was approximately 20 km from Asarsu portals of the Bolu tunnels. The surface rupture of the fault was within 3 km of these portals. In the main Asarsu tunnels within the metasediments, slight-moderate damage was observed as slabbing and spalling of shotcrete, and also longitudinal cracking and deformation of the potentially weak rock.. In the Asarsu Left Tunnel-Bench Pilot Tunnels (BPT) in fault gouge clay, moderate to severe damage was observed. Invert heave of 0.5 to 1.0 m occurred, together with damage to the shotcrete arch lining comprising of shotcrete/concrete slabbing, spalling, compression crushing and associated steel rib buckling.

Fig.19 - Geology and views of tunnel and surface depression

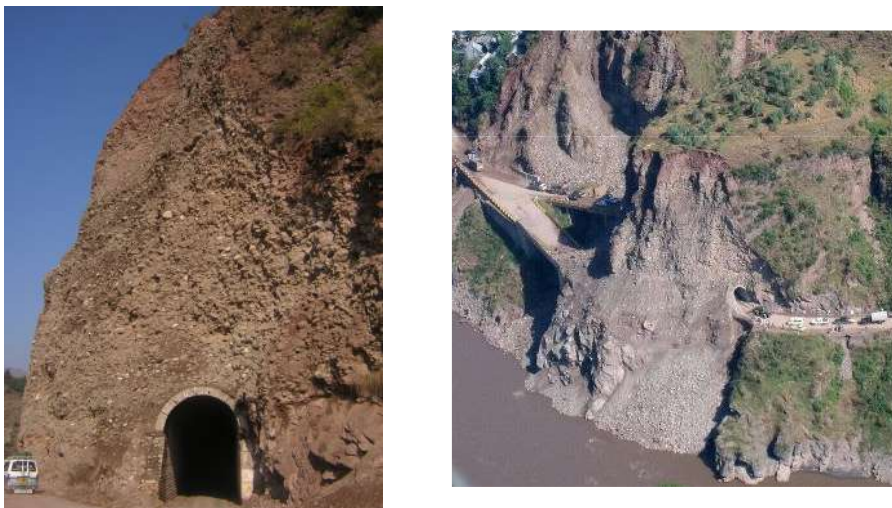
The only tunnel in the epicentral area of 2005 Kashmir earthquake was located about 4km south of Muzaffarabad (Aydan et al., 2009a). The tunnel is lined with stone masonry lining and it is excavated in shale with an overlaying conglomeratic deposit just above the tunnel crown. The south portal of the tunnel was lightly damaged by the slope failure of overlaying conglomeratic deposit as seen in Fig. 20.

Fig. 20 - Lightly damaged roadway tunnel

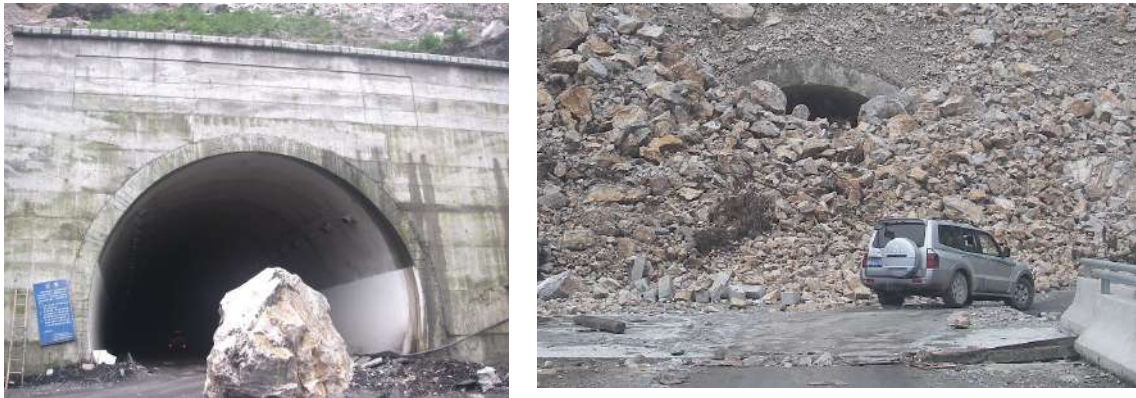
well known that the underground structures are earthquake-resistant compared to surface structures when ground shaking is concerned. The damage to tunnels is generally limited to portals, which are mainly caused by slope failures and rockfalls. Several examples of portal damage are shown in Fig. 21. Similar damage to portals of railway tunnels was also observed. Nevertheless, such damage is light in scale and did not cause any major structural stability problems so far.

Fig. 21 - Damage to tunnel portals

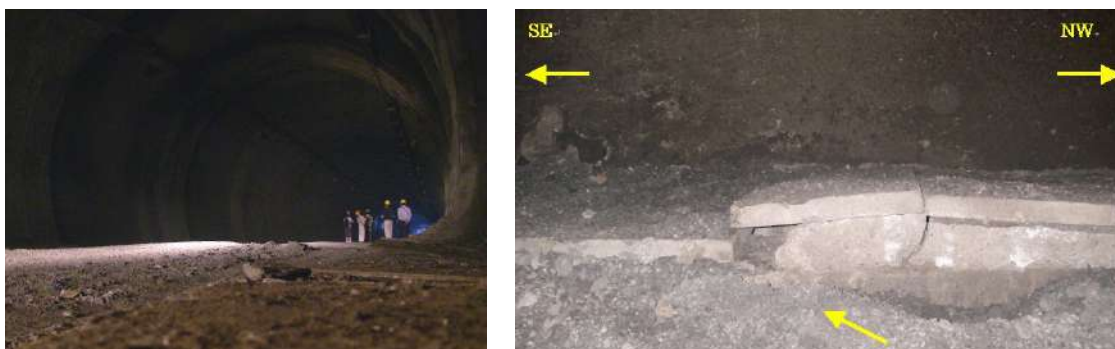
Fig. 22 - Views of repaired damaged section of the tunnel near the Zipingpu dam

The authors had the chance to visit five tunnels, three of which were under construction and suffered heavy damage during the earthquake. The tunnel nearby Zipingpu dam (N31.04888, E103.56463) is a two-lane tunnel with a length of about 1000m. The lining was damaged at several locations perpendicular to its longitudinal axis, which is aligned NW-SE direction. This tunnel was already repaired at the time of the investigation (June 21, 2008) (Fig. 22). The tunnel is about 18.5km away from the earthquake epicenter and it is very close to the Yingxiu-Beichuan fault. The tunnel floor was stepped at the damaged zones implying that the NW side is moved upward. Since this earthquake is of great scale and its relative slip was presumed to be about 7m, it is very natural to expect a diluted deformation zone as the fault approaches the ground surface due to the reduction of vertical stress. The damaged section of the tunnel was rebolted and shotcreted.

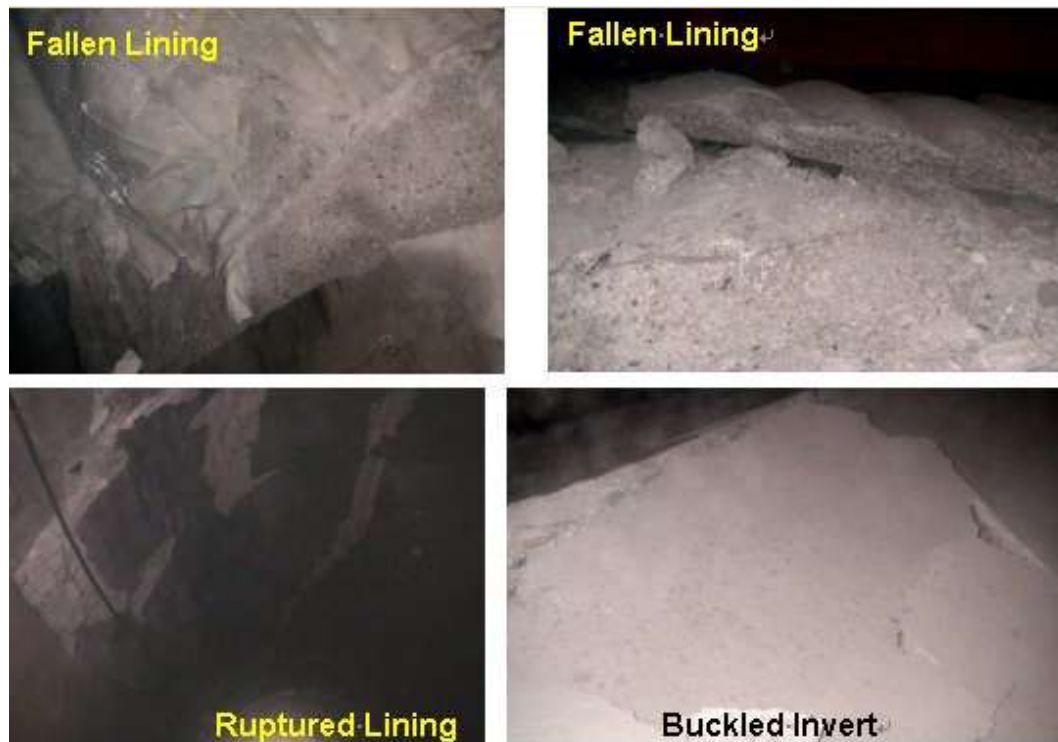
the SE portal and its strike is perpendicular to the longitudinal axis of the tunnel. The engineers informed the authors that they had difficulty of maintaining the stability and controlling the deformation of the tunnel during excavation, indicating that the tunnel experienced squeezing phenomenon. The tunnel was excavated using the rockbolts and shotcrete as an initial support and then the unreinforced concrete lining was constructed. The concrete lining was ruptured and the crown concrete had fallen down (Fig. 23). However, the overall rupture trace dips NW. The floor of the tunnel was also ruptured and uplifted by buckling. The tunnel collapsed at the location where the overburden is about 70m. The collapse may have created a sinkhole at the ground surface, which should be checked. The similar type of the collapse occurred at the Elmalik section of Bolu Tunnel during the 1999 Duzce-Bolu earthquake (Aydan et al. 2000). The ground conditions at both tunnels were remarkably similar to each other. The engineers still had not checked the zone beyond the collapsed section of the tunnel. The fundamental causes of the damage to this tunnel are probably the permanent ground deformations along the fault zones as well as high ground shaking.

Figure 23. Views of earthquake damage at Longxi (Longqi) Tunnel

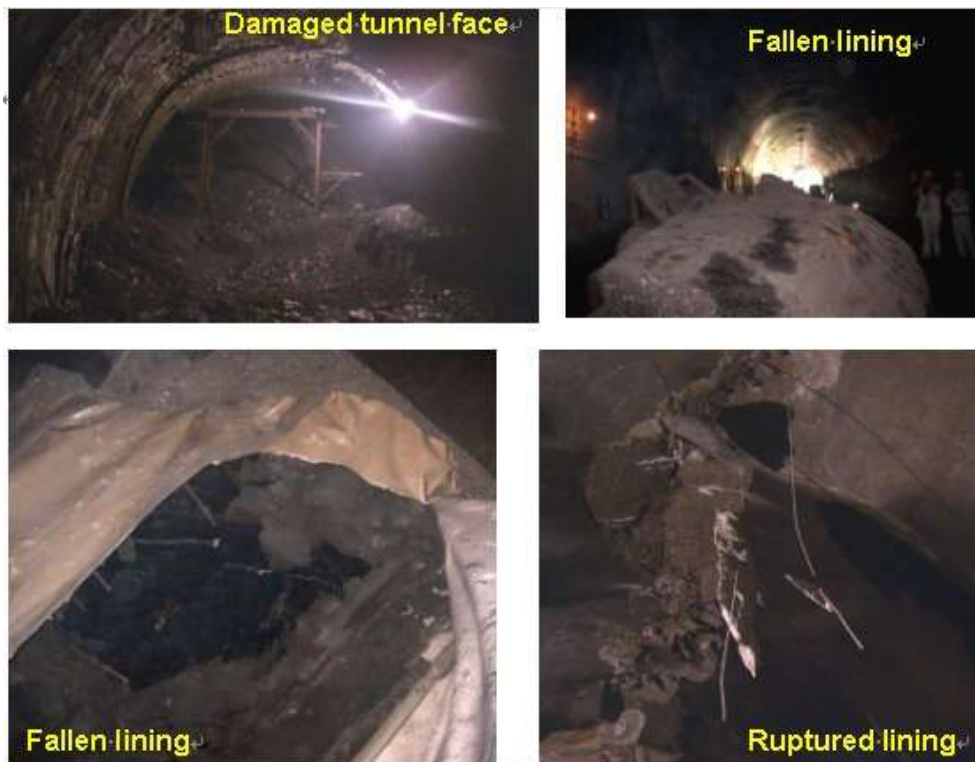
through several fracture zones. The engineers informed the authors that 30 workers were working at the tunnel face and one worker was killed by the flying pieces of rockbolts, shotcrete and bearing plates which were caused by intense deformation of the tunnel face during the earthquake. The concrete lining was ruptured and had fallen down at several section (Figure 24). However, the effect of the unreinforced concrete lining rupturing was quite large and intense in the vicinity of the tunnel face. The rupturing of the concrete lining generally occurred at the crown sections although there was rupturing along the shoulders of the tunnel at several places. Furthermore, the invert was uplifted due to buckling at the middle sections. Sometimes, the whole invert was pushed upward. The authors noticed that the tunnel heading was offset in a dextral sense with an upward movement with respect to the rest of the tunnel. The lateral and vertical offset displacements are approximately 100mm. This sense of deformation is very similar to that of the Longmenshan fault zone, which probably cuts through the tunnel with an acute angle of 50-60°. Besides the high ground shaking, the permanent ground deformations definitely played an important role on the damage observed in Jiujiaya tunnel.

Figure 24. Views of damage at Jiujiaya Tunnel

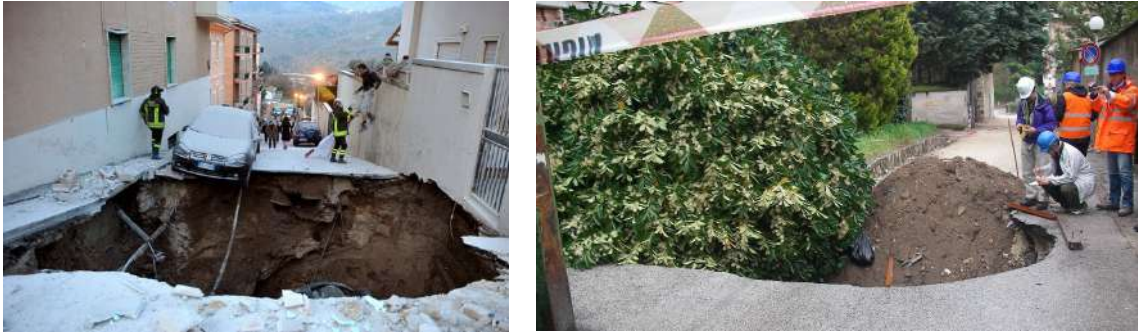
The l'Aquila earthquake caused a number of sinkholes in l'Aquila (Figure 25). One of the sinkholes was well publicized worldwide (Aydan et al., 2010). The width was about 10 m and its depth is not well-known. A car had fallen into it. Another sinkhole had a slightly smaller size. Its length and width were about 8 m and 7 m, respectively. The depth was about 10 m. The layers between the roof and road level were breccia with calcareous cementation, breccia with clayey matrix and top soil from bottom to top. A

side trench was excavated to a depth of 3 to 4 m from the ground surface on the south side of the sinkhole. The reconnaissance team of the GEER from USA also reported that a sinkhole occurred in Castelnuovo and it had a length and width of 5 and 3 m respectively, with a depth of 5 m. The roof thickness was about 1.5-2.5 m.

Fig. 25 - Sinkholes in L'Aquila (from Aydan et al. 2010)
