Stability Analysis of Some Hill Slopes for Tehri Dam Reservoir Area

N.C.N. Srivastava
Faculty and Web Developer
Shreevastava Computer Education
Block No. 58, Bansidhar Society (Part-I)
P.O. New Railway Colony, 'D' Cabin
Sabarmati, Ahmedabad - 380 019 (Gujrat), India
Email: naveen0504@yahoo.com

Indrajit Basu
Department of Earth Sciences
University of Roorkee
Roorkee - 247 667, India
Fax : 091-1332-73560

R. Anbalagan
University of Asmara
P.O. Box 9582
Asmara, Eritrea (N.E. Africa)
Email: anba@earth.uoa.edu.er

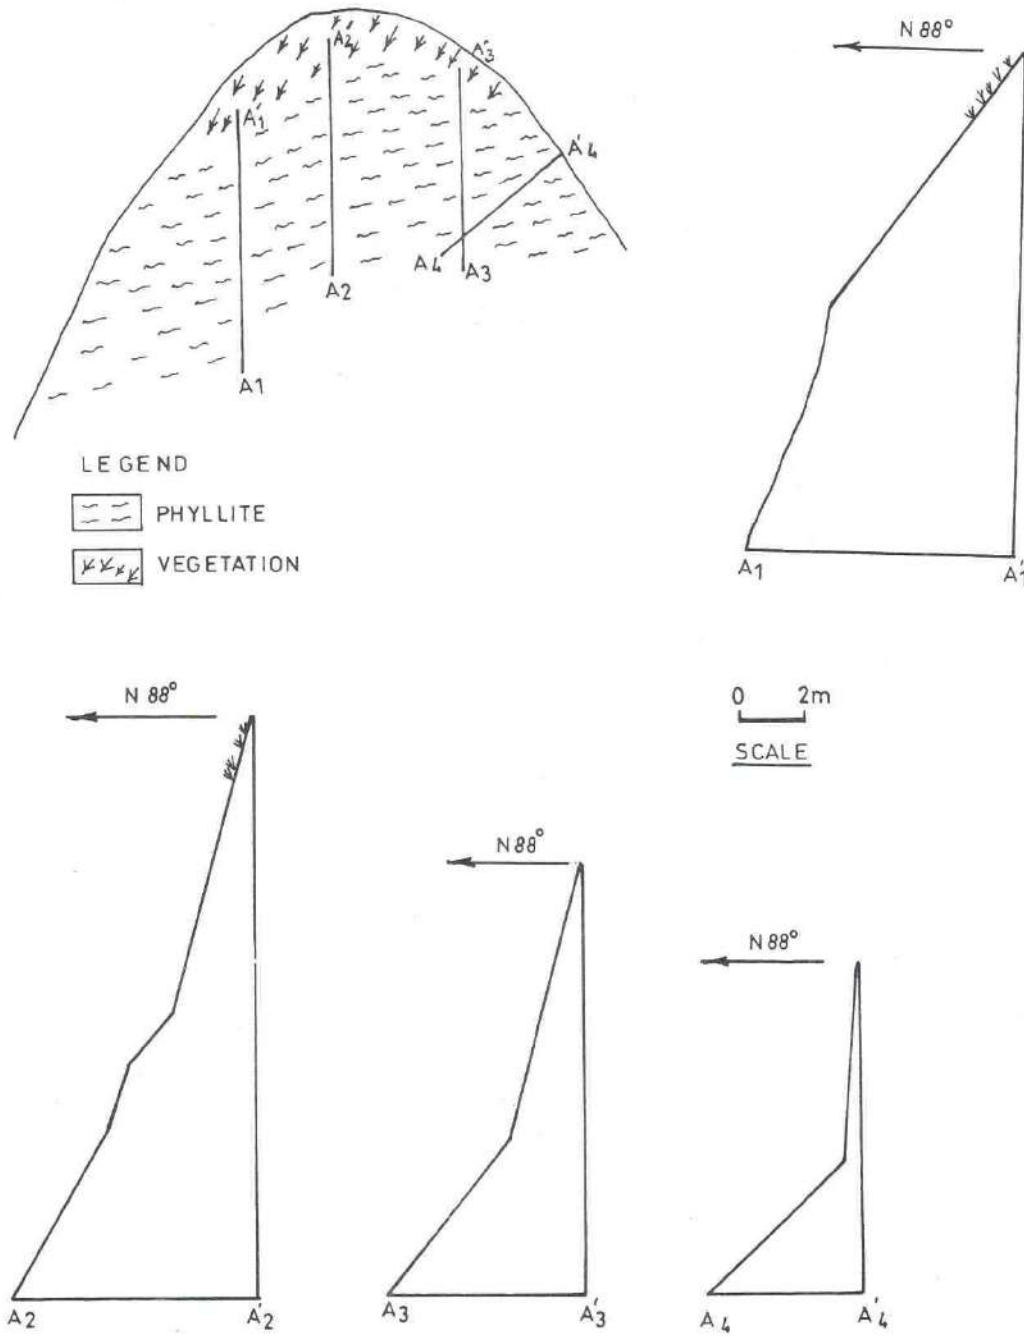
Fig. 4 - Plan and section of Site No. 1

It is located about 5 km NW of Tehri town, near Sirain village, on the right bank of the Bhagirathi river. Phyllite is exposed in the area. This slide extends upto a height of about 15 m above the level of the river with a lateral extension of about 24 m. Vegetation, mostly shrubs, covers the topmost portion of the landslide almost following the upper boundary. Rest of the portion is covered entirely by phyllites (Fig. 4). The following pattern of discontinuities has been observed in the nearby area.

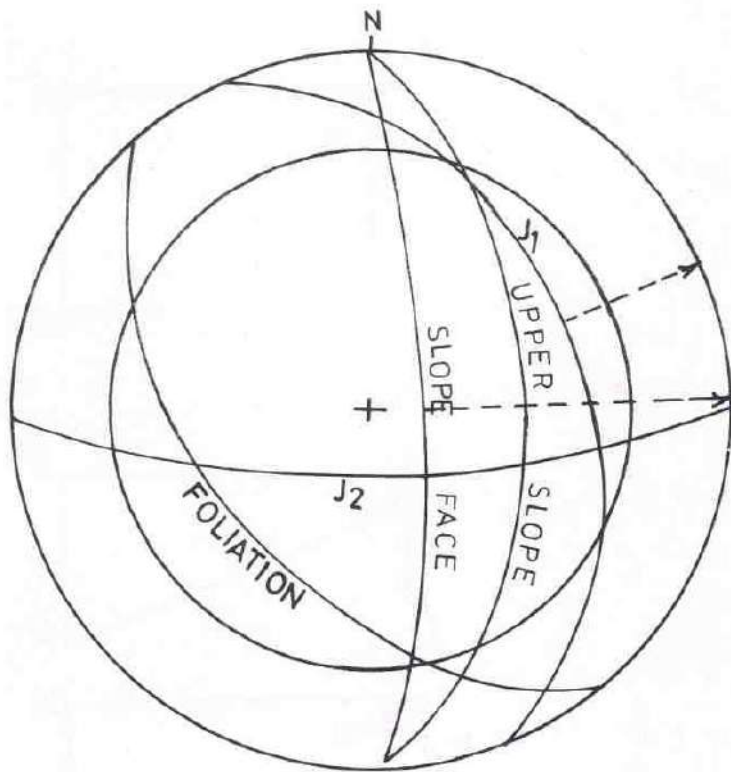
Fig. 5 - Stereographic analysis (Site No. 1, Section A₁ A₁')

The general slope dips 65° towards N88°. Stereographic analysis (Fig. 5) have been carried out for two different dip amounts of the slope face (ϕ_f), 80° and 55° respectively. Results of stability analysis for planar failure have been given in Table 2 in columns Site 1A and Site 1B.

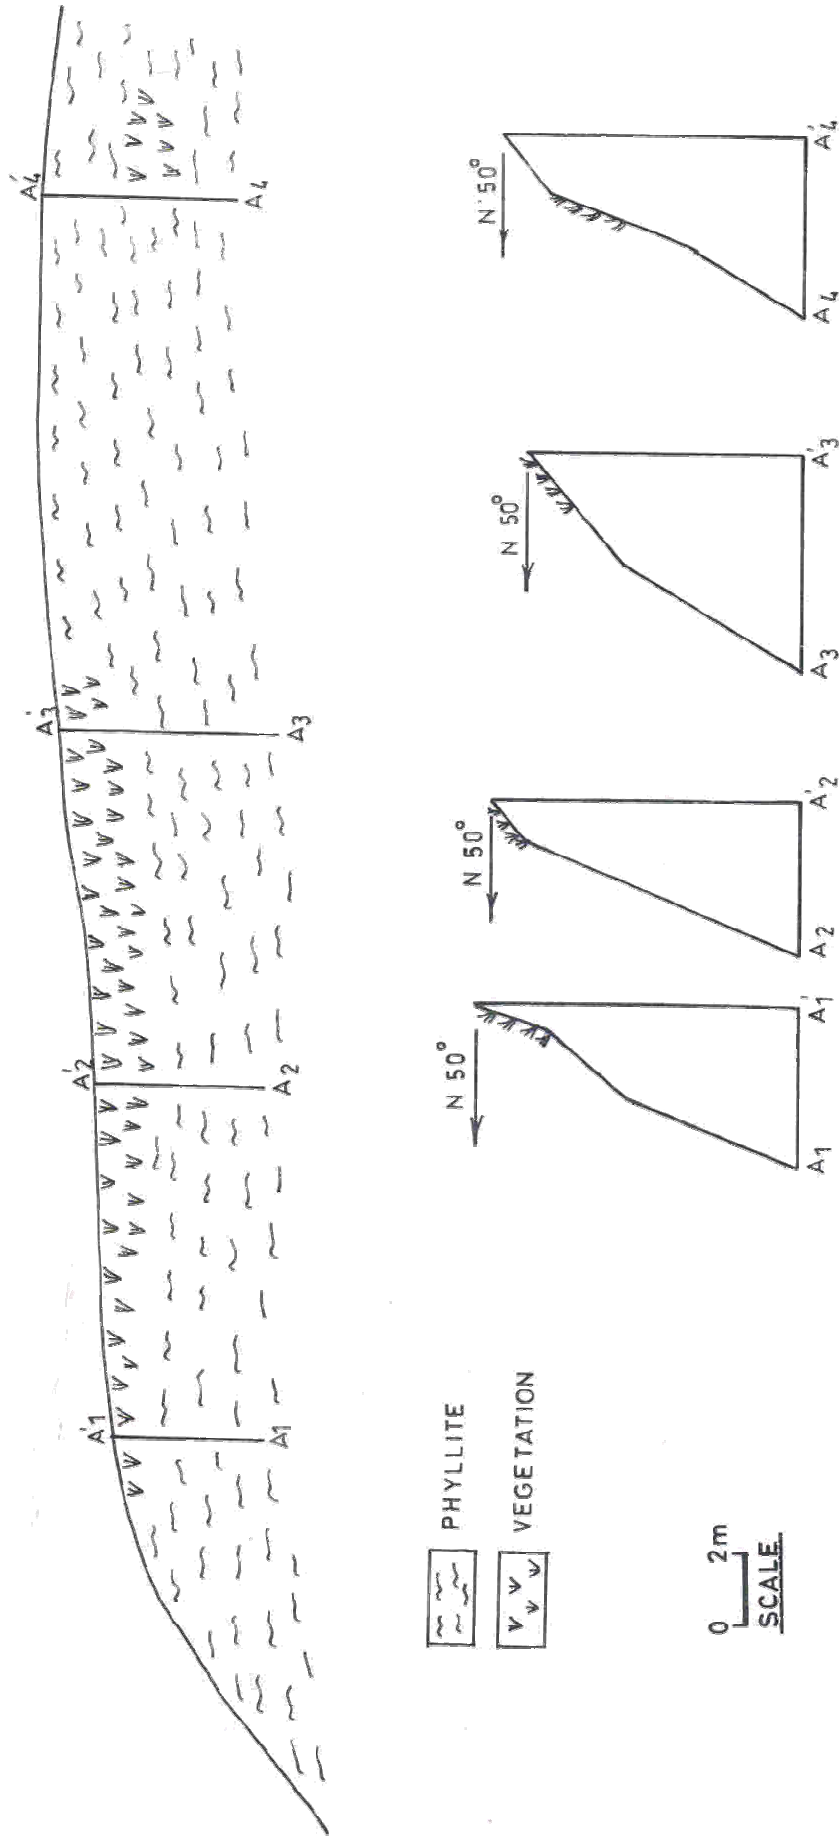
Fig. 6 - Plan and sections of Site No. 2

It is located barely 100 m SE of site no. 1 and the rock exposed here is phyllite. Height of this slide varies across its width from about 15 m to 30 m and it has a lateral extension of about 60m. Mainly grassy vegetation is exposed covering the top portion of the slide. Overburden have been found to be scattered at the toe of the slide (Fig. 6). The following pattern of discontinuities has been observed in the nearby area.

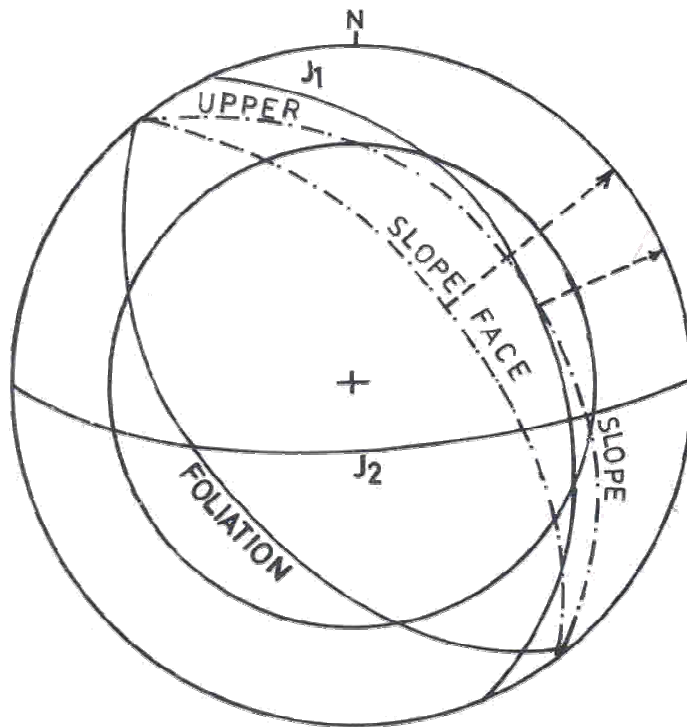
Fig. 7 - Stereographic analysis (Site No. 2, Section A₃ A₃')

The general slope dips about 55° towards N50°. Stereographic analysis (Fig. 7) have been carried out considering dip of slope face (ϕ_f) to be 60° . Value of Factor of Safety (FoS) is given in Table 2.

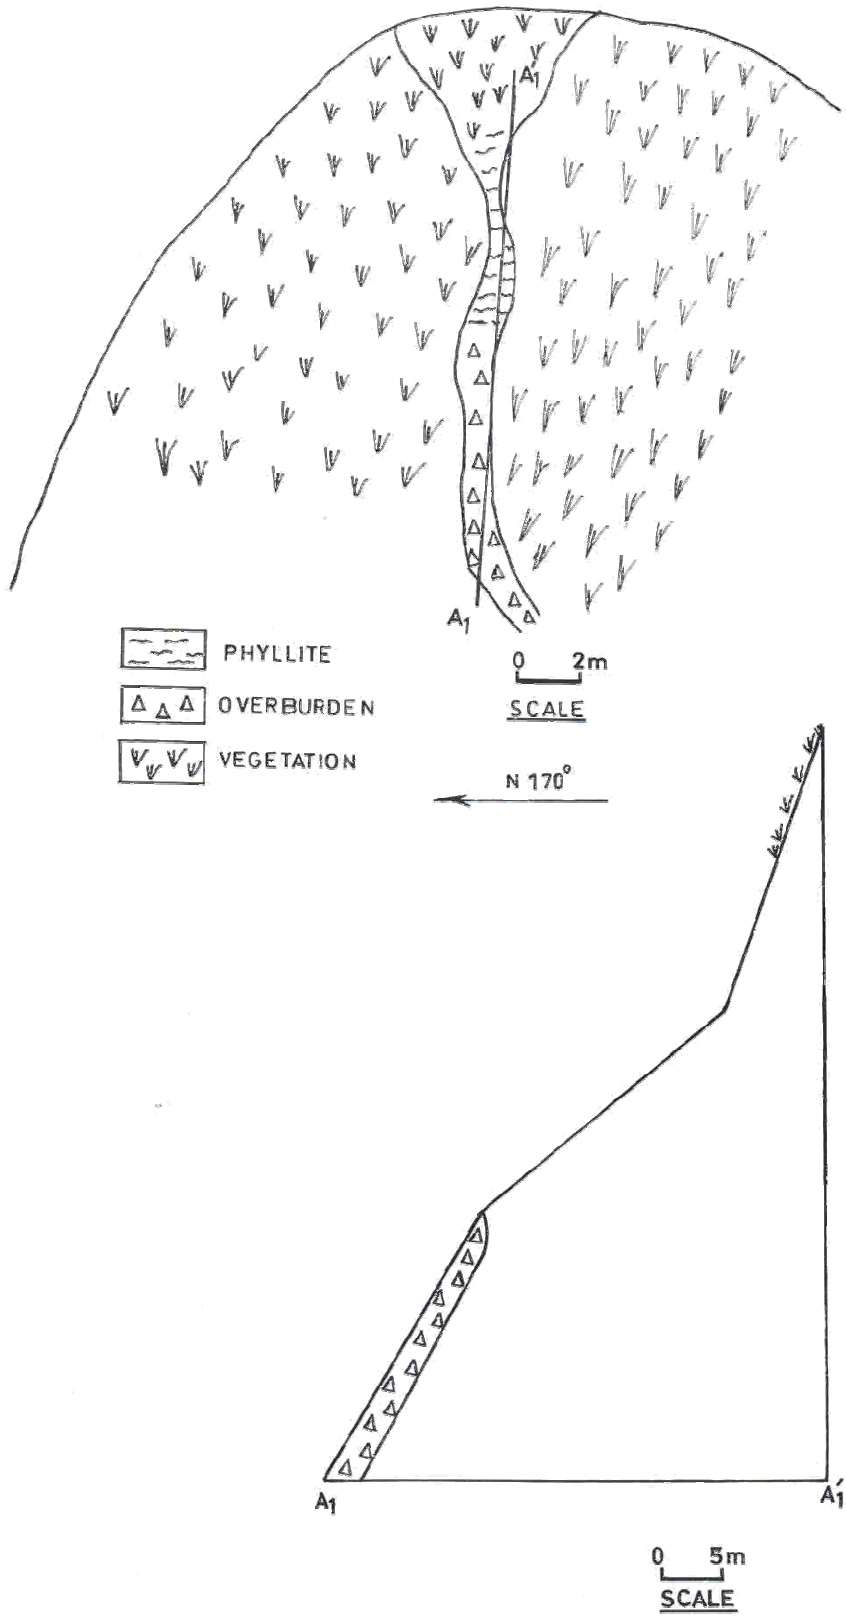
Fig. 8 - Plan and sections of Site No. 3

It is situated about 5.5 km NW of Tehri town, near Raolakot village on the left bank of the Bhagirathi river. The rock exposed is phyllite (Fig. 8). Height of hillslope is about 24 m with an average width ranging from 2 m to 5m. At the top portion, some bushy vegetation is seen. Loose overburden extends a long way down the hill slope upto its toe. The following pattern of discontinuities has been observed in its vicinity.

- (i) A wire crated wall of 2 m height and joining the river course in steps of 1m.
- (ii) Further, the entire area may be afforested by plant species suitable for thriving in that climate. For afforestation locally available plant species can be used namely chir pine (*Pinus Roxburghii*), Buras (*Rhododendron arboreum*), Oak (*Quercus incana*), Kilmore (*Berberis spp.*), Dhaula (*Woodfordia fruiticosa*), Hinselu (*Rubus ellipticus*), Deodar (*Cedrus Deodara*), Pipal (*Fias religrose*), Neem (*Azardirachta indica*), Barh (*Ficus benghalensis*) etc. and other plant species.

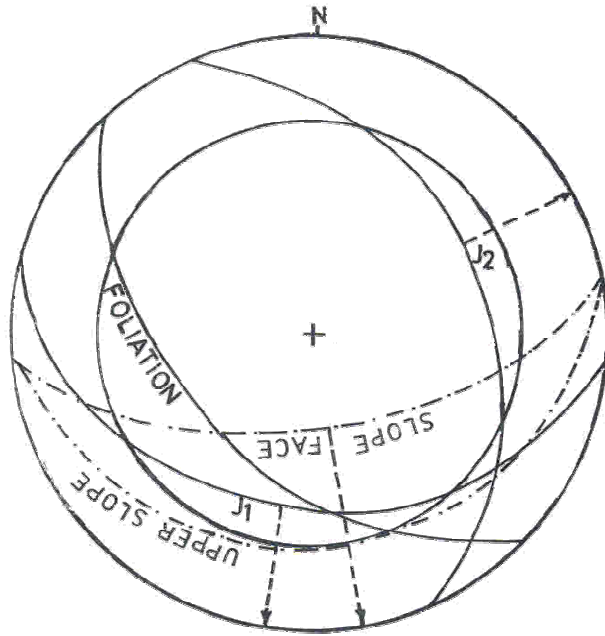
Fig. 9 - Stereographic analysis (Site No. 3, Section A₁ A₁')

The general slope dips 60° towards $N170^\circ$. Stereographic analysis (Fig. 9) has been done considering dip of slope face (ϕ_f) to be 60° . Results of stability analysis for planar failure have been given in Table 2. These values show planar failure during earth movement.

Out of the five potential unstable sites (as revealed from Markland test) one is accounted for planar mode of failure ($FoS < 1$), that is site no. 3. Following remedial measures have been suggested for this site:

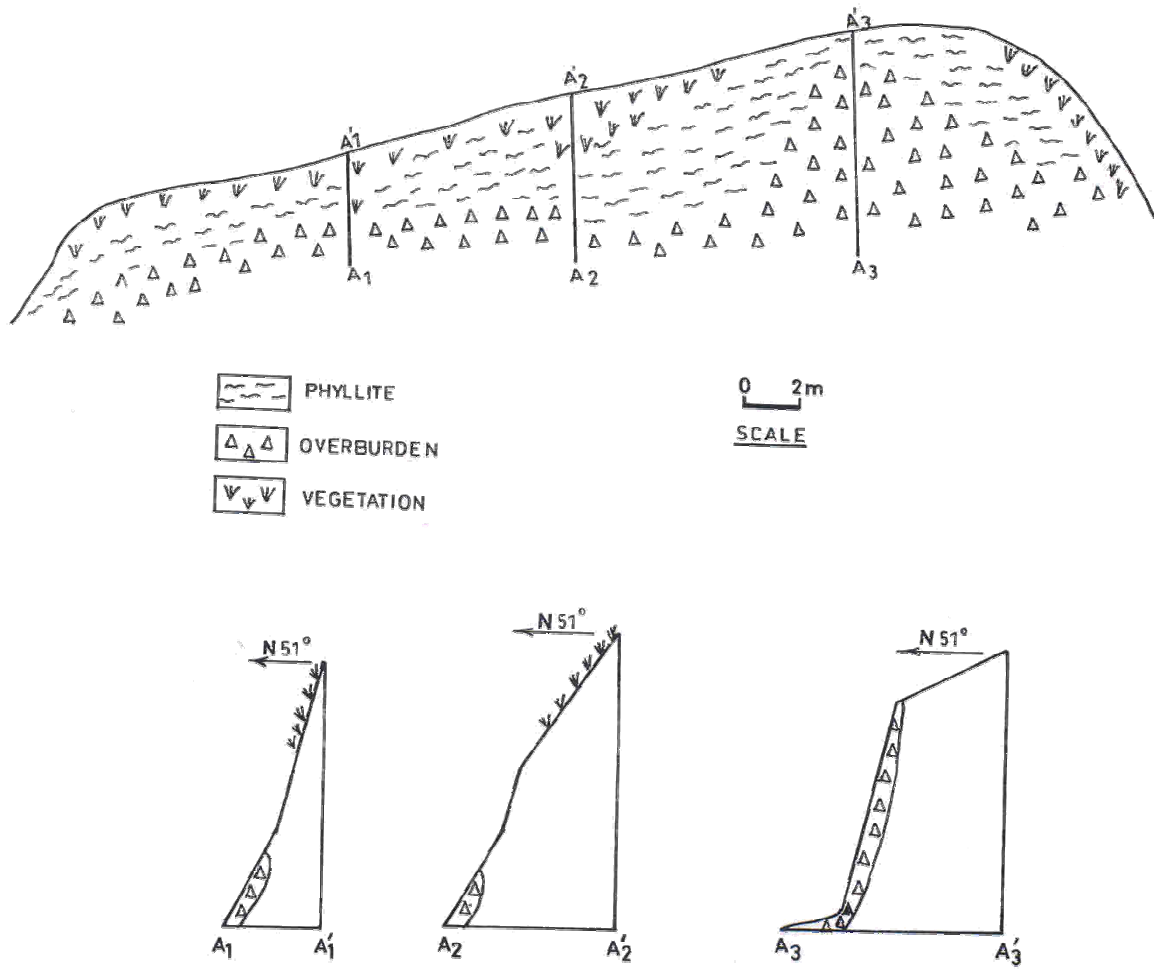
Fig. 10 - Plan and sections of Site No. 4

Nearly 400 m away from Site No. 3 on right bank of the Bhagirathi river is situated site no. 4. Again the rock type exposed is phyllite. Hill slope extends upto a height of about 22 m. above the level of the river and has a lateral extension of about 80m (Fig. 10). The following pattern of discontinuities has been observed in the nearby locality.

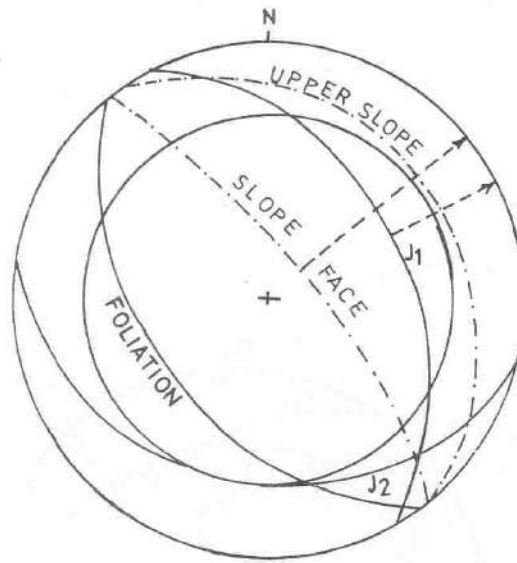
Fig. 11 - Stereographic analysis (Site No. 4, Section A₃ A₃)

The general slope dips about 55° towards $N51^\circ$. Stereographic analysis (Fig. 11) have been carried out considering dip of slope face (ϕ_f) to be 75° followed by stability analysis for planar failure. Values of Factor of Safety (FOS) as obtained, are given in Table 2.

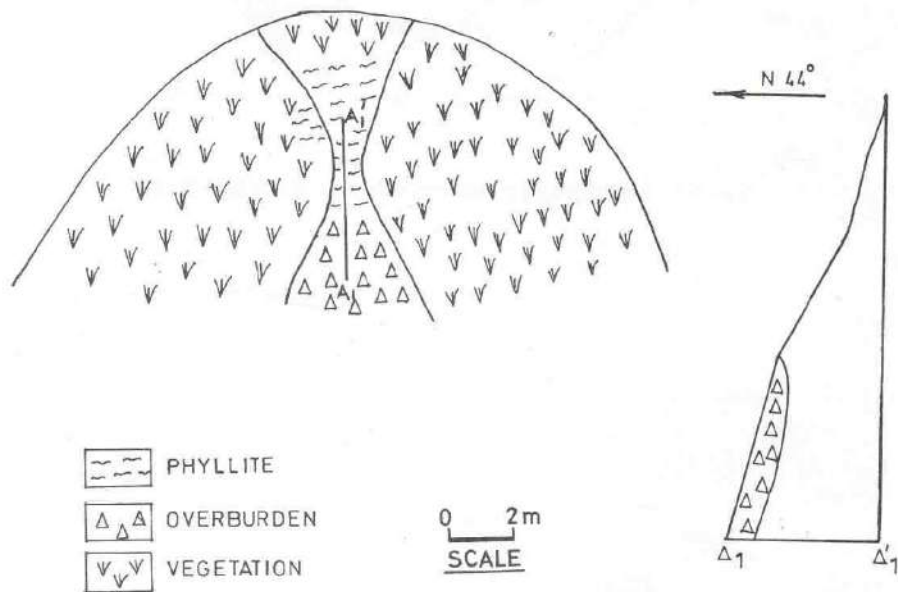
Fig. 12 - Plan and sections of Site No. 5

It is located barely 75 m away from site no. 4, on the right bank of the river. The only rock type exposed is phyllite. This slope extends about 15 m above the level of the river with a lateral extension upto 7 m. Vegetation is noticed only at the top portion, occurring as shrubs. There is presence of huge overburden spreading wide over the toe portion (Fig. 12). The following pattern of discontinuities has been observed in the proximity of this slope.

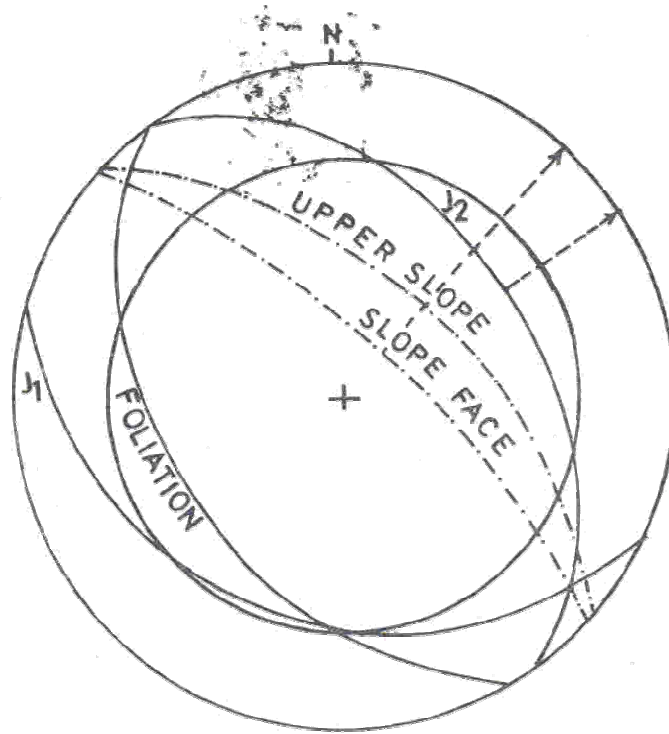
Fig. 13 - Stereographic analysis (Site No.5, Section A₁ A₁')

The general slope in this case dips at about 65° towards $N44^\circ$. Stereographic analysis (Fig. 13) have been carried out considering dip of slope face (ϕ_f) as 75° . Values of Factor of Safety (FOS) as obtained by stability analysis for planar failure are shown in Table 2.
