Steel Liners for Pressure Shafts – Hydrostatic Pressure Testing and Other Quality Control Aspects

Hari Dev^{1}, R.K. Jagota², Rajbal Singh¹*

¹ Central Soil and Materials Research Station, Hauz Khas, New Delhi, India

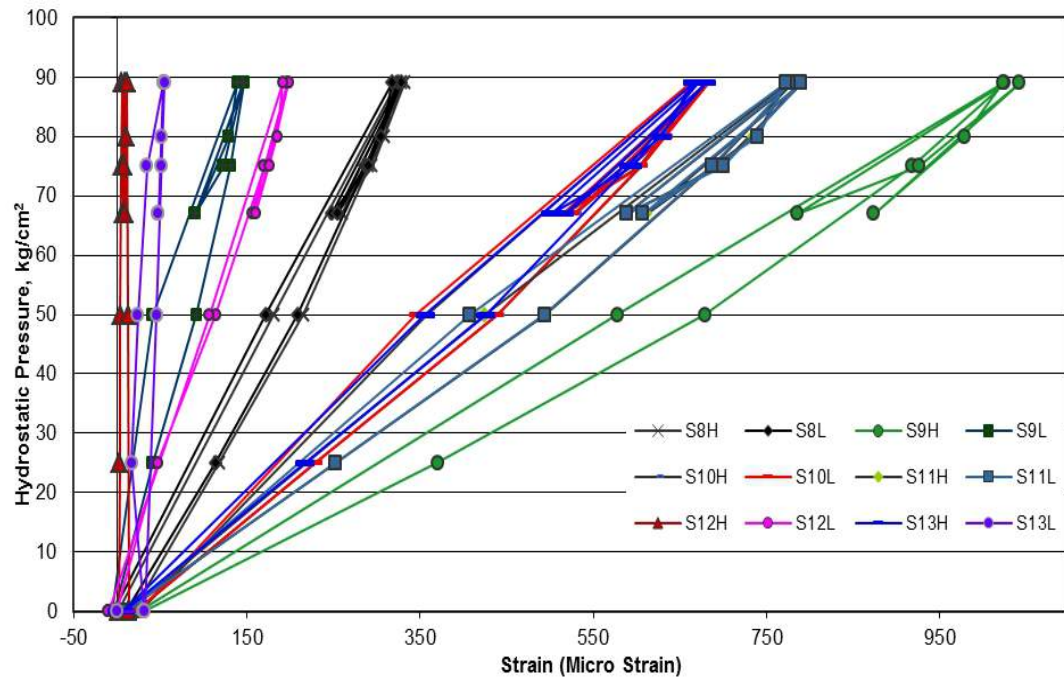
Fig. 8 - Stress-strain plot for bifurcation 1

Figures 8, 9 and 10 show the plot between hydrostatic stress and strains for bifurcations 1, 2 and straight section of liner, respectively. Maximum strains were recorded by strain gauges S-15 and S-16 located at the straight section. These hoops strains were used to determine the hoop stress on the liners. Strains measured at critical locations around Y-pieces were lower as compared to the straight section.

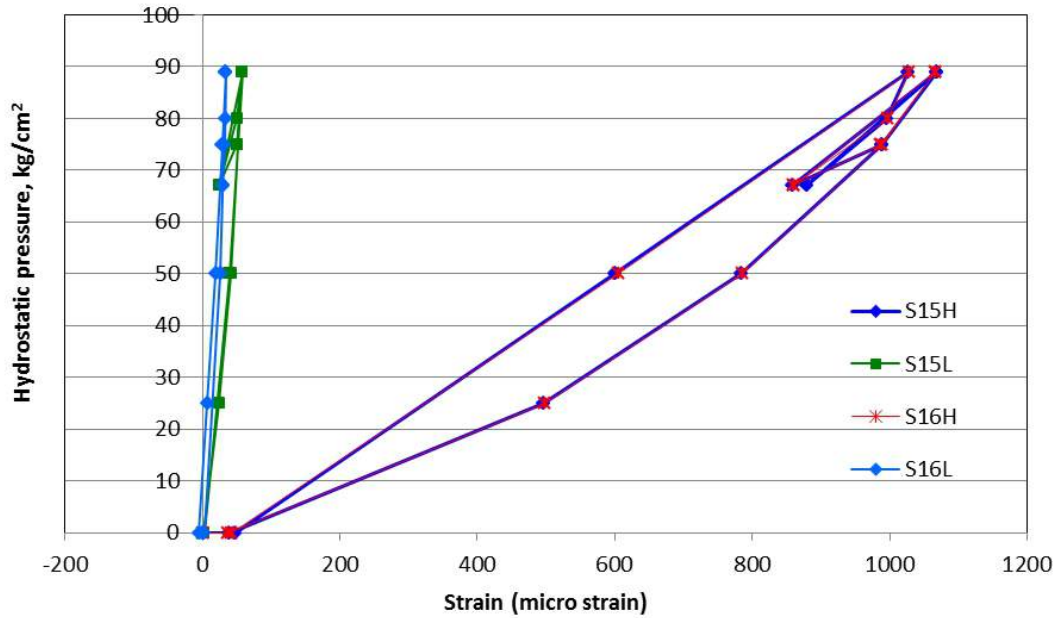
Fig. 10 - Stress-strain plot for straight section (S-15H and S-16H strain gauges)

Locations 15 and 16 were assumed to be sufficiently straight such that strains recorded by S15H and S16H were hoop strains. Further, Table 3 indicates that the strains measured by these strain gauges were same. Measured strains from S-15H and S-16H were almost same at various hydrostatic pressures. Hence, average values have been used for calculation of stresses using Equation 1:

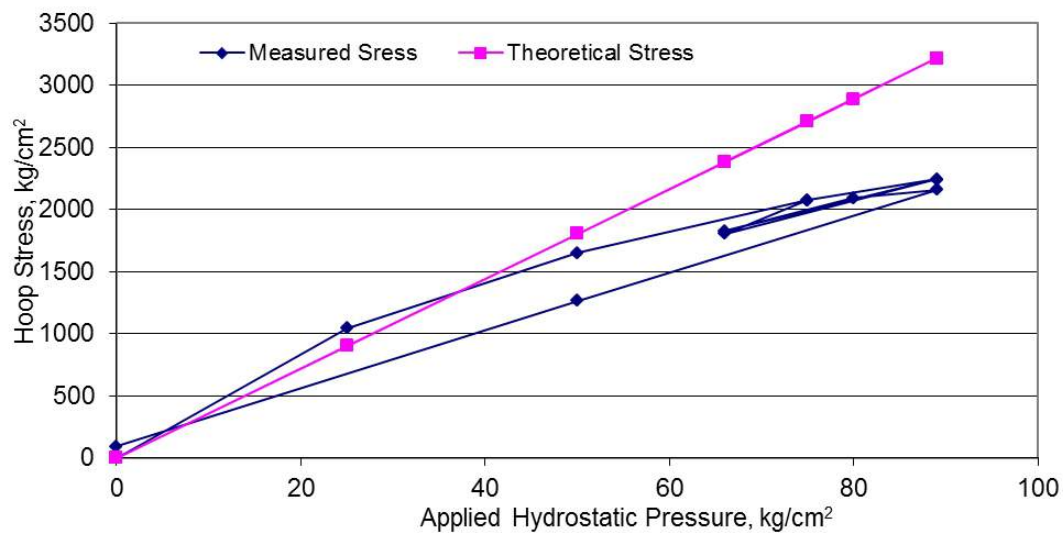
Fig. 11 - Theoretical and measured hoop stresses under cyclic hydrostatic pressure

At low hydrostatic pressure, the actual stresses seem to be slightly higher than the theoretical stress. However, at higher hydrostatic pressure, the actual stresses were found to be significantly lower than the theoretical values. Actual stresses acting on the liner were of the order of 70 - 75 % of the theoretical stresses. Therefore, the steel liners were found to safe against the applied internal hydrostatic pressure of the order of 89 kg/cm² (8.9MPa), thus satisfying the technical specifications criteria.
