Study of Roof Collapse in Rohtang Tunnel during Construction

K. K. Sharma

*Rohtang Tunnel, Border Roads Organisation, Manali, India
Email: kksharma18.iitd@gmail.com*

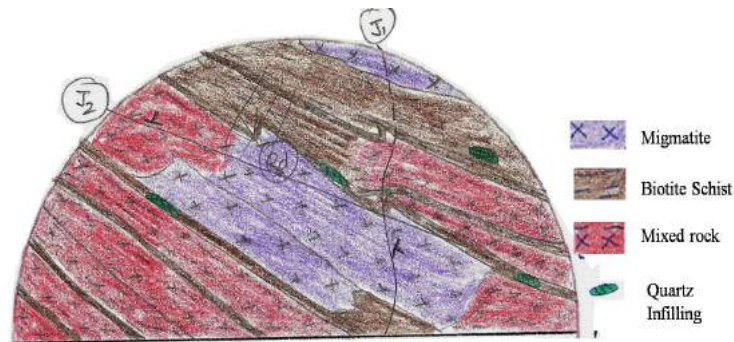
Fig. 3 - Geological face log at ch. 7239.0m

Tunnel drive direction is $S16^{\circ}4' W$. From the geological face logs (Fig. 3), it is clear that there are two prominent joint sets and one random joint. Dip direction/ dip of foliations joint is $230-240^{\circ}/25-30^{\circ}$. Tunnel is yet to be excavated in shear zone due to Rohtang ridge structure.

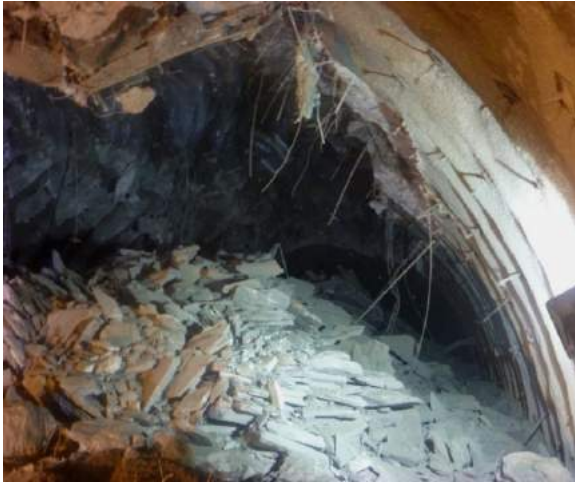
Incidence of roof collapse on 16th October 2013 occurred in between Ch. 7195m and 7245m. Fortunately there was no loss of life. A stretch of crown of approximately 50 m in length collapsed suddenly. Overburden in this area was approximately 1200m. Heading was 100m ahead of the collapsed area. It took almost two months to repair the collapsed area. Figure 4 is photograph of the tunnel section after collapse as seen from North portal. Figure 5 is the photograph showing the repairing works after clearing the debris from the collapsed area. Figure 6 shows the cross-section of the tunnel at ch. 7235.7m after collapse and as seen from South portal. It may be noted that the debris due to roof collapse was more than 1000 m³.

Fig.4 - Roof collapse at Ch. 7+210.89m, North portal

After clearing the debris due to collapse, repairing works was started. Repairing works included - reinstallation of lattice girders, reinstallation and extension of rock bolts (SDA type, IBO, Atlas Copco) and shotcreting with wiremesh (Fig. 5). It took almost two months to complete the repairing job. At other locations of the tunnel also, where tunnel deformations were observed to be higher/unsafe, extra rockbolts (swellex and IBO) were installed.

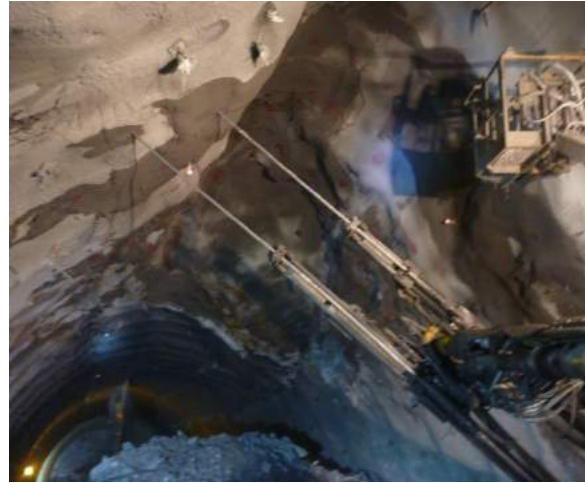
Fig.5 - Installation of extra IBO rock bolts in collapsed area

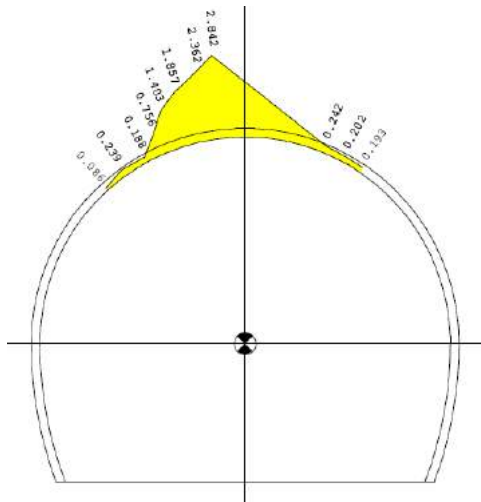
Fig. 6 - Cross-section after collapse at ch. 7235.7m as seen from South portal

Cavities formed due to collapse in between ch. 7195m and 7245m in North portal drive are in saw-tooth pattern along the tunnel alignment. Crown of wedges formed due to failures were lying in between 11:30 to 1:30 o'clock direction. Depth of wedge crown is upto 3.0 m while width is upto 6.0 m (Fig. 6).

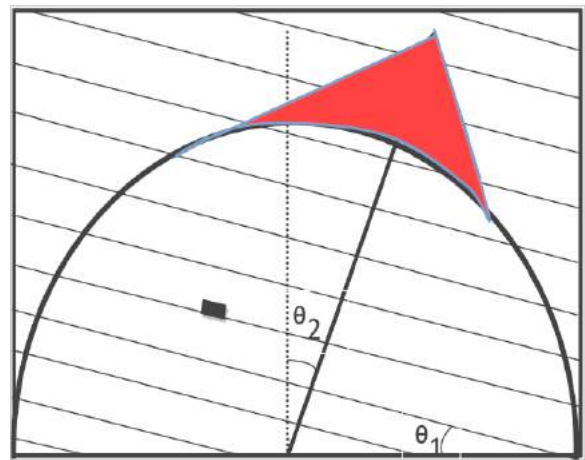
The apparent dip of joint (θ_1) and the approximate angle of the wedges in the crown from tunnel vertical axis (θ_2) were measured (Fig. 7). It is found that θ_1 is approximately equal to θ_2 .

Fig. 7 - Apparent dip of joint and angle of crown of collapsed portion from vertical axis as seen from north portal

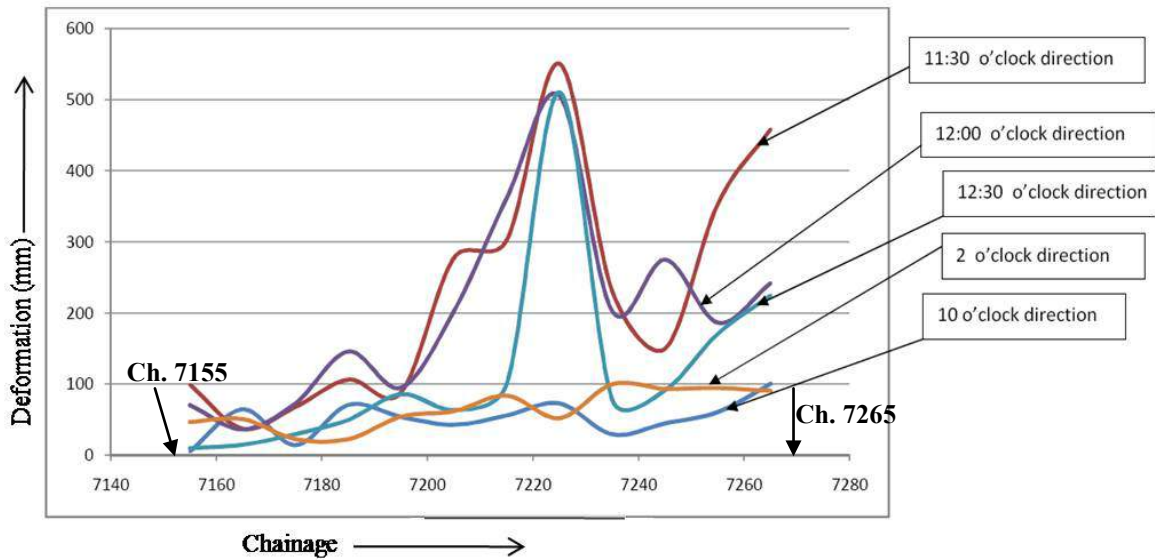
Figure 9 shows the deformations measured in collapsed section just one day before the collapse. Deformation in approximately one o'clock direction has been maximum throughout the collapsed length of tunnel. Maximum deformation noted in 1:00 o'clock direction was 575mm just one day before of collapse. Maximum longitudinal deformation noted were in the range of 100mm. High deformation at Ch. 7230m is due to detachment of shotcrete surface from the rock. From the figure it is clear that overall deformation of the section increases as the face of excavation moves ahead under increasing overburden.

Fig. 9 - Deformation (mm) versus chainage before a day of the collapse

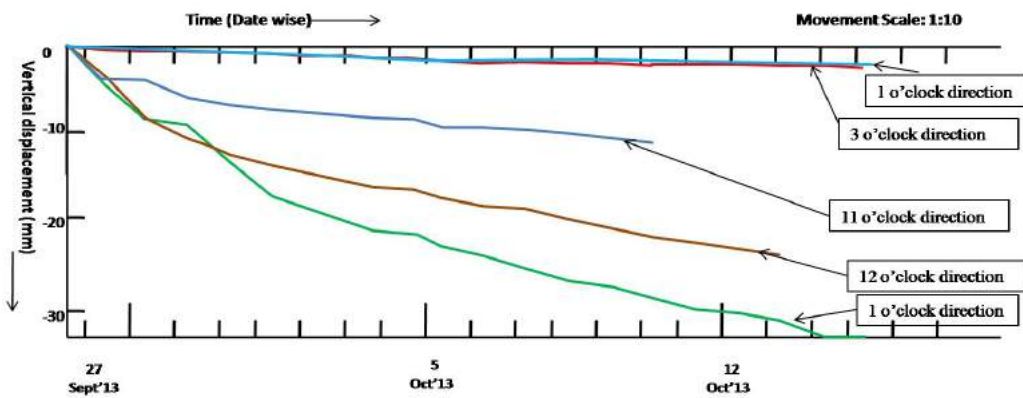
The 3D deformation monitoring is being carried out in tunnel on daily basis. Figure10 shows the deformation at ch. 7215m just one day before collapse. As overburden is increasing from the North portal drive, squeezing is increasing. Squeezing phenomenon is visible in the form of frequent cracks in shotcrete, bending of lattice girders and high deformations in crown areas.

Fig.10 - A sample of deformation measurement at ch. 7215.0m using optical targets

Steps taken to counter the problem of squeezing includes - thick layer of shotcrete, longer rock bolts, close spacing of lattice girder, installation of rock bolts after some deformation and leaving slots in shotcrete layer. A slot in shotcrete was believed to act as 'Apparent Lining Stress Controller'. This was thought to be useful in countering squeezing condition.
