Instrumentation for Study of Distress in Powerhouse and Concrete Dam – A Case Study

*Rajbal Singh**
*S.K. Verma***
*A.K. Dhawan***

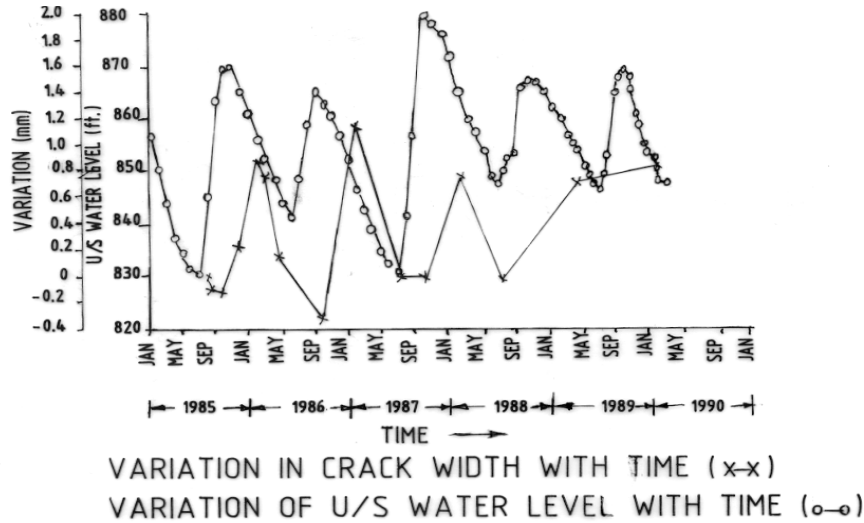
Movement Across Cracks: In all, monitoring of around 70 cracks spread all over dam body and powerhouse was done, and the details are available in the report of CSMRS (1991). Monitoring of cracks has revealed that both, horizontal and vertical cracks are active. The general behavior of cracks is of two types. At some locations, the cracks are steadily widening with time. The other type of behavior is cyclic in nature, which suggests its linkage with the variation in water level of the reservoir. However, a time lag of about four months is observed between the movement of crack and water level of the reservoir as shown in Fig. 2 (Sharma et al., 1991 and Abdullah et al., 1998).

Fig. 2 -Variations in crack width and up stream reservoir water level with time (Sharma et al., 1991)

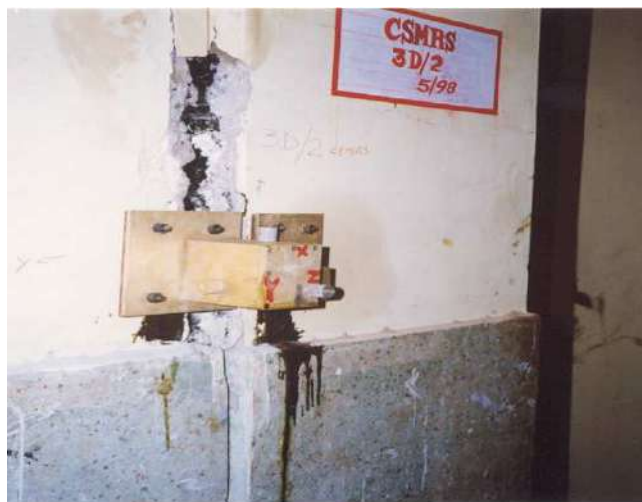
Fig. 4: Crack and Crack Monitor Near Lift of Powerhouse

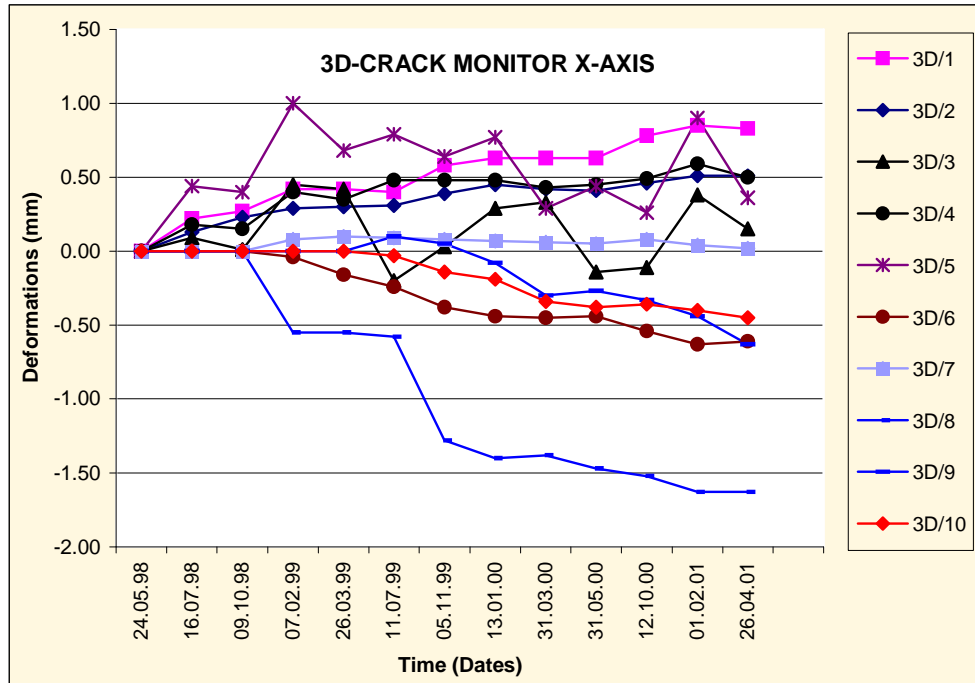
There have been significant movement across the cracks/joints i.e. opening and closing of the cracks have taken place during the recording period. There have been some shear and relative movements between both the walls of the cracks. The maximum shear movement in x-direction (Fig. 5) has been 1.00 mm in about 3 years time, which is not very significant. The maximum relative movement between both the walls of the cracks in z-direction (Fig. 7) has been 1.45 mm in about 3 years time, which is also not very significant

Fig. 5 - Variations of deformations with time at X-axis of the crack/joint

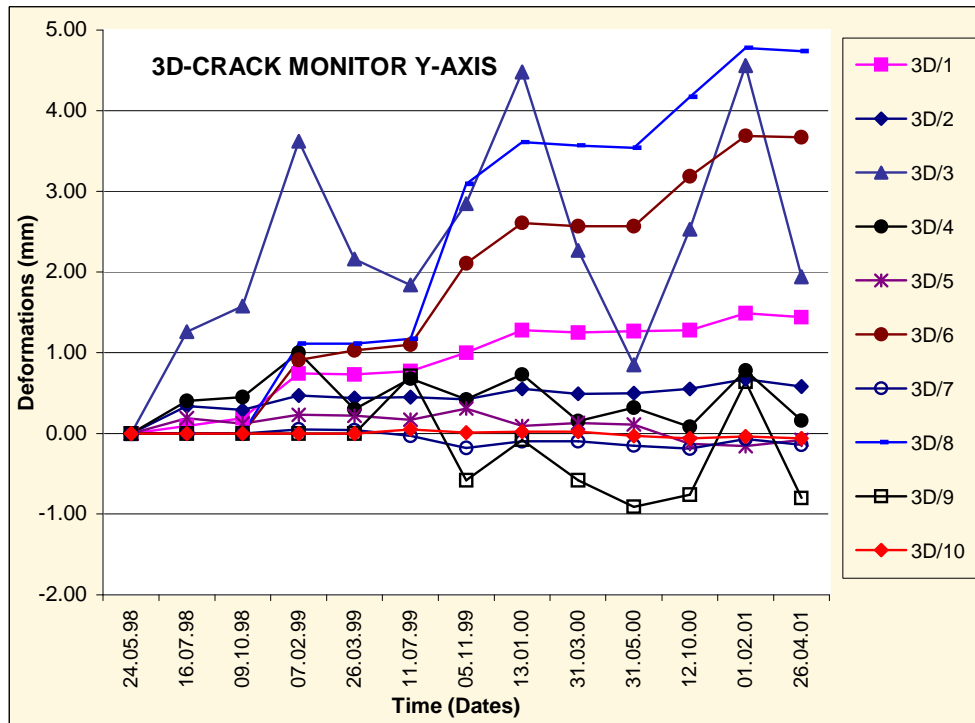
There have been significant movements at some locations across the crack in Y-axis as shown in Fig 6. The maximum movements in Y direction have been noticed as 4.56 mm at 3D/3 location, 3.69 mm at 3D/6 location and 4.78 mm at 3D/8 location (Table 2). In most of the cases the cracks have been opened up with time. The opening and closing of the cracks are also taking place at some locations as shown in Fig. 6.

Fig. 6 - Variations of deformations with time at Y-axis of the crack/joint

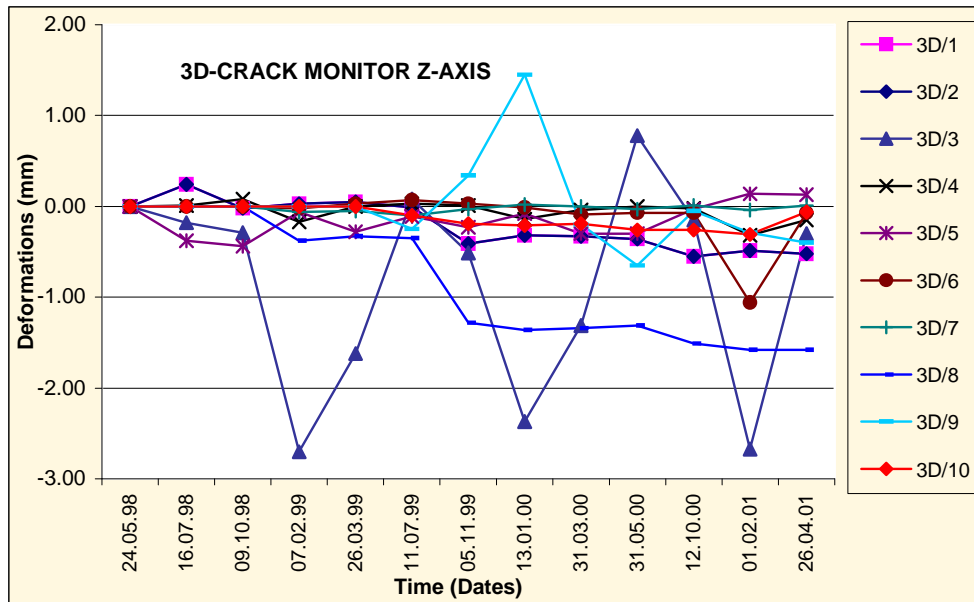
Fig. 7 - Variations of deformations with time at Z-axis of the crack/joint

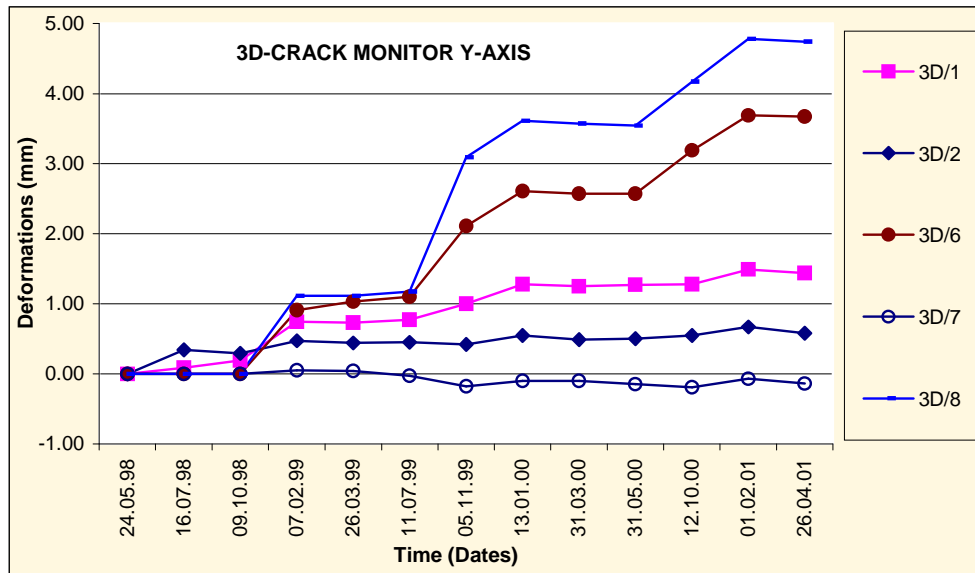
The deformations at elevation 207.33 m as shown in Fig. 8 are significant and are in increasing order with time. The maximum movements in Y direction have been noticed as 4.78 mm at 3D/8 location i.e. at an elevation of 207.22 m as also shown in Table 2. Crack monitors at locations 3D/1, 3D/2, 3D/6 and 3D/7 also showed similar behavior. All the crack monitors (as shown in Fig. 8) are installed at elevations 207.33 m except 3D/2 at an elevation of 216.67 m. It shows the effect of continued distress in the dam body as well as in the powerhouse.

Fig. 8 - Variations of deformations with time at Y-axis of the crack/joint at Elevations below 216.67 m

It is evident from Figs. 8 and 9 that the deformations at lower level are increasing with time due to the distress in the dam and powerhouse and the cracks and joints are closing and opening at higher elevation due to distress and water level in the reservoir. The crack monitors installed at locations 3D/3,

3D/6 and 3D/8 must be monitored carefully due to significant variations in the deformations with time in all the three directions.

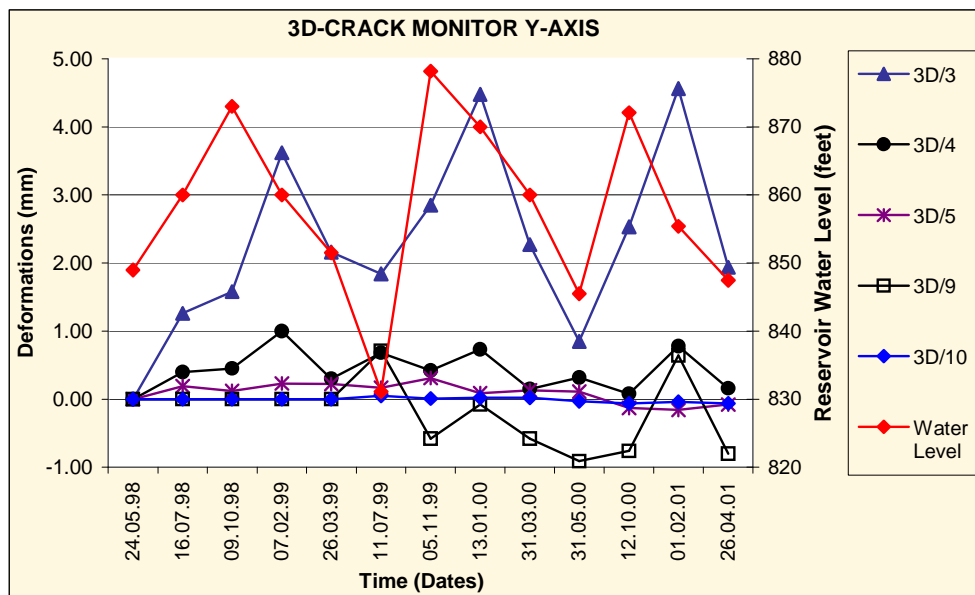
The crack monitor, 3D/10 (Fig. 9) installed at an elevation of 298.33 m is dummy (not installed on any crack or joint but installed on surface of the concrete at top of the dam) and it shows insignificant deformation variations of -0.06 mm to 0.05 mm (Table 2).

The deformations at elevations equal and above 227.67 m as shown in Fig. 9 are very significant and are increasing and decreasing with time i.e. opening and closing of the joint/cracks are taking place. This variation at higher elevation can also be related with reservoir water level as also shown in Fig. 2 by Sharma et al. (1991).

Fig. 9 - Variations of deformations with time at Y-axis of the crack/joint at Elevations above 227.67 m
