## *Case Study of Failure of Slopes at Morni Hills*

*Anupam Mital\**  
*Praveen Aggarwal\**  
&  
*Mohinder Pal Gupta\*\**

### **ABSTRACT**

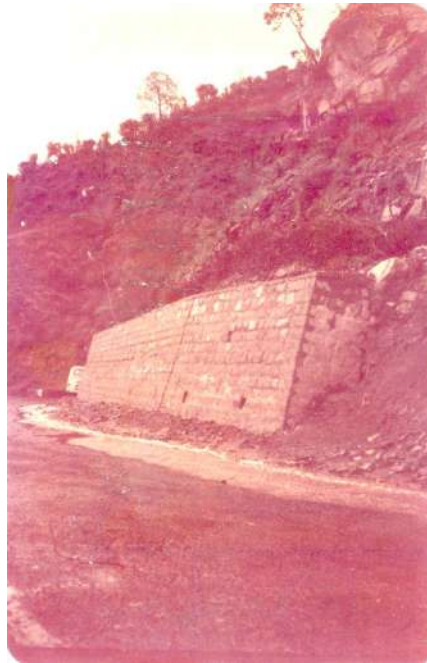
In the absence of adequate and proper drainage facility, the rain water formed preferential flow channels, eroding the slope (Fig. 1). Percolation of rain water into the soil caused an increase in pore water pressure. The process of saturation lead to the instability. Although the influence of increase of unit weight on the stability of slope was marginal, the effect of increase in pore water pressure lowered the shear strength of the soil by reducing the value of effective normal stress and resulted in instability.

Fig. 1 – Rain water flowing on the road in the absence of drainage facility. A breast wall is there on hill side

For improving overall drainage system, it is considered desirable to (a) provide impervious carpeting on the associated areas through which infiltration is suspected (b) repair existing drains, if any and (c) provide additional drains.

The drains should be constructed according to the scheme presented in Fig. 3. The recommended cross-sections of the drainage structures can be as shown in Fig. 6 (a & b). These cross-sections are based on past-experience and may call for some minor modifications. Figure 7 shows a view of the recently constructed side drain at R.D. 24000 near village Thana.

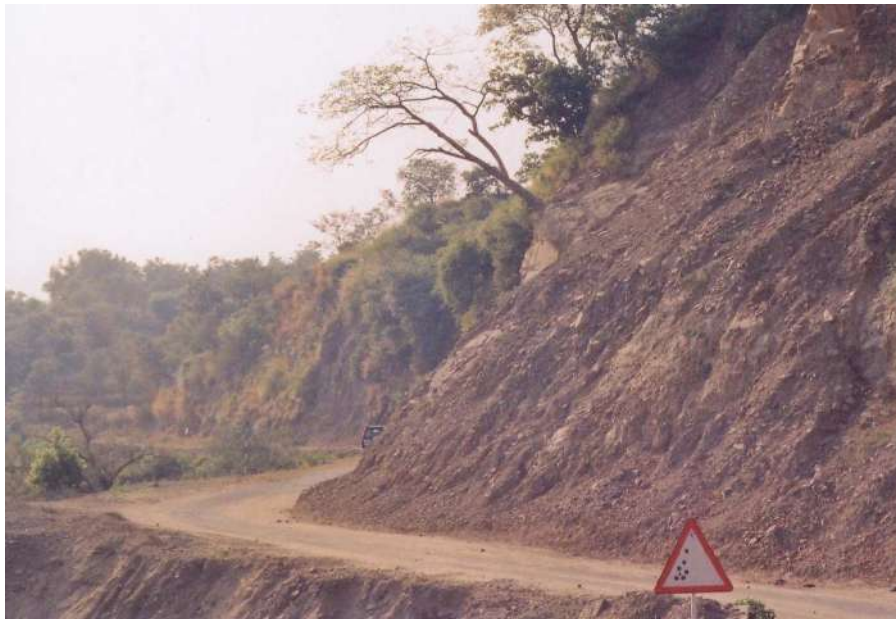
Excavation close to the toe of a slope caused the same effect as that of loading of slope. The removal of the lateral supports particularly the removal of the toe of slope for construction of highway was responsible for the slide (Fig. 2).

Fig. 2 – Slope failure because of toe-cutting for construction of highway

Here, the normal pressure on the potential slip surfaces decreased and the tensile and shearing stress in the unsupported earth or rock mass increased resulting in a slope failure.

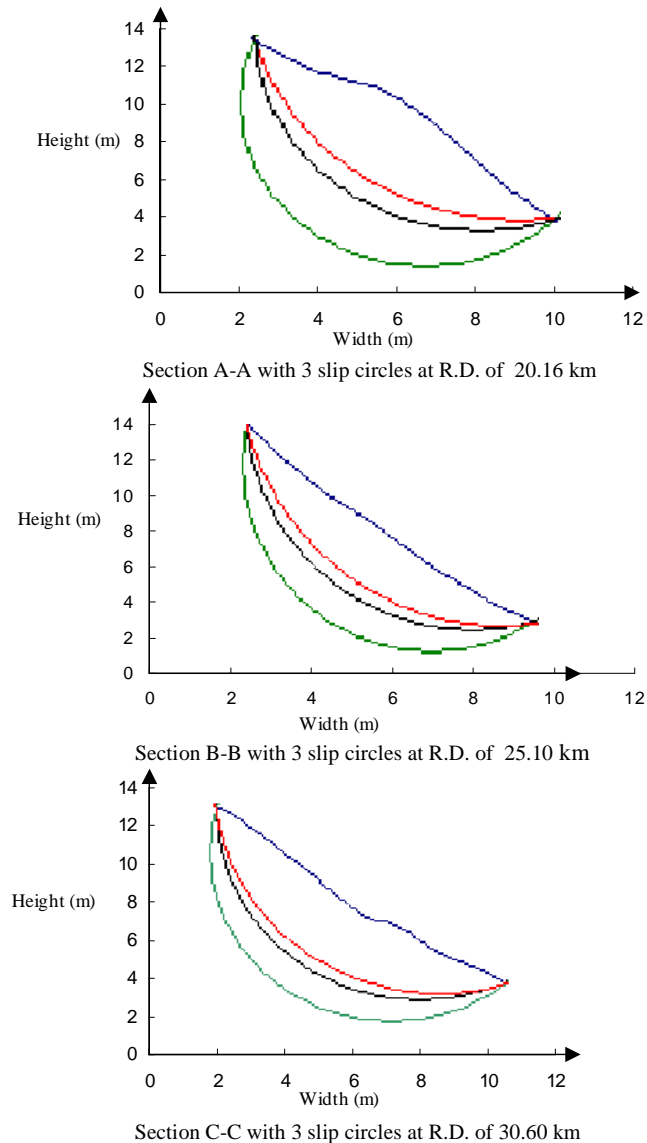
After identifying location of the problematic slopes as shown in Fig. 4 the areas were investigated for back-analysing the values of cohesion ‘c’, angle of internal Friction ‘φ’ and unit weight of the slope material ‘γ’. The values obtained for three sections are given in Table 1 assuming factor of safety (FOS) of 1.0 for failed slopes.

The three sections were analyzed from the stability point of view by method of slices (c-φ method).

For each section, three trials were made as in Fig. 4 for the assumed slip surfaces and factor of safety for each was calculated.

Fig. 4 – Slip circles at three critical sections A-A, B-B & C-C marked in Fig. 3

After the location of the three most critical slip surfaces corresponding to the three sections i.e. AA, BB and CC, the location of the retaining wall was decided, the wall being kept penetrating the critical slip surface for safety. To increase walls stability, the walls were tilted at an angle of  $10^\circ$  and the minimum depth of penetration for each was kept as  $H/10 + 30$  cms, where H is the height of the wall. As the area falls in Zone-IV of the seismic zones of India, the values of  $\alpha_h$  and  $\alpha_v$  were obtained as 0.05 and 0.025 respectively. A computer program was developed in FORTRAN language for the design of retaining walls. Using the computer program, trials were made with different wall dimensions, till all design criteria was satisfied. In this way, the final wall section was arrived at. The design was done for both static conditions (i.e.

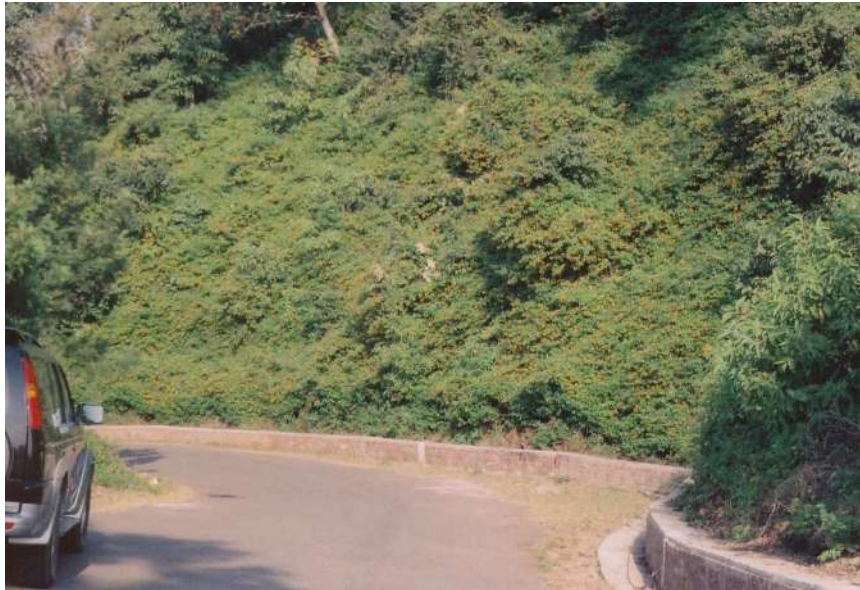
Fig. 7 – A view of the recently constructed side drain at the proposed location (RD 24000m)
