Rock Supports and Geological Appraisal for Head Race Tunnel of Tala Hydroelectric Project, Bhutan

***Hari Dev^{1,*}
Rajbal Singh¹
C.K. Sengupta²***

¹*Central Soil and Materials Research Station
Hauz Khas, New Delhi, India
* E-mail: haridev@nic.in*

This paper presents geological appraisal and the rock support systems adopted during excavation of the head race tunnel of Tala hydroelectric project in Bhutan. Rock supports in terms of steel fibre reinforced shotcrete (SFRS), grouted rock bolts, self-drilling anchors and steel ribs were provided for supporting the excavation. Finally, the tunnel was supported with concrete lining. Apart from this, contact and consolidation grouting was also done for improving the properties of rock mass. The rock mass class encountered during the excavation varied from good quality to squeezing condition. The support system was designed for different classes of rock mass and the same was implemented with some modifications as per the site conditions. DRESS technique was used. The extensive quality control and instrumentation were helpful to take the corrective measures, wherever required.

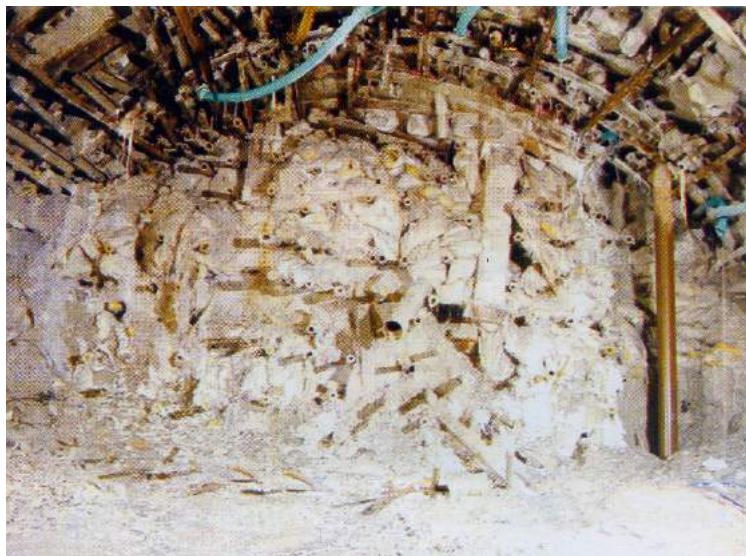
Fig. 3: Bamboo piling at HRT

- Tunnel face was tried to consolidate with bamboos pilings (Fig. 3)

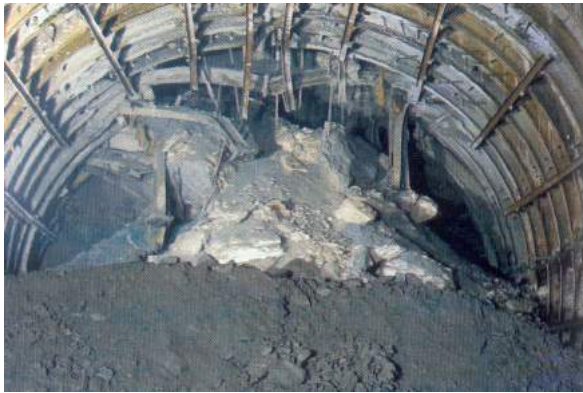
Fig. 5: Collapse in diverted alignment

After diversion of HRT, excavation was carried out with caution restricting the pull to 2 m irrespective of the rock mass class. At chainage 1005 m, a foliation parallel shear zone appeared at the crown dipping 40° to 45° with the drive and caused some over break. Though steel ribs were installed at a spacing of 0.5 m, but buckling and squeezing of the ribs was observed with time. This was due to the dead load of sheared rock mass comprising completely pulverised bands of quartzite, amphibolites and quartz-biotite-schist intermingled with clayey mass. Invert struts were also installed to counter the wall pressure. Buckling of ribs continued and ultimately 5 ribs from the face collapsed. Approximately, 15 m³ of muck filled the tunnel up to crown (Fig. 5).

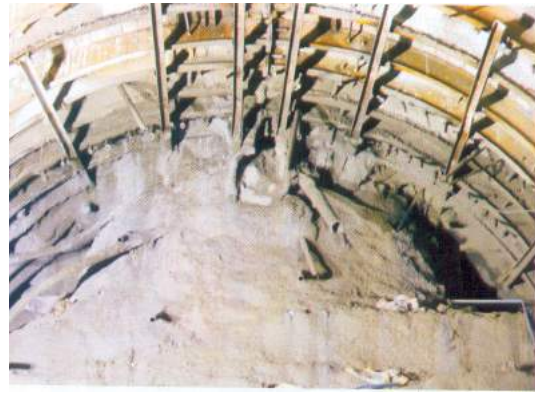
Fig. 6: Treatment of collapse in diverted alignment

Concrete could not be placed in the cavity and cement grouting had to be resorted ultimately. Two stage grouting was adopted. In the first phase, thirteen 8 m long and 51 mm diameter MAI anchors were inserted along the tunnel periphery at an upward angle of 20° . Grout (cement water mixture) was injected through these anchors. In the second phase, 27 numbers perforated MS pipes (8 m long and 50 mm in diameter) were inserted and grouting was done through them. A total of 146 MT of cement was injected through MS pipes and anchors. This grouting was helpful in filling up of the cavity as well as consolidation of the surrounding rock mass (Fig. 6). The damaged ribs were replaced one by one carefully.

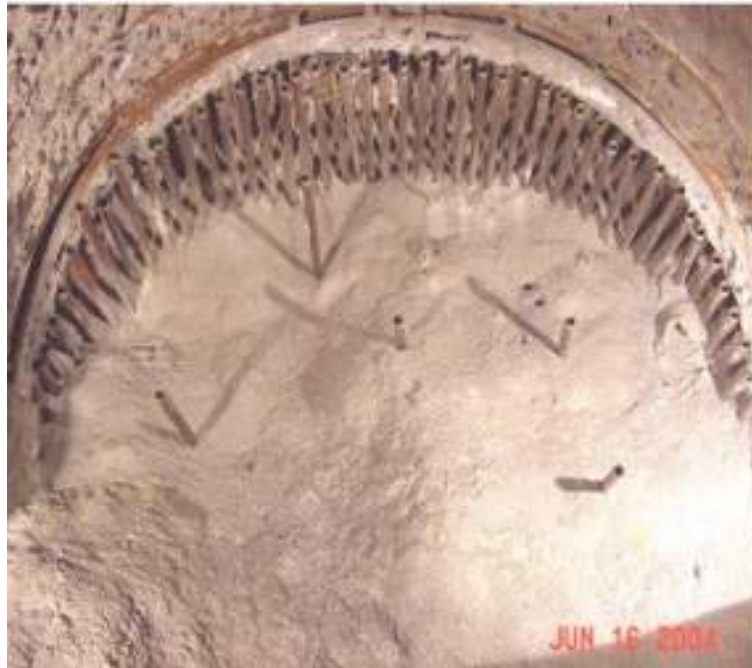
Fig. 7: Forepole umbrella with drainage holes in HRT AGO reach

Reinforcement: After installation of drainage system, face stabilization was done by putting wire mesh with shotcrete or SFRS to enable safe and stable working conditions. Perforated steel pipe forepoles (casings) of 114 mm outer diameter and 6 mm thickness in an upward direction of 6^0 to 8^0 were installed with the help of hydraulic drilling rig. The forepoles were spaced at 200 - 300 mm centre to centres. Afterwards, grouting was carried out systematically in a proper sequence starting from the far end of each pipe using a mechanical packer. The packer was retracted after every one meter once a pressure of 35 - 40 kg/cm² developed. Pipes were made solid by cement grout after completion of pressure grouting. As forepoles were perforated, grout also filled the annulus space between pipes which were very well observed during excavation stage.

Support Solution: In every stage of forepole umbrella, first rib was installed at minimum excavation line and subsequent ribs were provided in a variable progressive excavation line radius to facilitate forepoling machine working in next stage of forepoling. By providing the incremental rib profile, a step of 45–55 cm in height and 30–50 cm in radius was gained. Three different steel rib sections ISMB 250x125, ISMB 300x140 and ISMB 350x140 were used as rock supports at spacing of 350 mm, 400 mm and 500 mm c/c respectively. Once 4 to 5 ribs were installed, invert struts were also placed making it a closed section to counter movement of side walls and upheaving of invert. View of forepole umbrella arch with drainage holes in the face is shown in Fig. 7. Summary of the forepoles are given in Table 2.

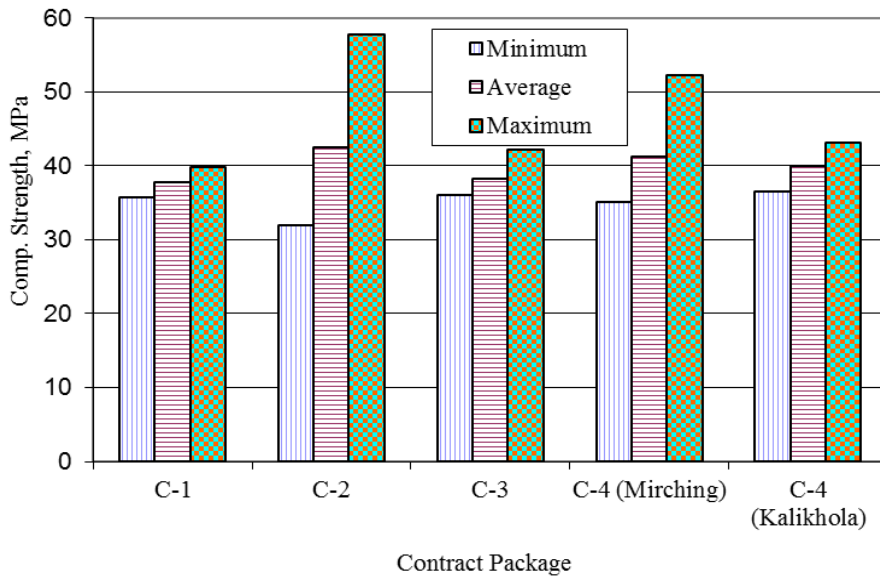
Fig. 8: Compressive strength of SFRS cores

Thickness of shotcrete was measured at random points (roughly one measurement every 100 m²) via coring. SFRS cubes were cast for determining the compressive strength. Cores extracted out of the in-situ shotcrete were tested for evaluation of in-situ strength after cutting/capping. Cores of shotcrete with an age of 28 days should have equivalent cube compressive strength of at least 85% of the specified grade of shotcrete. The equivalent cube compressive strength at 28 days was found to be as per specification

requirements (IS 516:1959 – Reaffirmed in 1999). The average compressive strengths of SFRS cores have been shown in Fig. 8.

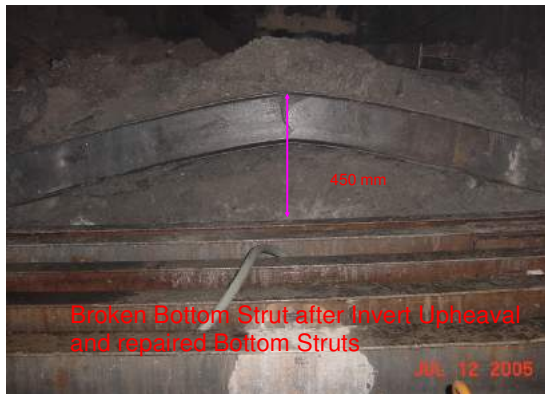
Fig. 10: Broken/replaced invert struts

pressures and upheaval. Bending of steel ribs was observed at some critical sections. Because of the considerable wall pressures, upheaval took place resulting into bending and cracking of invert struts in AGO reach. These damaged invert struts were replaced before start of concrete lining in this AGO reach (Fig. 10). Invert struts were welded properly to the ribs as shown in Fig. 11. Backfilling of the ribs and the rock interface was given due importance to prevent concentrated loads on the steel ribs which may otherwise result in distortion of steel ribs. Tensile properties of steel ribs were evaluated in accordance with IS 2062 (1985).

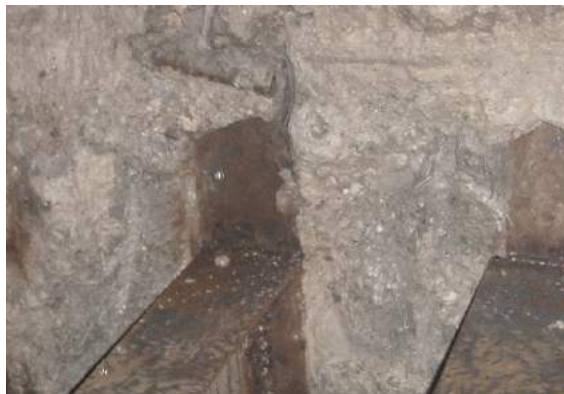
Fig. 11: Invert struts welded to the steel ribs

Steel ribs were used to support the HRT with M15A20 grade of backfill concrete for rock classes IV to VI wherever found necessary. Invert struts were also provided in extremely poor rock mass conditions so as to form closed section to counter the wall

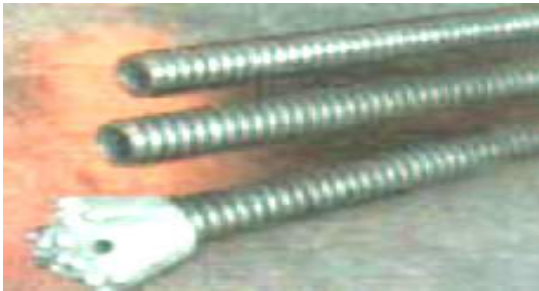
Fig. 12: Hollow core self-drilling anchor

Hollow core self-drilling anchors of 12-16 m long were also provided in the squeezing rock mass conditions in Kalikhola and Mirchingchu for face stabilisation as well as countering the side wall pressures. These anchors have been used as means of draining the rock mass and also for grouting to improve properties of the rock strata (Bhandari et al., 2004). These self drilling anchors were very effective in channelizing the seepage because of hollow core. For anchoring steel arches, anchors of 8 m length were installed in a systematic pattern. The locations indicating rising trend of rock loads were provided with 12 m long anchors. Photograph of the hollow core self-drilling anchors and the load-displacement curve for pull out test on these anchors are shown in Figs. 12 and 13 respectively.

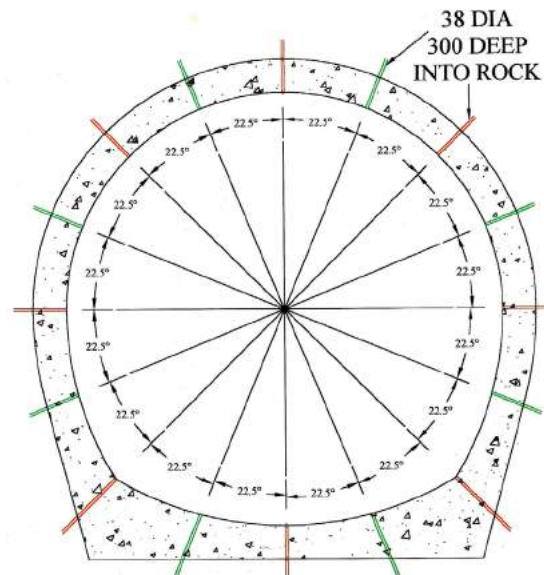
Fig. 15: Design of drill holes in HRT for contact grouting for rock classes V to VI

Contact grouting involves the filling of voids between concrete lining and excavated surface of the parent rock. Contact grouting is sometimes referred to as backpack grouting also. Design of drill holes for contract grouting in HRT between concrete lining and rock mass are shown in Figs. 14 and 15 for rock classes I to IV and V to VI, respectively.
