Evaluation of Shear Strength Parameters in Jointed Rock Mass

Rajbal Singh, D.V. Sarwade

*Central Soil and Material Research Station, New Delhi, India
Email: rajbal.singh@nic.in; sarwadedv@rediffmail.com*

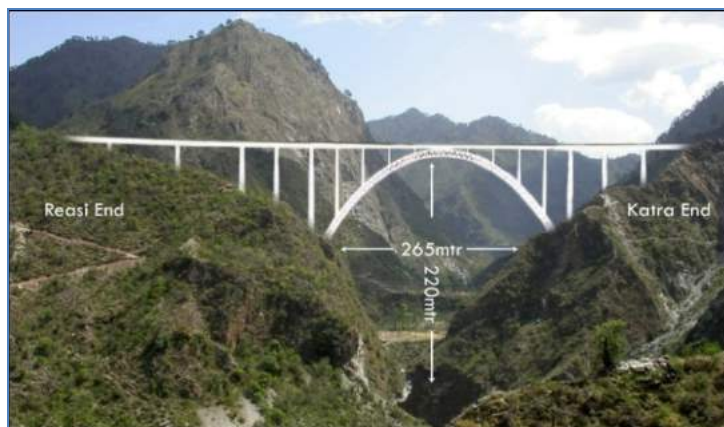
Fig. 2 - Schematic view of proposed Anji Khad bridge

It was proposed to construct an arch bridge for Udhampur-Srinagar-Baramulla Rail Link (USBRL) project, across Anji, a seasonal tributary of Chenab River, near Reasi district, Jammu & Kashmir, India. The proposed Anji Bridge is 186m high from river bed level and 657m long. The location map of the project is shown in Fig. 1. Schematic view of proposed Anji Khad Bridge is shown in Fig. 2. The Central Soil and Materials Research Station (CSMRS) undertook the investigation work of determining the deformability and shear strength characteristics of rock mass required for the design of railway bridge foundation at Anji Khad (CSMRS 2009a, 2009b and 2009c).

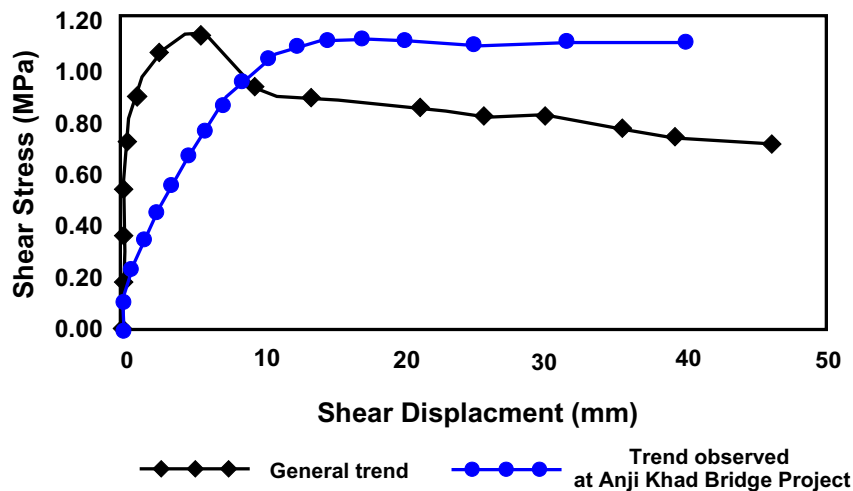
Fig. 3 - Shear stress versus shear displacement with trends in general and at present project

In general when in situ shear tests are conducted under constant normal load, the peak shear strength is attained first and then residual shear strength is determined. In shear stress versus shear displacement plot, the shear stress reduces suddenly just after achieving peak stress and then comes residual stress after applying shear stress continuously and getting shear displacement without getting much ups and down in shear stress. In the present investigation, as the rock mass was jointed and fractured with few shear zones, the shear strength parameters were evaluated only for residual value as peak values could not be differentiated

(Fig. 3). This phenomenon was noticed in all the eleven blocks on the left abutment and five blocks on the right abutment. These tests were conducted inside the drifts on the rock slopes of left and right abutments of the Anji Khad. It appeared from the test results that peak strength must have already been attained during natural shearing on the rock slopes as the shear stress was applied perpendicular to the rock slope.

Strata of the area are characterized by prominent one sub-horizontal foliation joint and two sub-vertical joints. The foliation joint strikes roughly N-S and dips 20° to 30° in East direction. Generally in a shear test, the peak value is attained first followed by residual stress as shown in Fig. 3, when shear displacement is obtained without increase in shear stress. However, shear stress gets reduced even after regular hydraulic pumping and thus the residual stress is obtained when there is almost no change in shear stress with the increase in shear displacement. Lot of shearing must have already taken place at this location along the rock slope and peak values must have been attained during this natural in situ shearing of the rock mass. It was a unique experience at this project site. It is clear from Fig. 9 that there is no peak stress at this location from all the tests.

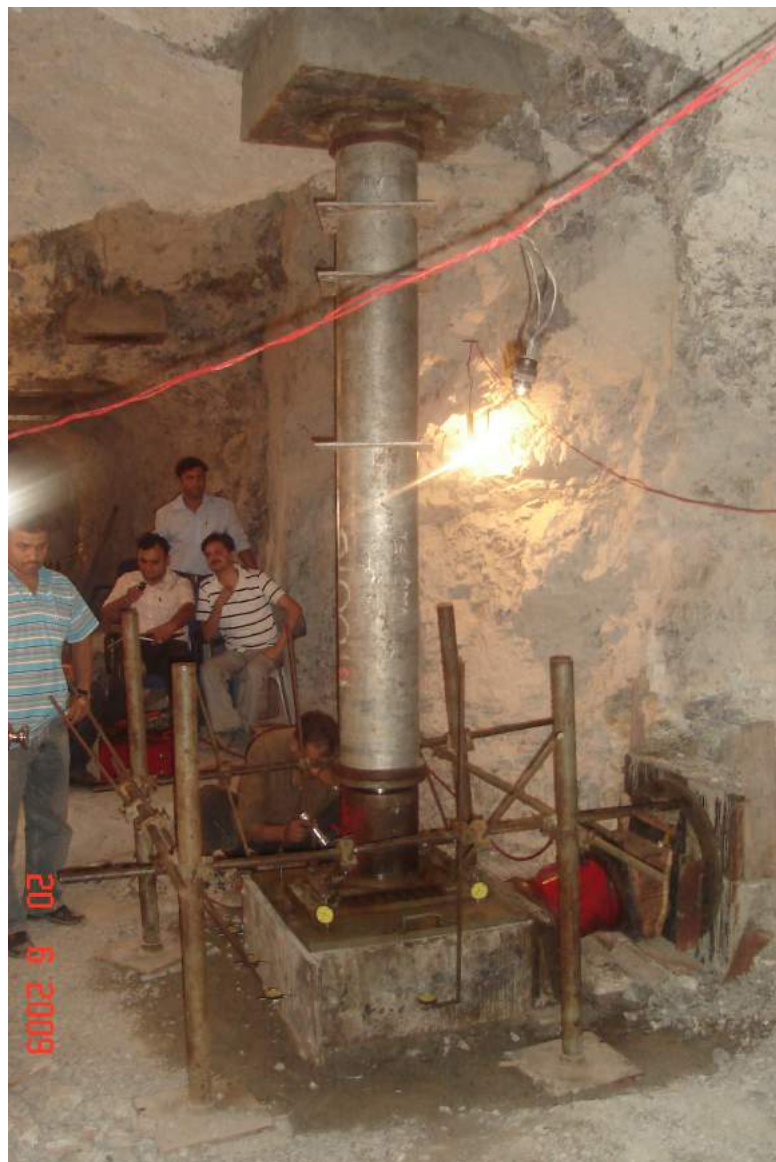
Fig. 4 - In situ shear test assembly inside drift

For conducting this test, the rock surface was prepared by careful manual chiselling. The rock blocks were prepared by drilling 0.35m deep overlapping holes in such a way that the area of rock block was 0.70m x 0.70m. To avoid any disturbance in the test block during shearing, the block was surrounded by filling concrete around the block with the help of steel frame along with an angle of 15° on the upstream side of the block. The same steel frame was used during test to avoid any disturbance of the block.

Before conducting tests, a channel approximately 20mm deep and 80mm wide was cut around the base of the block to allow freedom of shear and lateral displacements. The vertical reaction was taken against a reaction pad cast at the crown. The reaction for shear load was taken against a concrete pad cast at the upstream face of the drift. The direction of the shear load was kept the same as anticipated shearing in the structures, in the case of the bridge abutment, the shear load was applied towards inside the hill slope.

The normal load was applied using 100 tonne (T) jack and the shear load was applied using another 200 T hydraulic jack. The hydraulic jack for shearing was set up at an inclination of 15° to the horizontal on the vertical side of the block so that the shearing load passes through the centre of the base of the block without causing any overturning movement (Fig. 4). The displacements were measured in the directions of normal, shear and lateral to the sheared plane. The displacements can be measured either with dial gauges or LVDT (Linear Voltage Differential Transducers) with an accuracy of 0.01mm and a travel of at least 70mm.

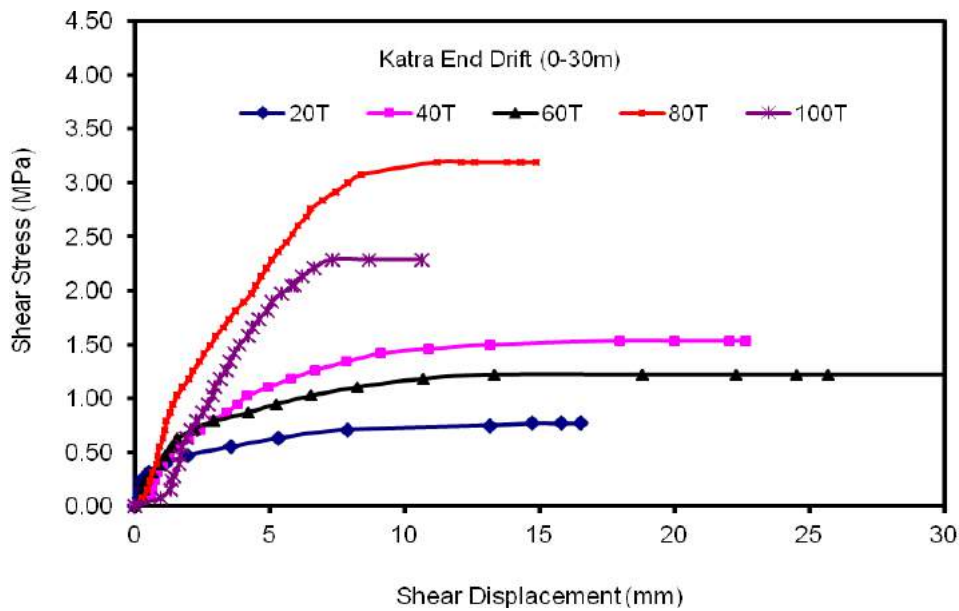
Fig. 5 - Shear stress versus shear displacement of five shear tests conducted at left bank abutment
(Normal load=20T to 100T; RD= from 0m to 30m from the portal)

In this drift of 30m length, five shear tests were conducted to determine the shear strength parameters of rock mass. It is seen from Fig. 5 that the variations in shear stresses are not proportional to the normal stresses. The maximum shear stress was for a normal load of 80T which was more than the shear stress for 100T of normal load. The shear stress at normal load of 40T was higher than the shear stress at 60T. This has all happened due to variations in number of joints and strength properties of joints in rock mass.

Shear stress versus shear displacement plots are shown in Fig. 5 and the shear stress versus normal stress plot is shown in Fig. 6. The results interpreted from five blocks between RDs of 0.0 to 30m showed that the value of cohesion (c) and friction angle (ϕ) were 0.39MPa and 49°, respectively, for residual shear strength parameters. There was slight deterioration in the shear strength parameters on left bank drift as compared to right bank drift. It was, therefore, decided to extend the drift up to the length of exact bridge abutment location. The drift was extended up to 68m and a set of six more shear blocks were tested in the extended portion of the drift.

As the rock mass was jointed and fractured with few shear zones, the shear strength parameters were evaluated only for residual value as peak values could not be differentiated, which was clear from the shear stress versus shear displacement curve. Lot of shearing must have already taken place at this location along the rock slope and peak values must have been attained during this natural in situ shearing of the rock mass. It was a unique experience at this project. In general, peak stress is attained first in all the in situ shear tests and peak shear stress is followed by residual shear stress in the plot of shear stress versus shear displacement.

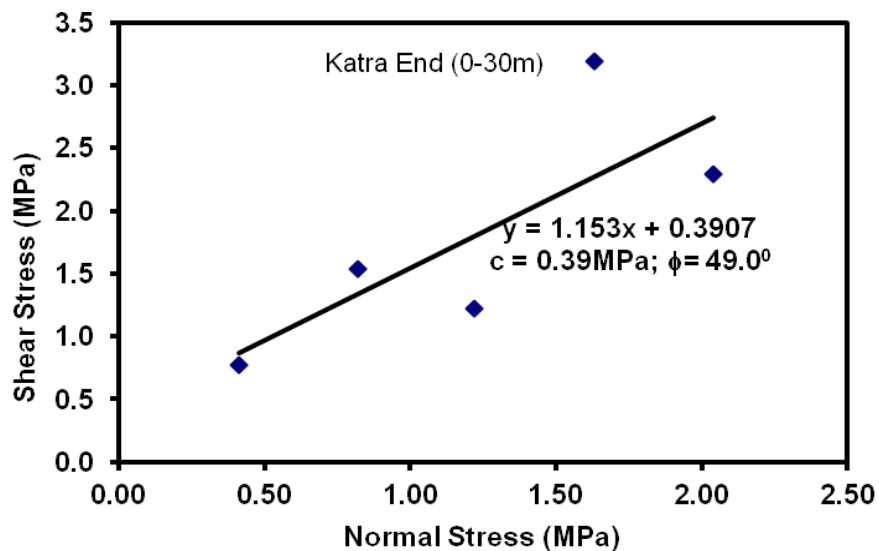
Fig. 6 - Shear stress versus normal stress for left bank abutment

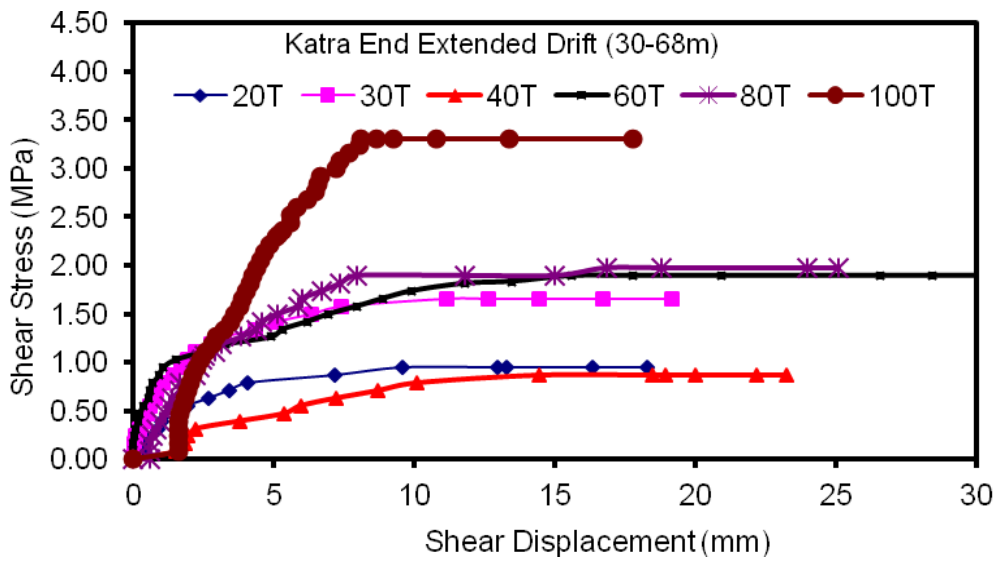
Fig. 7 - Shear stress versus shear displacement of six shear tests conducted at left bank abutment
(Normal load 20T to 100T; RD= from 30m to 68m from the portal)

The variations of shear stress versus shear displacement curves at different normal loads for all six blocks on the left abutment (Katra end; Extended Drift, RD 30-68m) are shown in Fig. 7. It is clear from left abutment data also that no peak shear stress was attained during testing. The shear stress versus normal stress plot is shown in Fig. 8. The results interpreted from six blocks between RDs of 30 to 68m showed that the value of cohesion (c) and friction angle (ϕ) were 0.38MPa and 51.12° respectively for residual shear strength parameters. There was slight improvement in the shear strength parameters after extending the drift. Similarly, it was noted that there was improvement in modulus of deformation and modulus of elasticity with improvement in rock mass in the extended drift with applied stress of 5.66MPa in plate loading test (CSMRS, 2009a and 2009b).

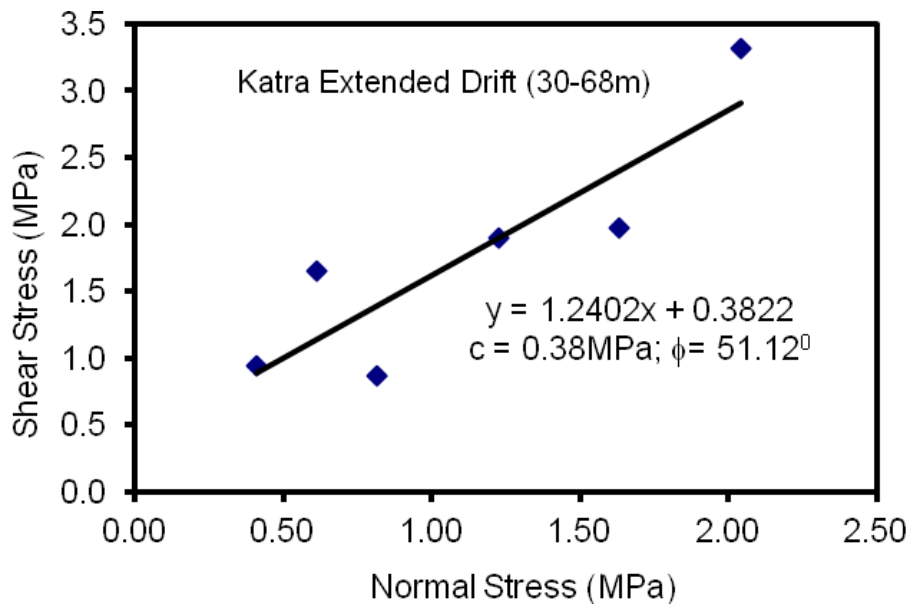
Fig. 8 - Shear stress versus normal stress for six shear tests on left abutment in extended drift

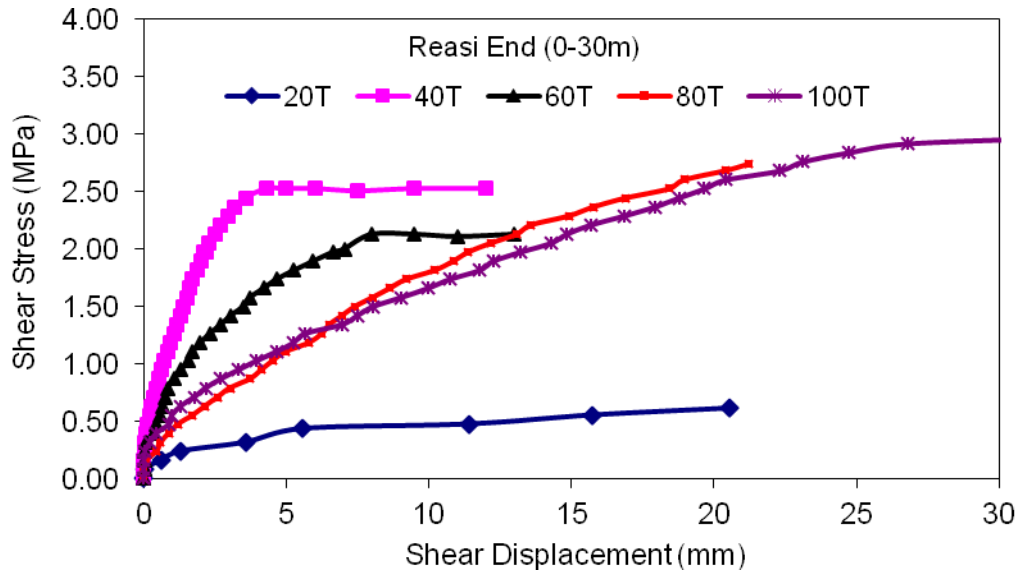
Fig. 9 - Shear stress vs shear displacement of five shear tests conducted at right bank abutment (Normal load=20T to 100T; RD= from 12m to 27m from the portal)

In right bank drift of 32m length, five shear tests (SHT) were conducted to determine the shear strength parameters of rock mass. Shear stress versus shear displacement plots are shown

in Fig. 9 for all five tests on the right abutment. In general, shear stress increases with the increase in normal stress. However, the different magnitudes of peak and residual shear stresses were obtained exceptionally due to change in rock profile at same magnitude of normal stress (Singh, 2009). It is also seen from Fig. 9 that the variations in shear stresses are not proportional to the normal stresses. The maximum shear stress is for a normal load of 100T which is more than the shear stress for 80T of normal load. However, shear stress at normal load of 40T is higher than the shear stress at 60T of normal load. This has all happened due to variations in number of joints and strength properties of joints in rock mass.

In the present case study, the blocks were sheared in horizontal directions which were almost along the foliation joints. Due to highly jointed nature of rock mass and shearing almost along the foliation, only residual stresses were obtained from Fig. 9 at different normal stresses for respective blocks. From the “curve of best fit” for shear stress versus normal stress plot as shown in Fig. 10, the value of cohesion ‘c’ is 0.71MPa and ‘ ϕ ’ is 50.48°, as obtained for residual shear strength on rock to rock interface.

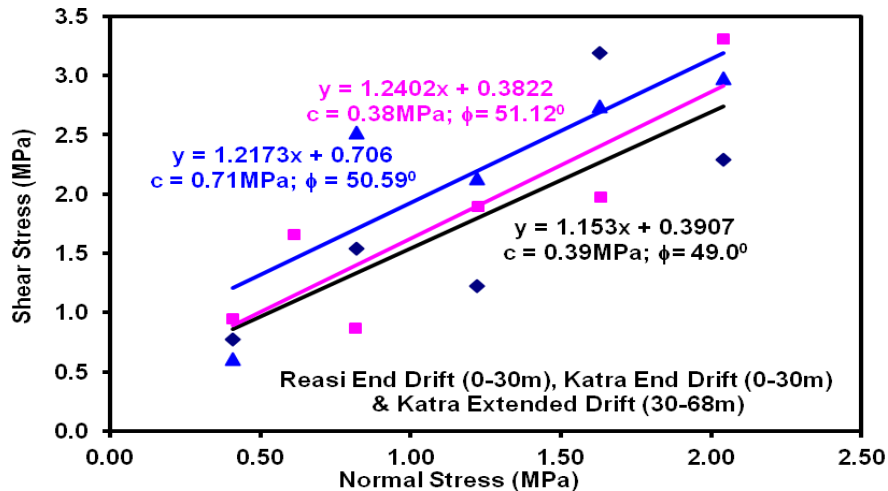
Fig. 11 - Shear stress versus normal stress for 3 sets from left and right abutments

The shear stress versus normal stress plot is shown in Fig. 11 for three sets of shear tests conducted inside drifts on left and right abutments. The trend lines for 3 sets are almost parallel to each other with slight variations in shear strength parameters of rock to rock interfaces.
