***Geotechnical Investigations and Stability Analysis of
Slopes at Matli Site, Uttarkashi District,
Uttaranchal State, India***

ABSTRACT

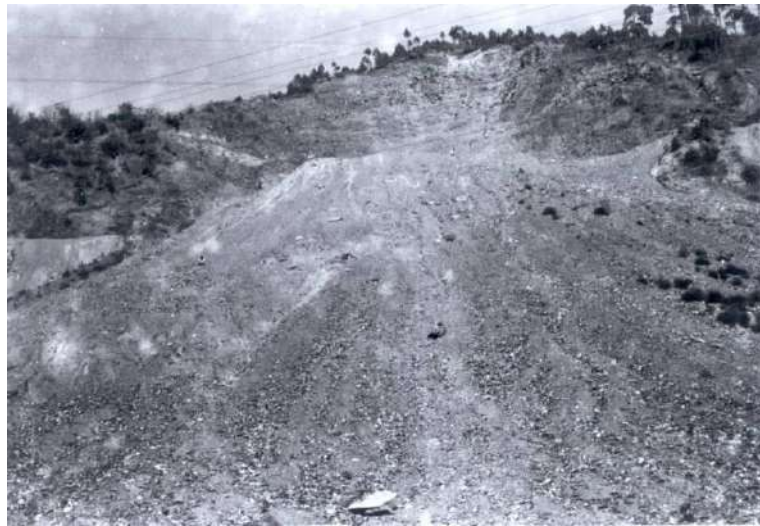
Fig. 1 - Panoramic view of problematic slope at Matli site

The hill slopes near village Matli constitute the most problematic failed slope (Fig. 1) along the state highway 53. The site located at a distance of 139.8 km from Rishikesh, on a sharp bend on the right bank of the river Bhagirathi is significant from techno-economic and socio-ecological point of view and has been selected in consultation with Border Roads Organisation (BRO) for detailed investigations and field monitoring in order to understand the nature and behaviour of these slopes and to suggest appropriate remedial measures.

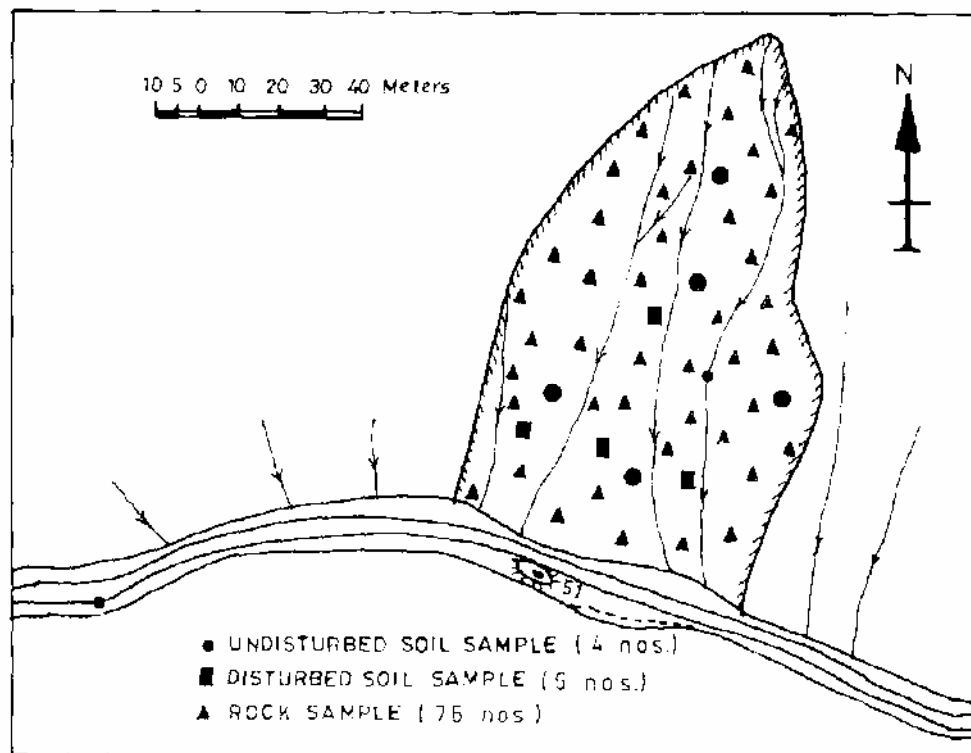
Fig. 2 - Locations of samples at Matli site

In order to assess the stability of slopes at Matli site (Fig. 1), an evaluation of the geotechnical properties of the slope materials in field conditions is necessary. Investigations have been made in the field as well as in the laboratory. The rock and soil samples (both disturbed and undisturbed) have been collected from the site for laboratory testing. The locations of these

samples are shown in Fig. 2. The geotechnical parameters viz. uniaxial compressive strength of the rocks, grain size distribution of soils, Atterberg's limits of soils, bulk density, water content and shear strength of soils have been studied from these samples and the results are presented in Tables 1 and 2.

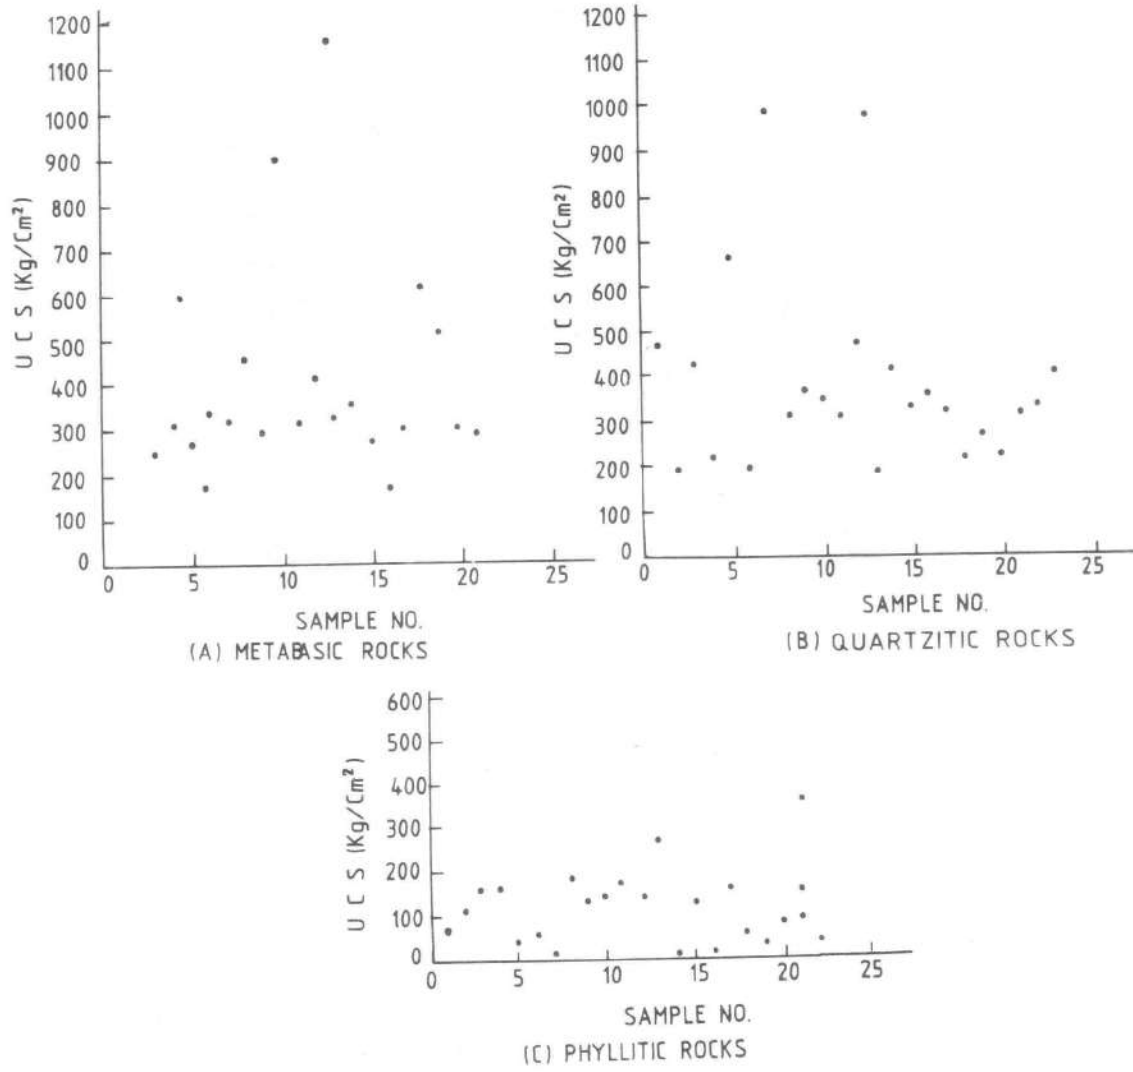
* UCS - Uniaxial Compressive Strength

Figs. 3 (A to C) - Uniaxial compressive strength of rock samples from Matli site

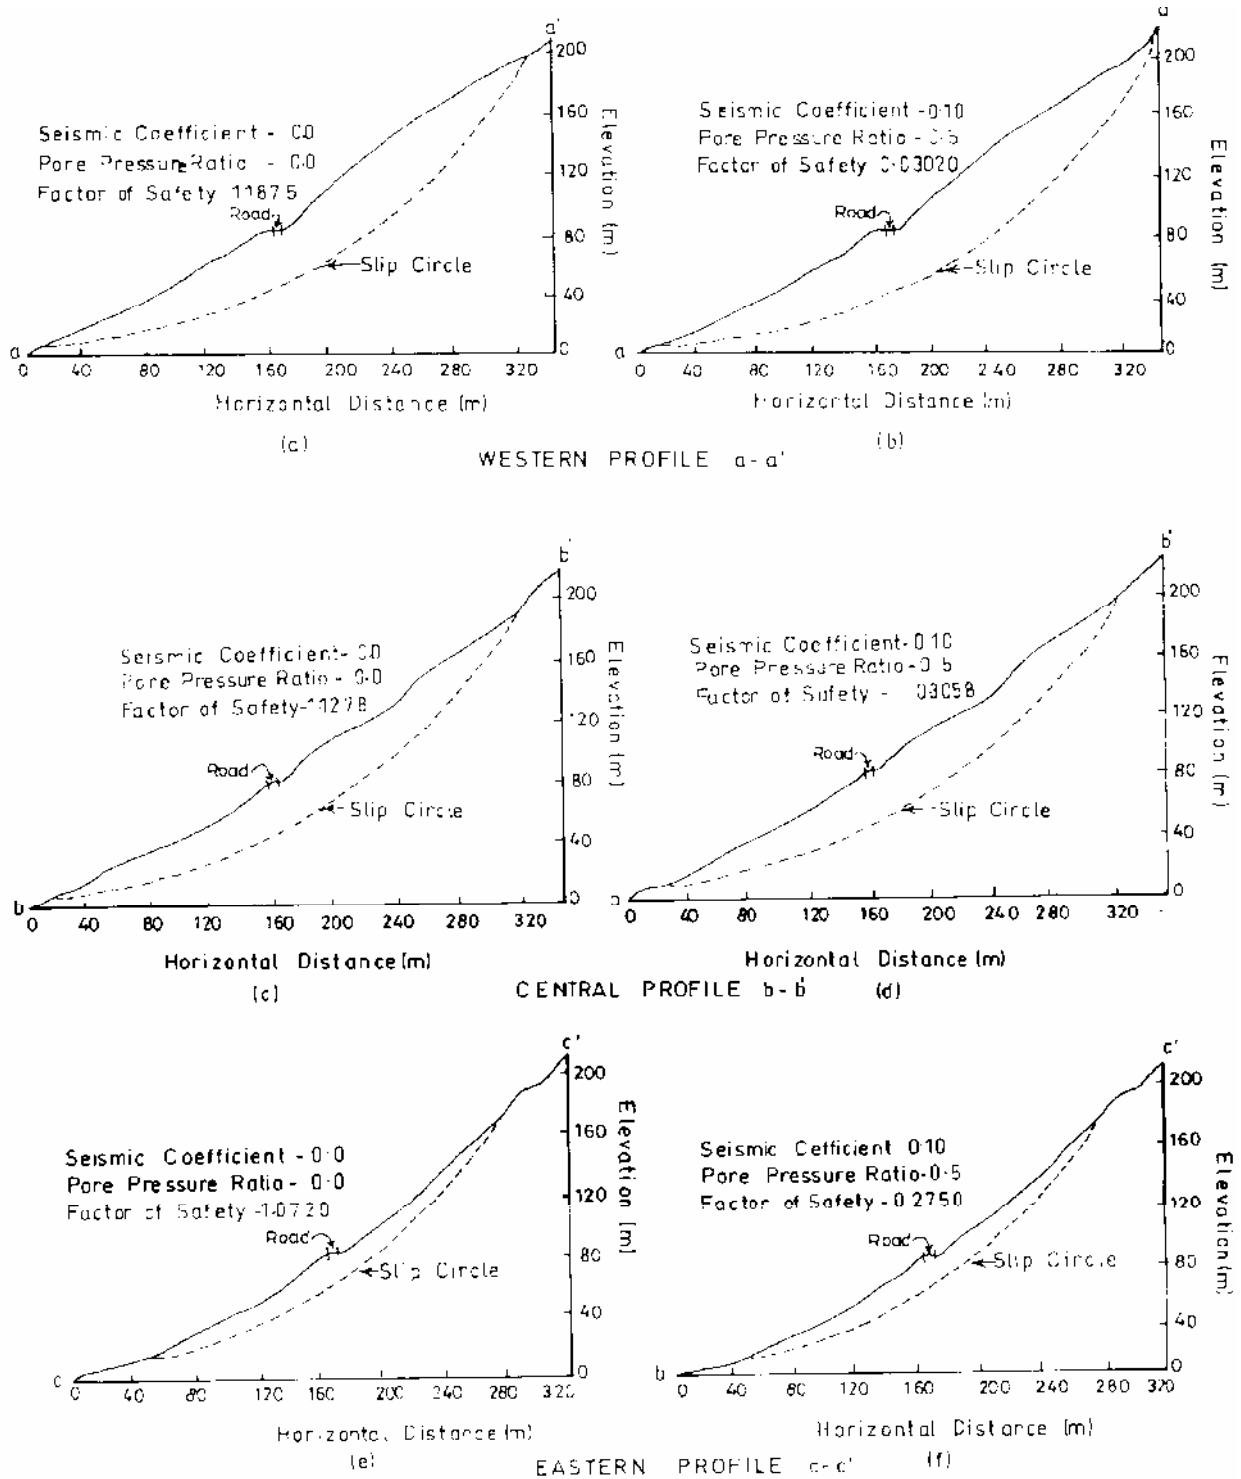
Figs. 8 (a to f) - Potential slip surfaces along different profiles at Malti site

At Matli site, the slope material is highly weathered, jointed and fractured which clearly indicates that the failure surface may tend to follow a circular path. The stability analysis of this site has been carried out using a computer program, which is based on Bishop's simplified method of slices. An attempt has also been made to consider the seismic accelerations and pore water pressures on the stability of slopes.

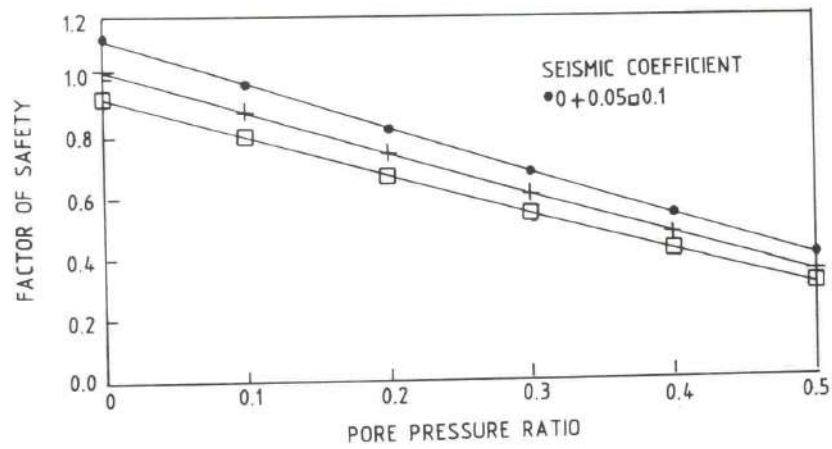
Fig. 9b - Factor of safety versus pore pressure ratio along profile BB'

Three cross-sections (Fig 7) of the failed site in the eastern, central and western parts have been considered for stability evaluation in the present case. The results are presented in Table 3. The Table shows the variations in the values of factor of safety with changes in pore pressure ratios and seismic coefficients for different profiles. It has been observed that the factor of safety varies between 1.1875 and 0.275. The slip surfaces for the three profiles at minimum water content with minimum ground accelerations as well as in the extreme conditions when the water content and ground accelerations are maximum, have been shown in the Fig. 8 a-f. An attempt has also been made to know the variations in the factor of safety with changes in pore pressure ratios at different seismic coefficients along these profiles. It can be observed from these figures that the site is stable only in dry conditions when there is no ground acceleration. An increase in water content even by 10% makes the slopes unstable. The results also indicate that the western profile has the lowest factor of safety compared to central and eastern profiles.

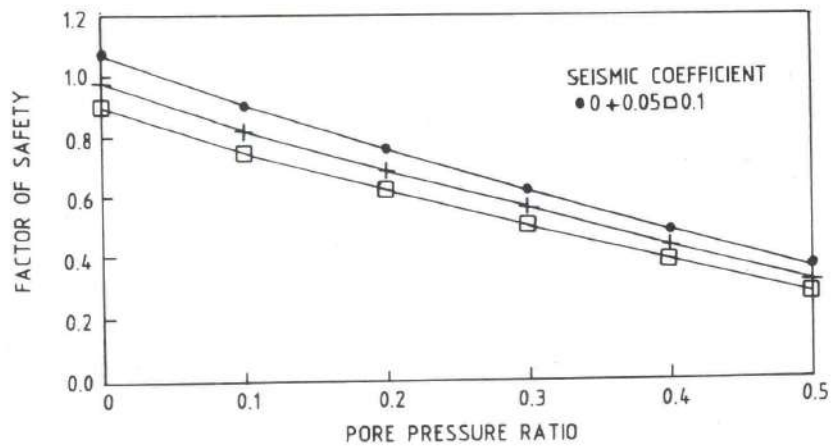
Fig. 9c - Factor of safety versus pore pressure ratio along profile CC'
