Seri Nalla Fault Zone, Atal Tunnel, Rohtang- Overcoming the Challenges

Mridupam Pathak

PEMS Engineering Consultants Pvt. Ltd., D2-PEMS-ICT JV, Manali, India

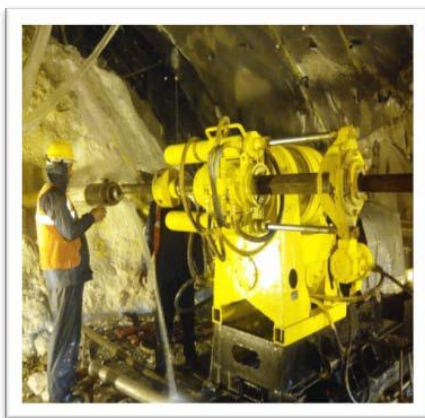
Figure 15 - Core drilling

Core drilling was first carried out during October 2012 at Ch. 2+053, 2+066, 2+070 and 2+072 m. Drill holes at Ch.2+072 and 2+070m were carried out in the face at an angle 10° upwards with the horizontal. The holes were drilled till depth of 15 to 30 m. In all the holes highly fractured and sheared rock with some clay seams were encountered (Figs. 15 & 16).

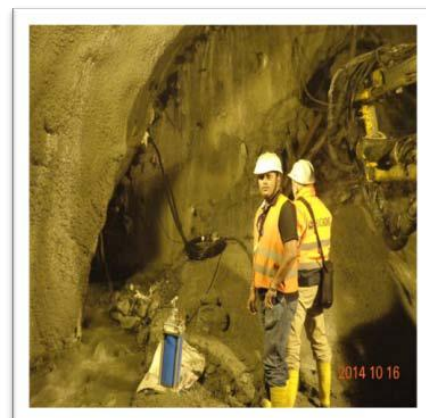
Figure 16 -Water pressure test

Water pressure test were done at different Ch.s in Seri Nalla before grouting to find out the Lugeon value. The Maximum Lugeon value recoded was 98.0 (turbulent flow) at Ch 2+410 and minimum value recoded was 0.42 (turbulent flow) at Ch. 2+389.5m. Between Ch 2+406 to 2+411, the average value of Lugeon was recorded 81.15, which was very high and indicate that large grouting was required in this reach (Table 2).

Based on the water pressure tests, consolidation grouting in single stage and multi stage was done before the advancement of the tunnel.

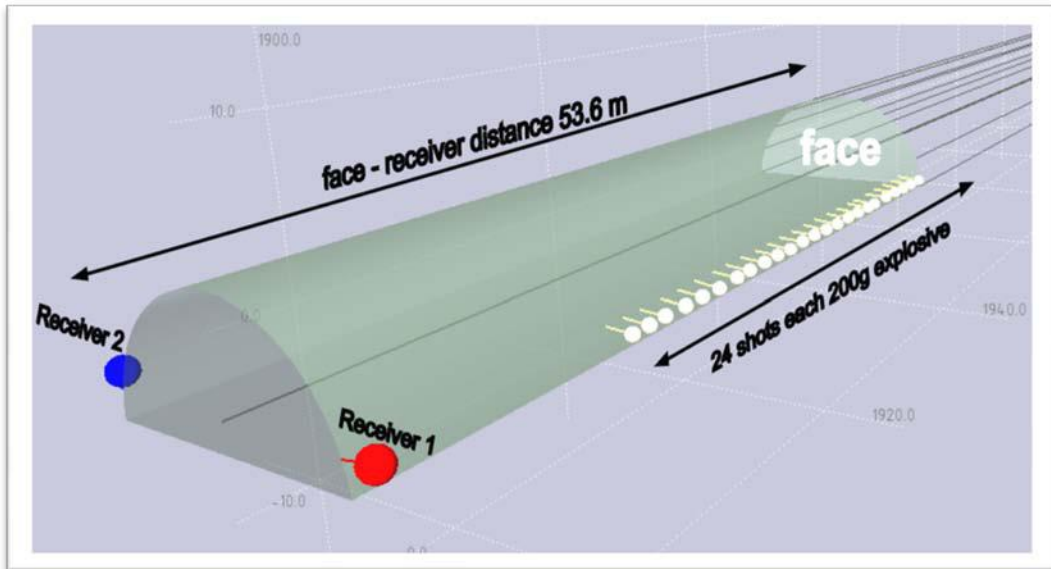
Figure 17 - Layout of TSP survey at Atal tunnel, Rohtang

Total 8 numbers of TSPs were carried out in this project out of which 6 nos. were done in the South portal side and all in the Seri Nalla zone. The first was carried out at Ch. 1+943m and the sixth was carried out at Ch. 2+391m (Fig. 17).

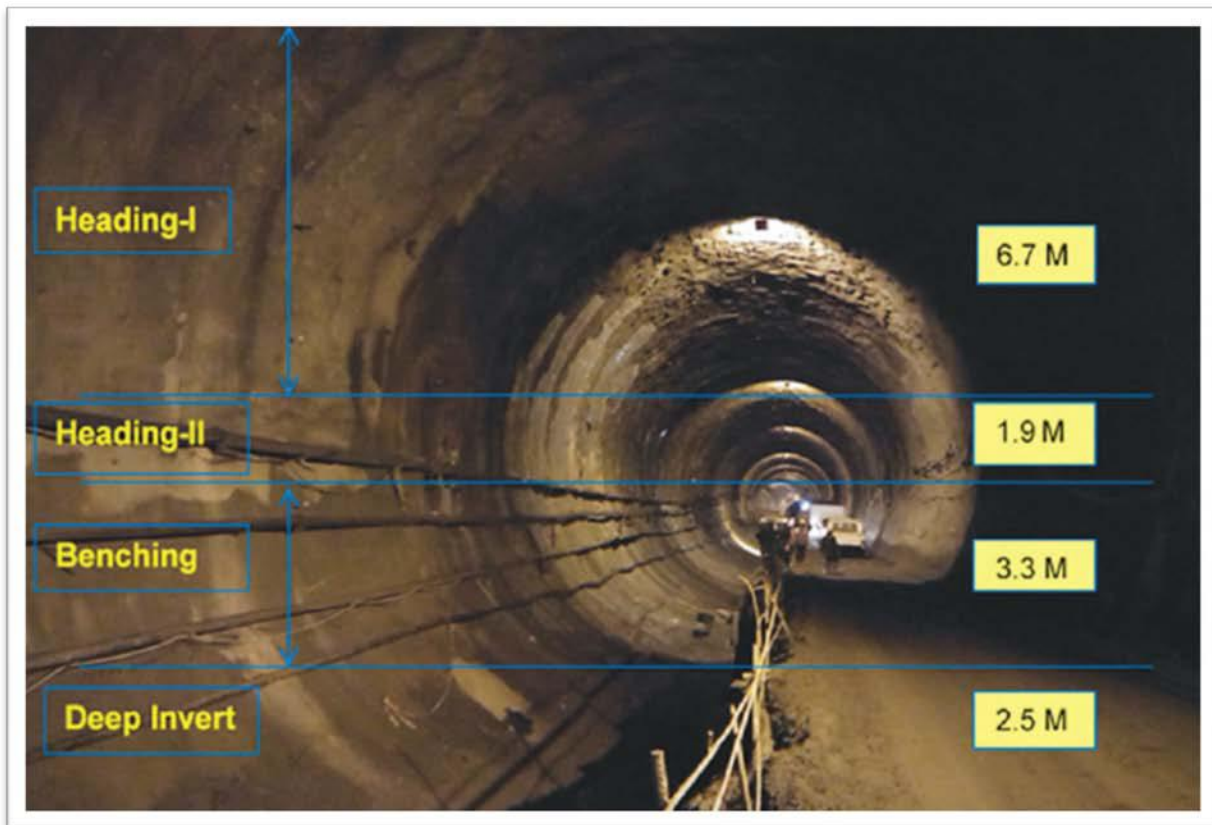
Figure 28 - Sequence of extension of heading 2, benching and invert

Though the nature of the strata to be encountered was known, but how it would behave was not exactly known as the water was moving within the strata. So, the section was divided into heading 2, benching and invert section as shown in Fig. 28. Heading 2 was excavated on both sides leaving central portion for movement of traffic.

Deep invert was constructed across the entire Seri Nalla stretch. This was done mainly to close the tunnel ring so that there is even distribution of stresses across the soft and weak Seri Nalla zone. The deep invert excavation was carried out to the required levels as per the design, half side for facilitating traffic movements.

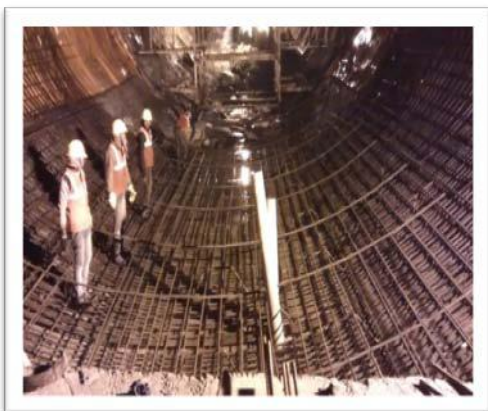
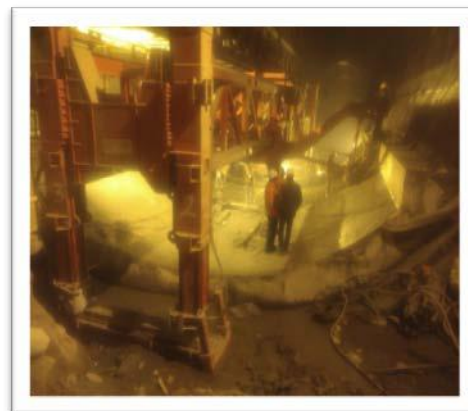
Figure 33 - Reinforcement for deep invert

Figure 34 - Lining of deep invert

A 100 mm protection concrete layer with wiremesh was applied on top of the water proofing membrane. On top of this protective concrete layer, 500 mm RCC (Main bar 25 mm and Distribution bar 20 mm) lining was done with the grade of concrete being S35 as shown in Figs. 33 & 34.

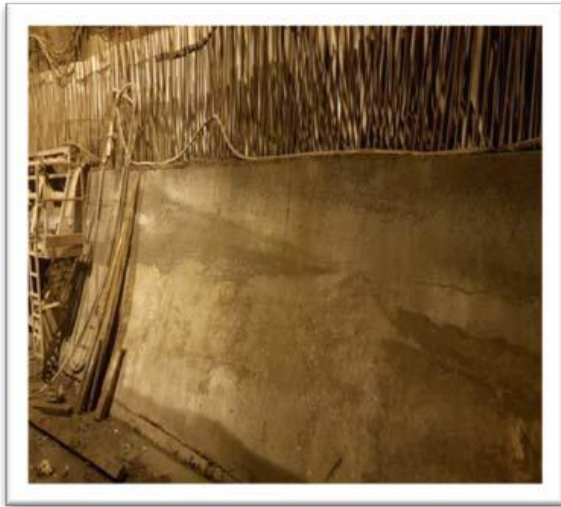
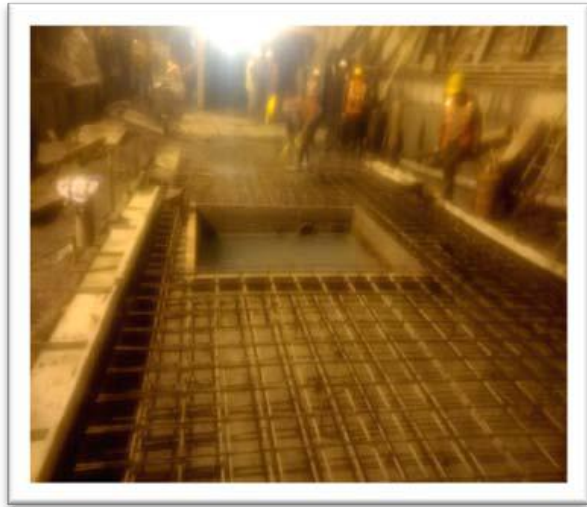
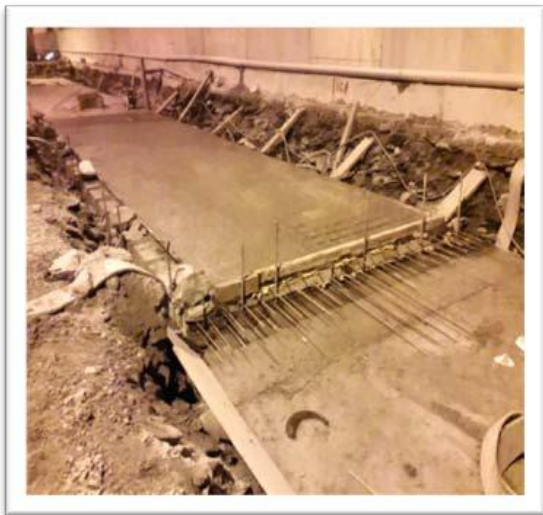
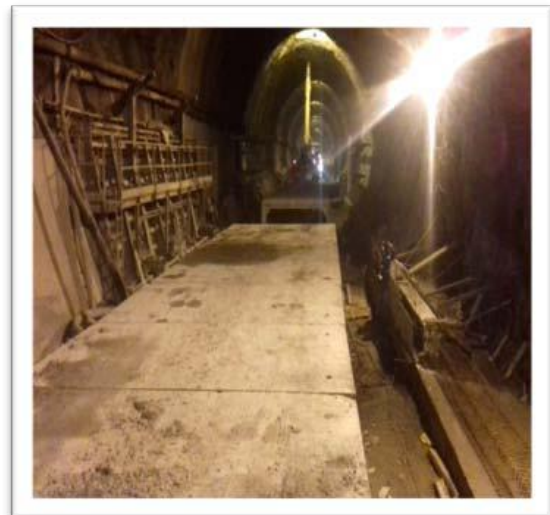
Figure 35 - Reinforced kicker lining

Figure 36 - Reinforcement of base slab

Figure 37 - Concreting of base slab

Figure 38 - Lining of deep invert

After the lining of the deep invert, other activities like the reinforcement and concreting of the kicker lining and reinforcement and concreting of the base slab followed by installation of the pre-cast EET (emergency egress tunnel) is carried out as shown in Figs. 35, 36, 37 and 38.

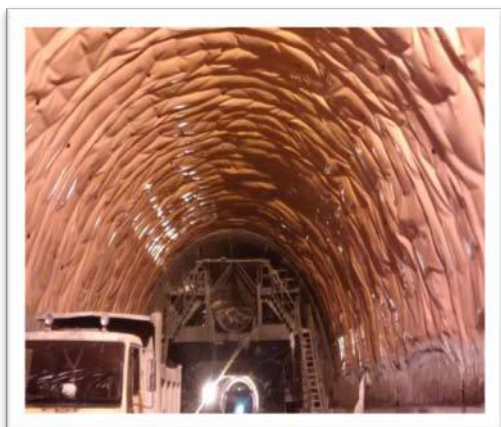
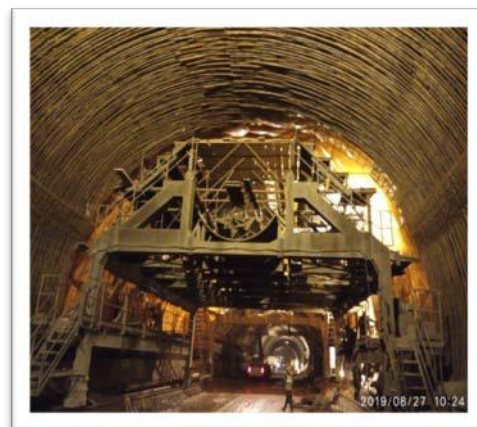
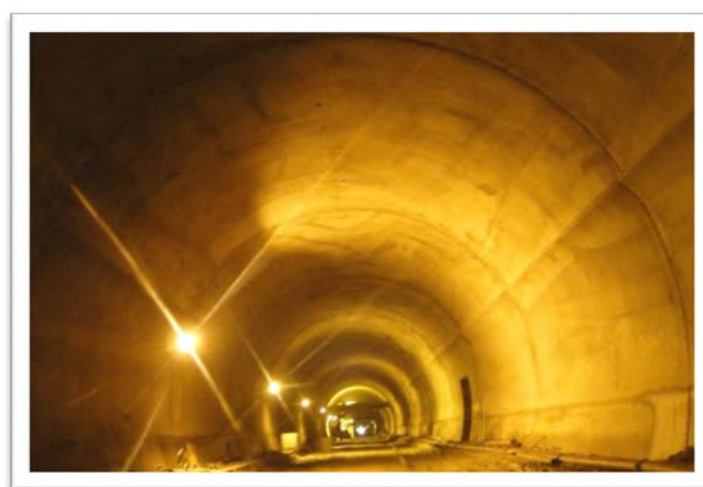
In case of Overt Section, re-profiling had to be carried out at several places due to undercuts in those sections as a result of higher deformations in those areas. As a result scaling of these areas had to be carried out together with cutting of the previously installed pipe roofs and new lattice girders had to be installed followed by wire mesh and shotcrete (Figs. 39, 40 and 41).

Figure 39 - Water-proofing of overt section

Figure 40 - Reinforcement of overt

Figure 41 - Completed final lining of overt

After re-profiling, geo-textile and geo-membrane were installed before the reinforced lining. In this zone 500 mm RCC (Main bar 25 mm and distribution bar 20 mm) final lining was carried out with the grade of concrete being S35.
