Stress Mapping for Preferred Orientation of Galleries in Underground Coal Mines

*Dr.D.N.Sharma
U.Shivnarayana
Pankaj Kulshrestha*

*The Singareni Collieries Co. Ltd,
Kothagudem-507101, A.P., India
Ph.: 08744 242418
Fax: 08744 245968
E mail: drdn_sharma@yahoo.co.in*

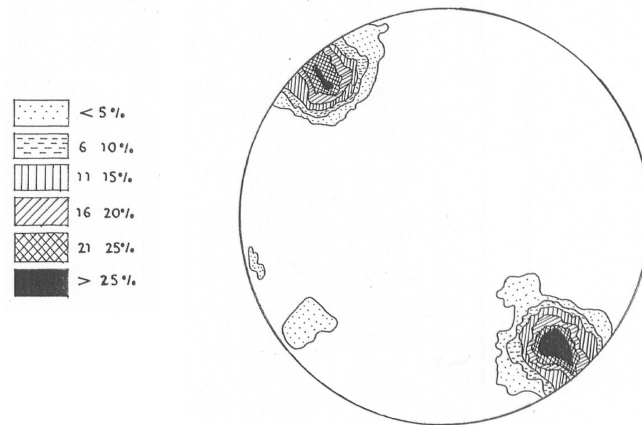
Fig. 5 – Contour diagram of joints plotted on equal area projection, lower hemisphere (100 joint poles)

Similar stress conditions of VK-7 are observed in the area under reference that is 5 shaft, being northern continuity. The rose diagram drawn for 100 readings of joint orientation reveals two distinct directions of joints viz. J_1 and J_2 (Fig. 4). The most prominent joint set J_1 is in the direction of $N45^\circ E$ which is almost perpendicular to level galleries and next prominent joints J_2 trends in $N 55^\circ E$. The least prominent sets J_3 and J_4 fall in the directions $N 45^\circ W$ and $N 35^\circ W$ respectively. The identification of total number of joints sets and their dips and dip direction is very important in the analysis of stability of underground openings. As such, true dip and dip directions of a large number of joints are measured in the study area. Zhang and Tong (1988) developed a computer program, STEREO, for automatic plotting of pole concentration. Using the software of Singh and Goel (2002), the poles of the joints are plotted on the stereonet and are contoured at 5% interval to infer the major principal stress direction (σ_1) indirectly, as there are no major or minor folds in the study area to derive the σ_1 from the orientation of fold axis (Fig. 5).
