# ***Response and Earthquake Induced Damage of Underground Structures in Rock Mass***

***Ömer Aydan\****

***Keywords:*** Underground opening; Earthquake damage; Fault; Shaking; Concrete lining

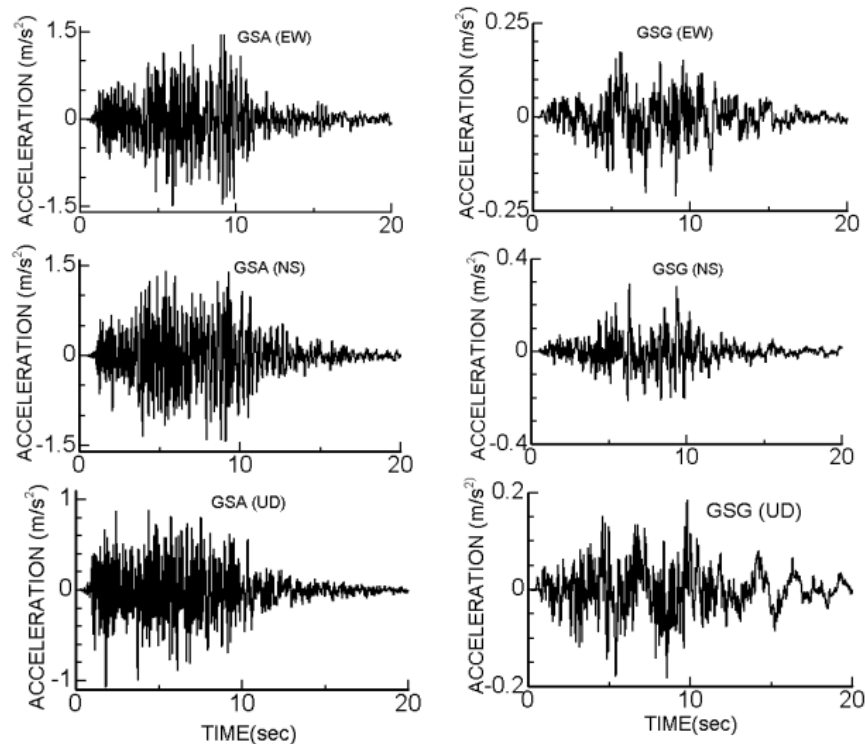
Figure 1 shows the acceleration records measured on the ground surface (GSA) and underground (GSG) during the 2009 Mw 6.3 L'Aquila earthquake. The GSA station is at Assergi and the GSG station is located in an underground gallery. Both stations are founded on Eocene limestone with a shear wave velocity of 1 km/s. Although the epicentral distances and ground conditions are the same, the acceleration at ground surface is amplified almost 15 times that in the underground gallery.

Fig. 1 - Acceleration records at GSA and GSG strong motion stations (Aydan et al., 2010)

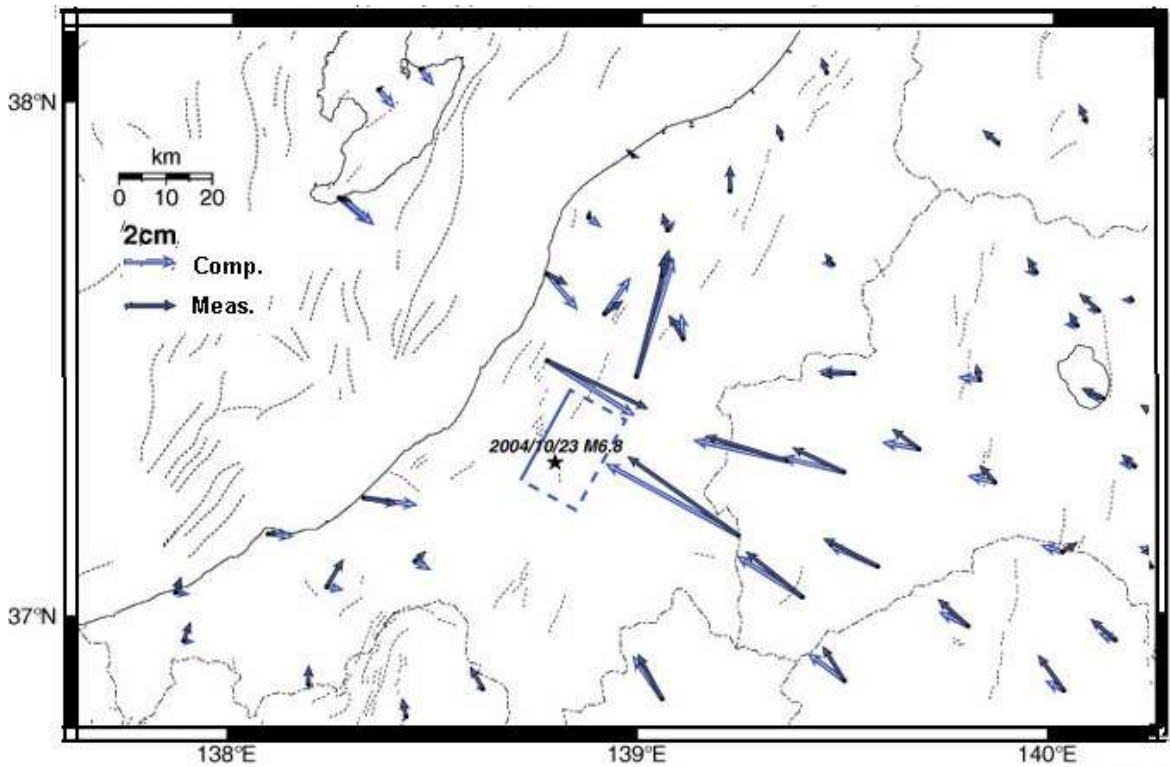
The recent global positioning system (GPS) also showed that permanent deformations of the ground surface occur after each earthquake (Fig. 2). The permanent ground deformation may result from different causes such as faulting, slope failure, liquefaction and plastic deformation induced by ground shaking. Although this type of ground deformations will have limited effect on structures except the surface breaks pass

Fig. 2 - Permanent ground deformations induced by the 2004 Chuetsu earthquake

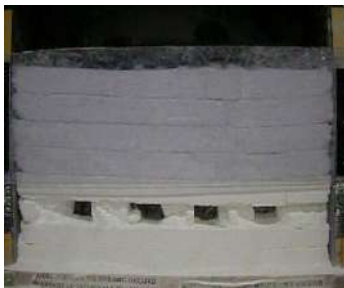
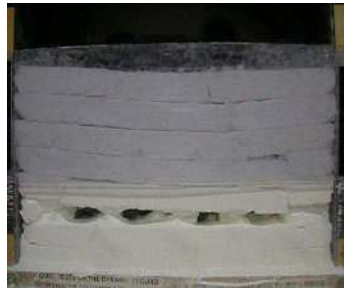
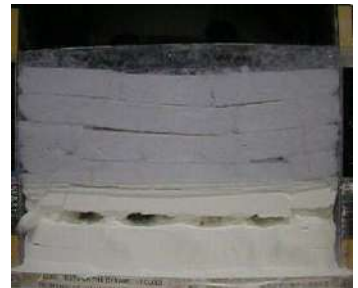
(a) Compressive failure of pillars

Fig. 6 - Some views of models of abandoned lignite mines during shaking table tests

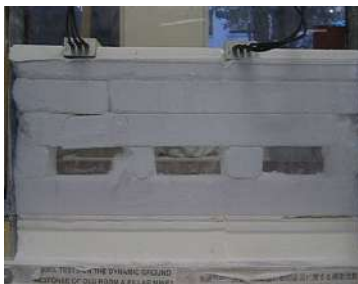
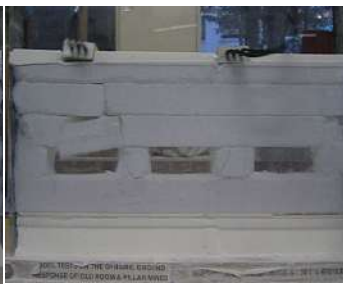
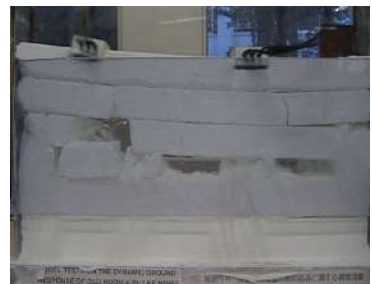
(b) Bending failure of roof layers

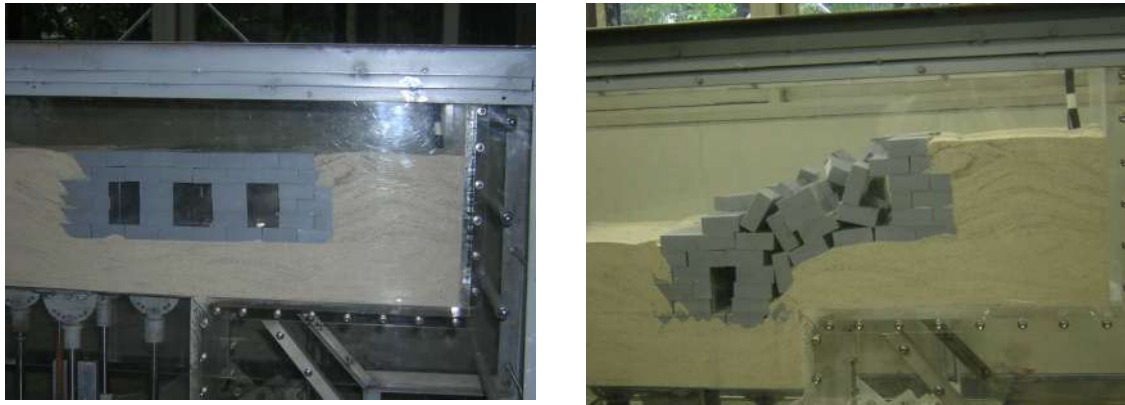
In some of model tests, the effect of faulting was also investigated. Fig. 7 shows some views of a model test of an abandoned room and pillar mine in jointed rock mass induced by vertical normal faulting.

Fig. 7 - Views of damage to an abandoned room and pillar mine by vertical normal faulting

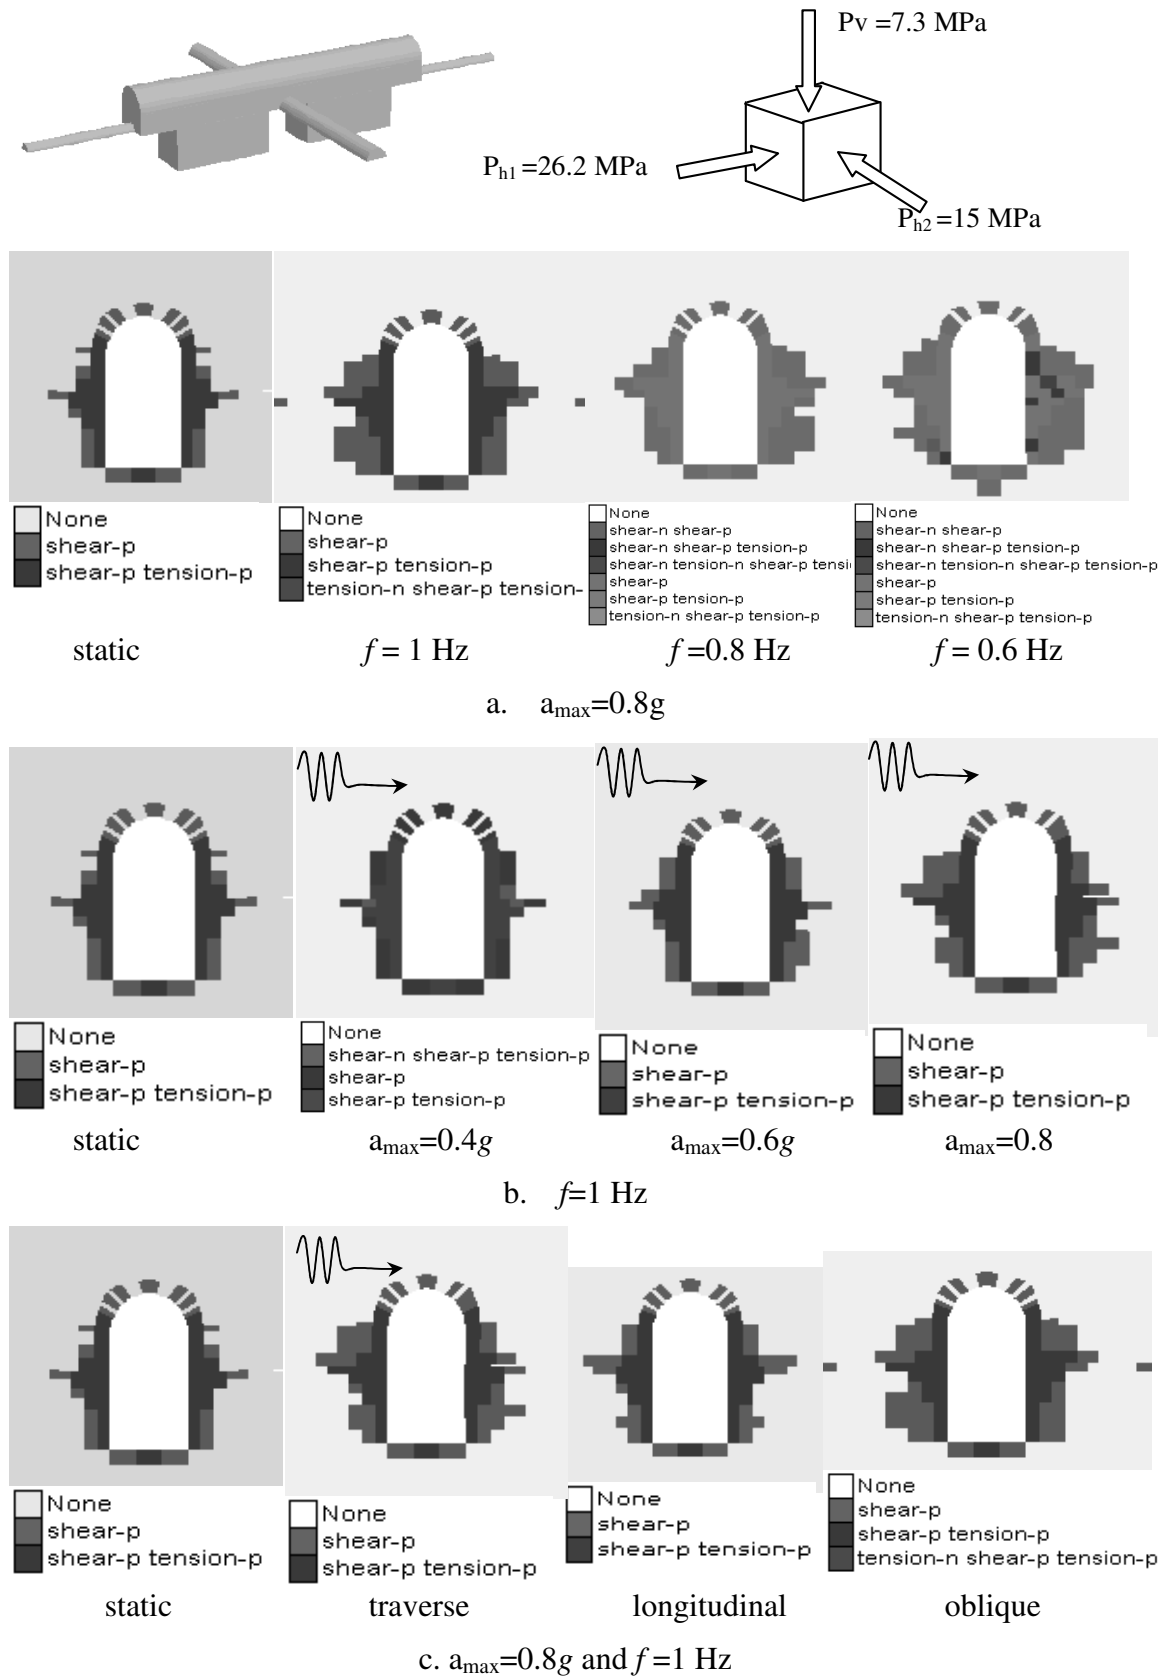
A series of numerical studies for the static and dynamic stability assessments of a large underground opening for a hydroelectric power house was carried out (see Genis and Aydan (2007) for details). The cavern is in granite under high initial stress condition and approximately 550 m below ground surface and the area experienced the largest inland earthquake with a magnitude of 8 in 1891 in Japan. In the numerical analyses, the amplitude, frequency content and propagation direction of waves were varied (Fig. 10). The numerical analyses indicated that the yield zone formation is frequency and amplitude dependent. Furthermore, the direction of wave propagation has also large influence on the yield zone formation around the cavern. When maximum ground acceleration exceeds 0.6-0.7g, it results in the increase of plastic zones around the opening. Thus, there will be no additional yield zone around the cavern if the maximum ground acceleration is less than this threshold value.

Fig. 10 - Yield zone formation of underground power house for different cases of input ground motions (Genis and Aydan, 2007)

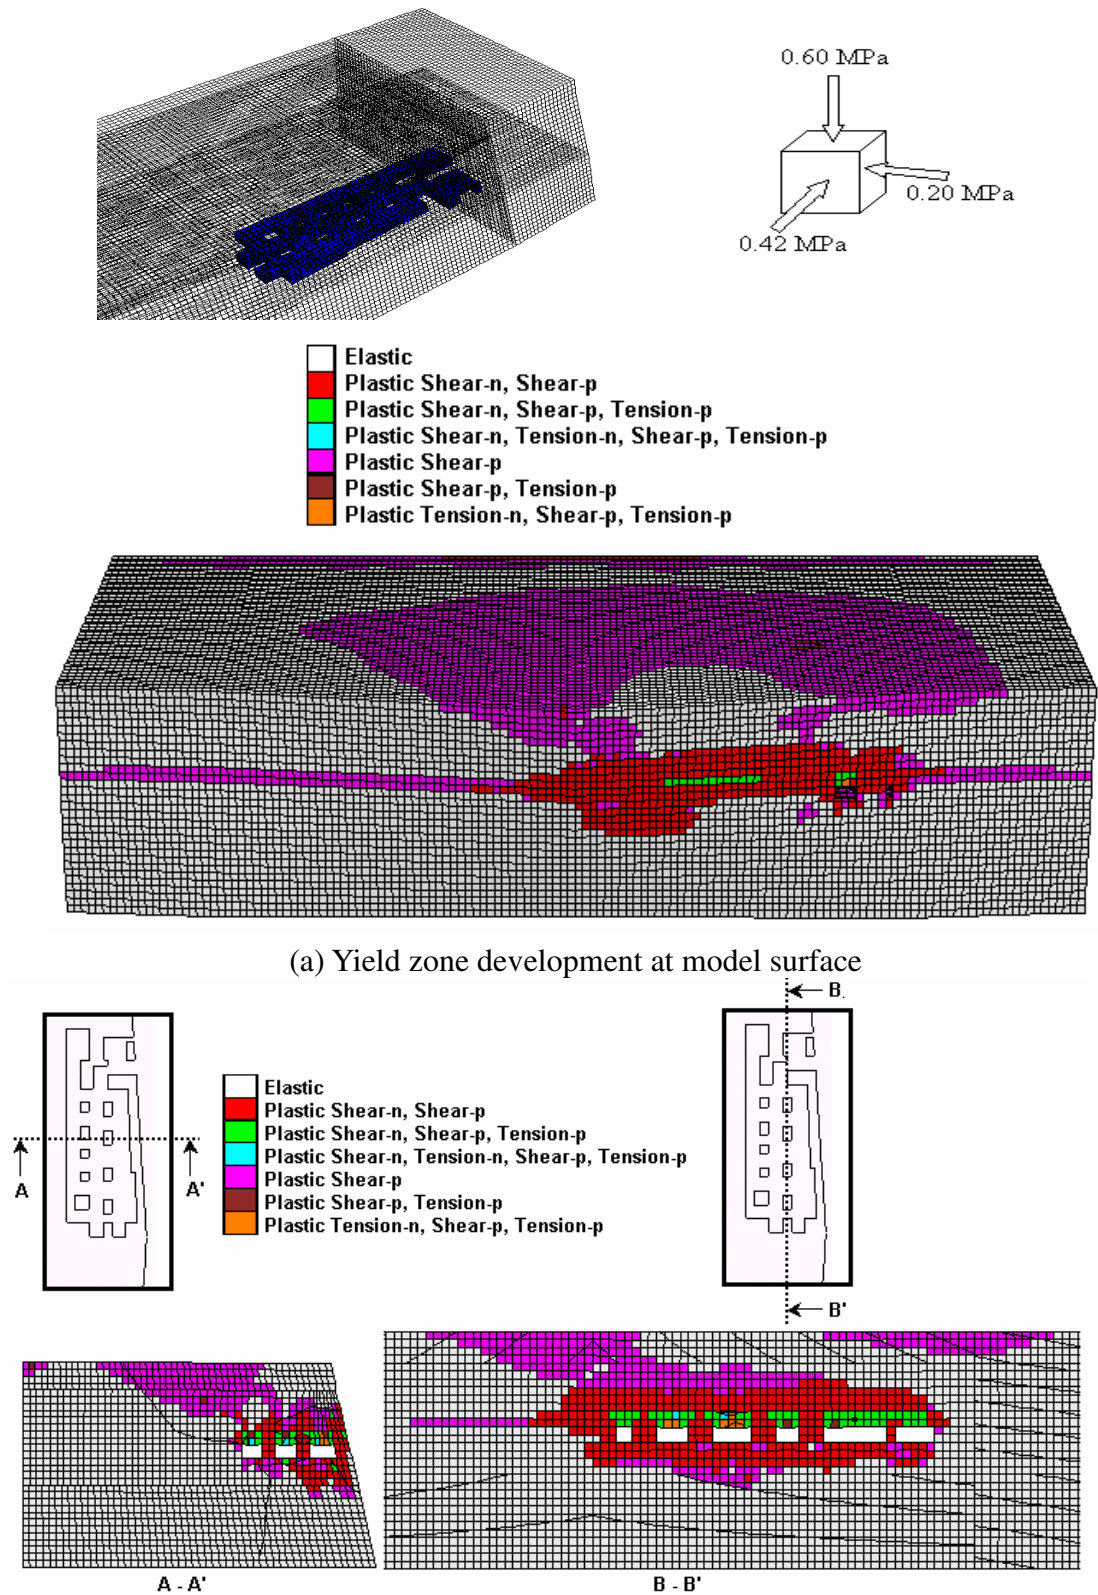
Fig. 11 - Yield zone around mine for ground with reduced strength properties (Genis and Aydan, 2008).

Figure 11 shows the yield zone development at the model surface and at EW and NS sections. This situation probably corresponds to a state of the total collapse of the abandoned mine. As seen in Fig. 11, the yielding at ground surface extends to a large area and the yielding in EW (A-A') cross section resembles to a slope failure containing the abandoned mine.

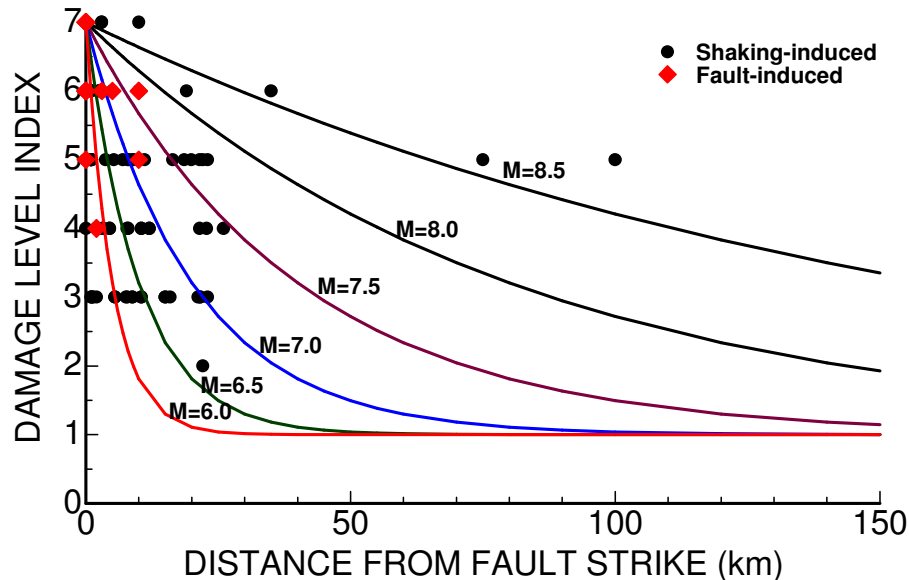
The definitions of structural damage of underground structures are generally too broad and a more refined classification of damage is felt to be necessary. The authors would propose a classification for this purpose as given in Table 1. Based on this classification, the authors re-plotted data shown in Fig. 27 as a function of distance from the surface trace or extrapolated surface trace of the earthquake fault. However, this is just a trial plot and how to consider the magnitude of the earthquake, which is a measure of the power of the seismic load, support system and ground properties, still remains as a challenging problem.

Fig. 27 - Relation between distance ( $R_f$ ) from surface trace of the fault and damage level index (DLI)
