Stability Analysis of Some Hill Slopes for Tehri Dam Reservoir Area

N.C.N. Srivastava
Faculty and Web Developer
Shreevastava Computer Education
Block No. 58, Bansidhar Society (Part-I)
P.O. New Railway Colony, 'D' Cabin
Sabarmati, Ahmedabad - 380 019 (Gujrat), India
Email: naveen0504@yahoo.com

Indrajit Basu
Department of Earth Sciences
University of Roorkee
Roorkee - 247 667, India
Fax : 091-1332-73560

R. Anbalagan
University of Asmara
P.O. Box 9582
Asmara, Eritrea (N.E. Africa)
Email: anba@earth.uoa.edu.er

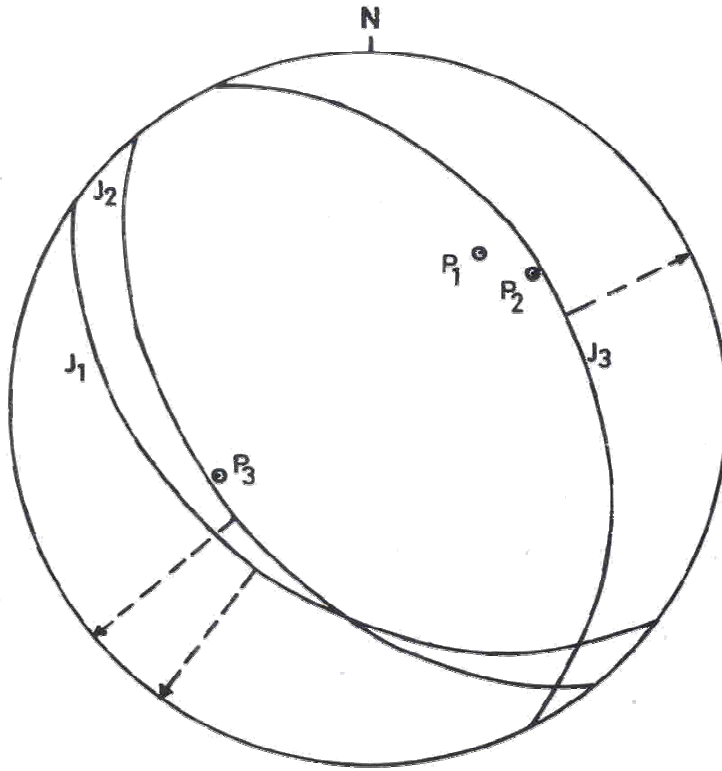
Fig. 3 - General pattern of discontinuities in the area of study.

right bank, old terraces are present at lower levels, and thick alluvial materials and colluvial soil cover are present on the upper levels. (Gupta & Anbalagan, 1997). The general pattern of discontinuities in the entire area of study has been shown in Fig. 3.
