Study of Roof Collapse in Rohtang Tunnel during Construction

K. K. Sharma

*Rohtang Tunnel, Border Roads Organisation, Manali, India
Email: kksharma18.iitd@gmail.com*

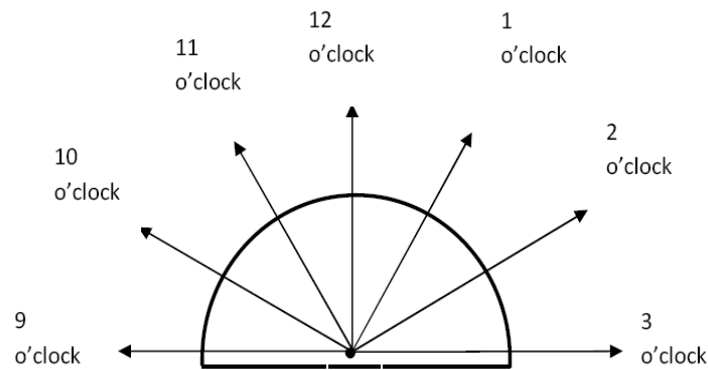
Fig. 8 - Directions for reference as seen from north portal

Figure 8 shows the direction of references inside the tunnel. Optical targets for measuring 3D deformation are generally installed in 10:00, 11:00, 12:00, 1:00 and 2:00 o'clock directions. Optical targets are being installed at distance of 10m but can be reduced to 5m wherever required.

All the wedges formed due to collapse had crown in approximately 1:00 o'clock direction, i.e. height of crowns of wedges measured from the periphery of the tunnel opening are maximum in this direction.

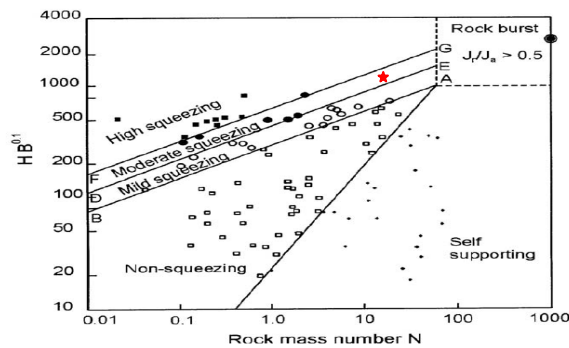
Fig.11 - $HB^{0.1}$ versus rock mass number N (Goel, 1994)

Table 2 shows the values of different parameters for calculating Q value at ch. 7+214. Squeezing ground condition is observed in weak rock mass with high overburden. In Rohtang tunnel, tunnelling media consists of hard rock (migmatite) and soft rock (mica schist) in alternate layer (Fig. 3). Figure 11 shows the relationship between $HB^{0.1}$ and rock mass number (N) for different squeezing condition as given by Goel (1994). Here, H is tunnel depth and B is tunnel span or diameter in metre.

In Rohtang tunnel north portal drive J_r/J_a is equal to 0.5 and hence just the border case for the squeezing condition. Generally, deformation is increasing with increasing overburden. But deformations in 11:00 and 1:00 o'clock directions are very high as compared to values in other directions on the same cross-section of the tunnel. So higher values of deformations in specified direction is not matching with squeezing condition as stress development due to high overburden should not vary much in different direction at one cross-section of tunnel. So it is clear that failure is not due to squeezing condition alone. Other factors also must be contributing.

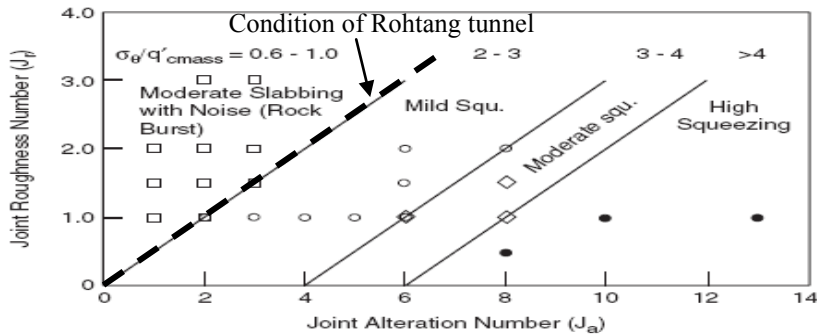
Fig.12 - J_a versus J_r for different squeezing and rock burst conditions (Kumar, 2002)

Rock bursting condition is observed in hard rock with high stress which increases generally with increasing overburden. Figure 12 shows the different combinations of J_r and J_a for squeezing and rock burst conditions as given by Kumar (2002). In Rohtang tunnel north portal drive J_r/J_a is always greater than or equal to 0.5, hence mild/ moderate rock burst condition is anticipated. Air blast is being observed after heading blast. But, no rock burst has been observed till now.

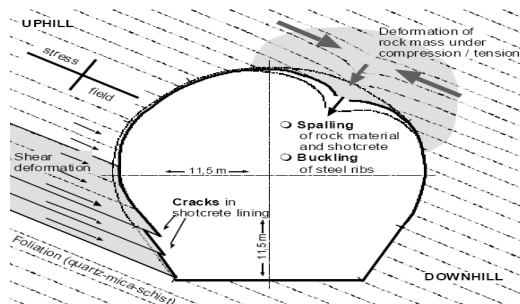
Fig.13 - Deformation/failure of rock mass under compression in approx 1:00 o'clock direction (Thuro and Eberhardt, 2001)

Figure 13 shows the typical deformation pattern in the HRT of NJPC project near (Rattanpur adit intersection) due to foliation orientation and deep seated slope movements. Similar conditions are being observed in Rohtang tunnel North Portal drive. Direction of foliation plane with respect to tunnel in the north portal drive of Rohtang tunnel is almost same as that in HRT of NJPC project. Deformation in 1:00 o'clock direction is increasing due to release of high stress under high overburden. Cracks in shotcrete, bending of lattice girders in the specified direction indicate the same condition as shown in Fig. 13. Therefore, it can be concluded that the roof collapse in Rohtang tunnel in between ch. 7245m and 7195m on 16th Oct 2013 is due to high stress concentration/release in specified direction. So rock bolt should have been provided in this part in zigzag pattern in the perpendicular direction of foliation. Later on as part of remedial measure in other location of the tunnel, where cracks were developed, rock bolts were installed in between 11:00 and 2:00 o'clock direction and perpendicular to foliation plane. It proved to be fruitful to stabilize the deformation. Hence not providing more numbers of rock bolts in this part of crown was the major cause of failure. Further this part was weakened by leaving slot in shotcrete.

A slot in shotcrete was left initially in 1:00 o'clock direction and later in 11:30 o'clock direction. Initially slot in shotcrete acted as apparent lining stress controller (LSC). But, in long term it allowed cracks to expand and when rocks were unable to support itself, it collapsed. So, leaving a slot in shotcrete layer proved detrimental. It has been avoided in further excavation of tunnelling. Leaving slot in shotcrete in 1:00 o'clock found to be a major cause of failure.
