Instrumentation for Study of Distress in Powerhouse and Concrete Dam – A Case Study

*Rajbal Singh**
*S.K. Verma***
*A.K. Dhawan***

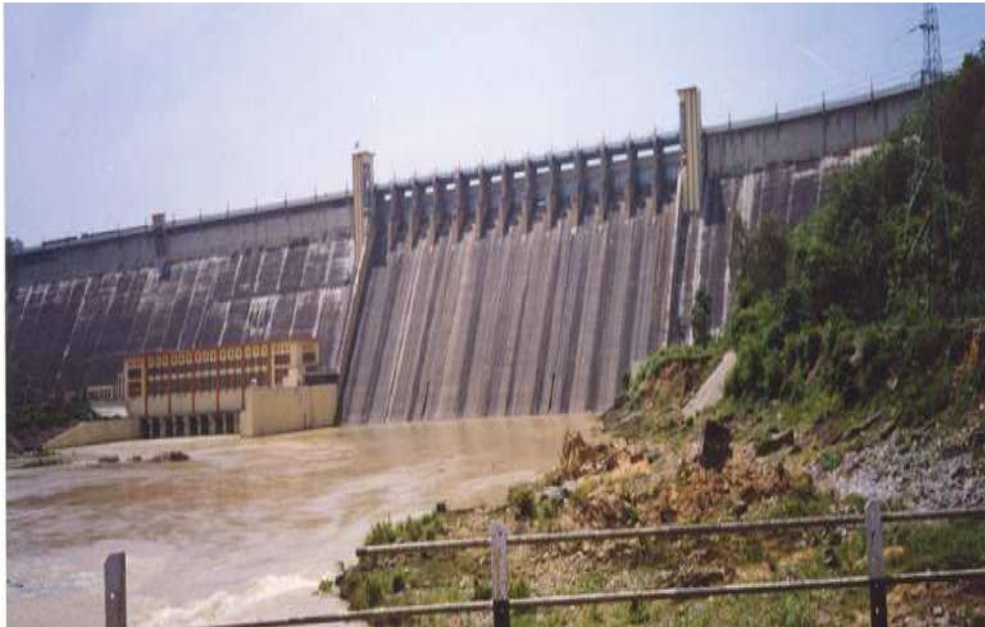
Fig. 1 - Down stream view of Rihand dam along with surface powerhouse

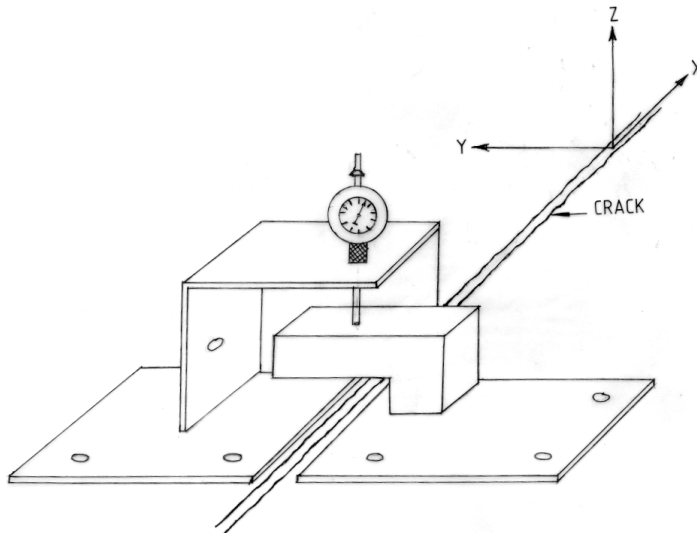
The 3-D crack monitor developed by CSMRS New Delhi is shown in Fig. 3. The crack monitor is capable of measuring crack deformations in three mutually perpendicular directions as shown in Fig. 4. X-axis measures the deformation along the crack i.e. the shear movement of the crack. Y-axis measures the deformation across the crack or perpendicular to the crack. The opening and closing of the crack/joint can be measured by Y-axis accurately. Z-

Fig. 3 - Layout presentation of 3-Dimensional crack monitor on the crack/joint
